CERTIFICATE OF APPROPRIATENESS

Re: Avery House, 328 West Mountain

Re: Avery House Rehabilitation Work

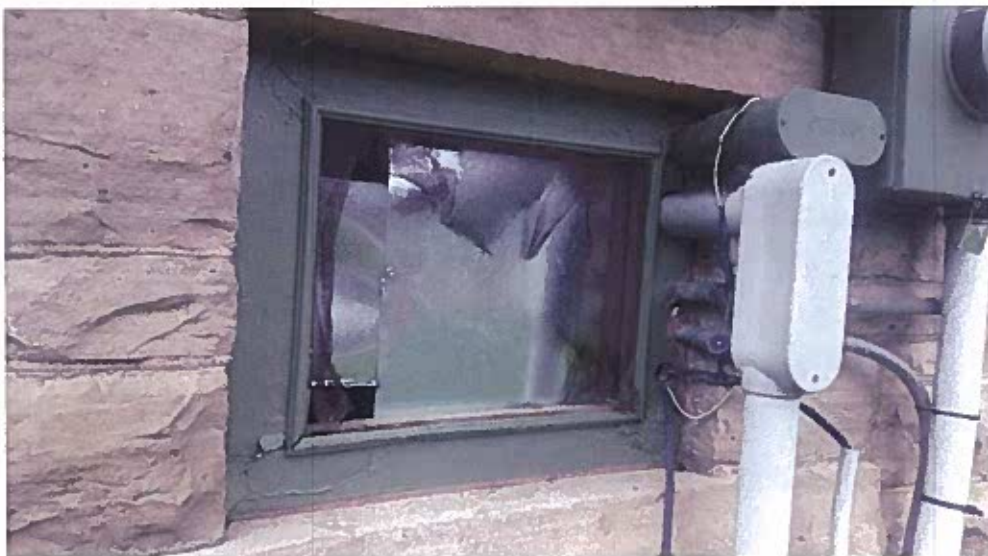
Vent Window: There is a vent window on the north side of the house that has been compromised in a couple of ways. Someone has pushed the screen in for some reason, and new electric has been installed through one of the wood sides of the sash.

Also, the bottom of the sash is rotted under the paint. The left side of the sash also has rot problems too. Of note, someone has also placed sheet metal over the opening for security. It is understood there is worry that someone could reach in and turn off power.

- Remove the vent sash on three sides as well as rot on the fourth side.
- The fourth side (enclosing the electric) would be trimmed to remove rot and leave the electric intact.
- The sash would be rebuilt similar to the original with repairs not to disturb the electric.
- The screen would be replaced to match the original.
- On the interior of the vent (if Historic Preservation agrees and the vent is not needed) we could place either a bead board panel or a lexan panel to seal the opening.

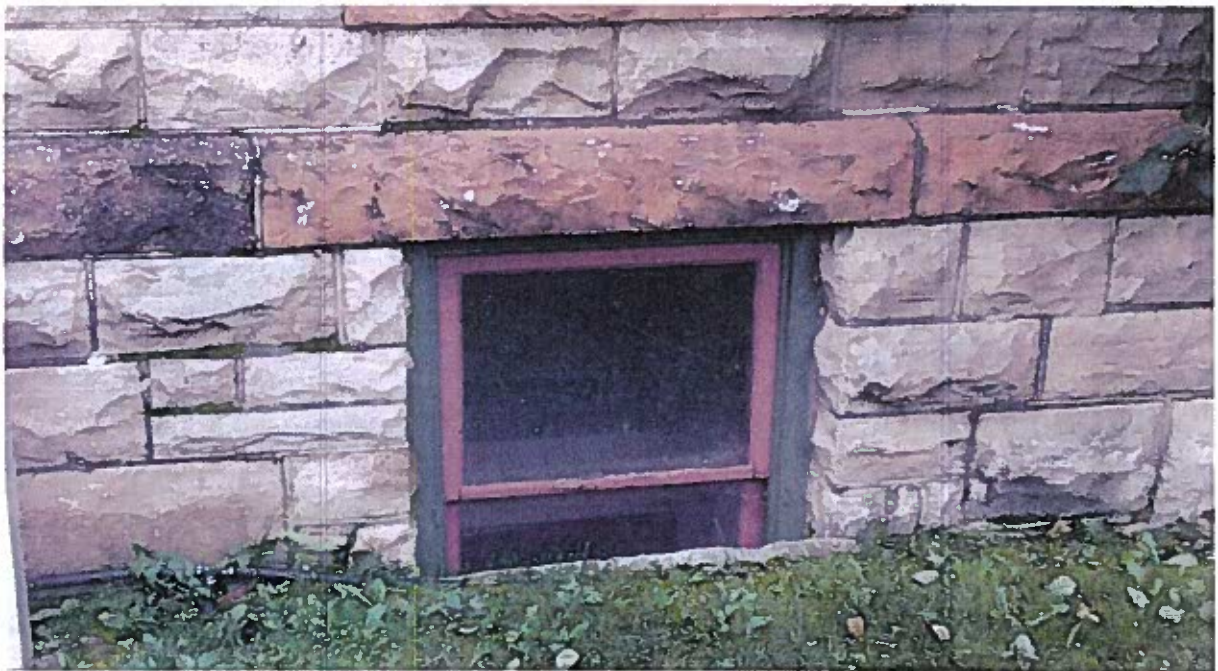
Basement Window: This is something I noticed when I went looking for the vent window. The basement has a double-hung window that is mostly underground.

The meeting rail for the upper sash is deteriorated and starting to come apart. The edge of the glass is exposed in one spot. The lower sashes bottom rail has some deterioration showing too.

- Removal of sashes and temporary boarding up of opening.
- Manufacture and install a new window sill from a weather resistant wood material; prime & paint.
- Rebuild upper sash as needed, possibly replacing the meeting rail. Reglaze, prime & paint.
- Rebuild lower sash as needed, possibly replacing or partially replacing lower sill. Reglaze, prime & paint.
- Consolidate any other failing wood members, fill & repaint.
- Reinstall sashes.
- Possibly install some type of lexan panel to minimize moisture sitting in window well. (This last one is complicated as any installed panel could be a safety problem if someone stood on it.)

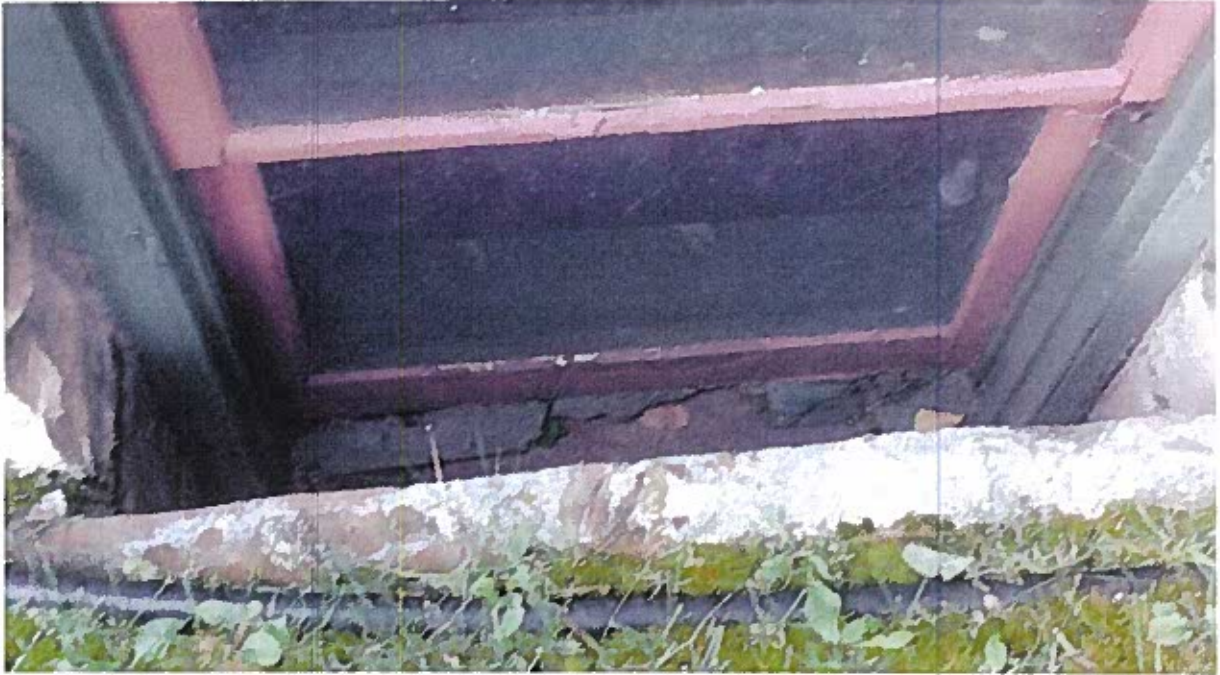
The sill is rotted away and coming apart in chunks. By NPS Historic Preservation Brief #9 (The Repair of Historic Wooden Windows) classification, this window is a class three repair. To repair this window, we would suggest:

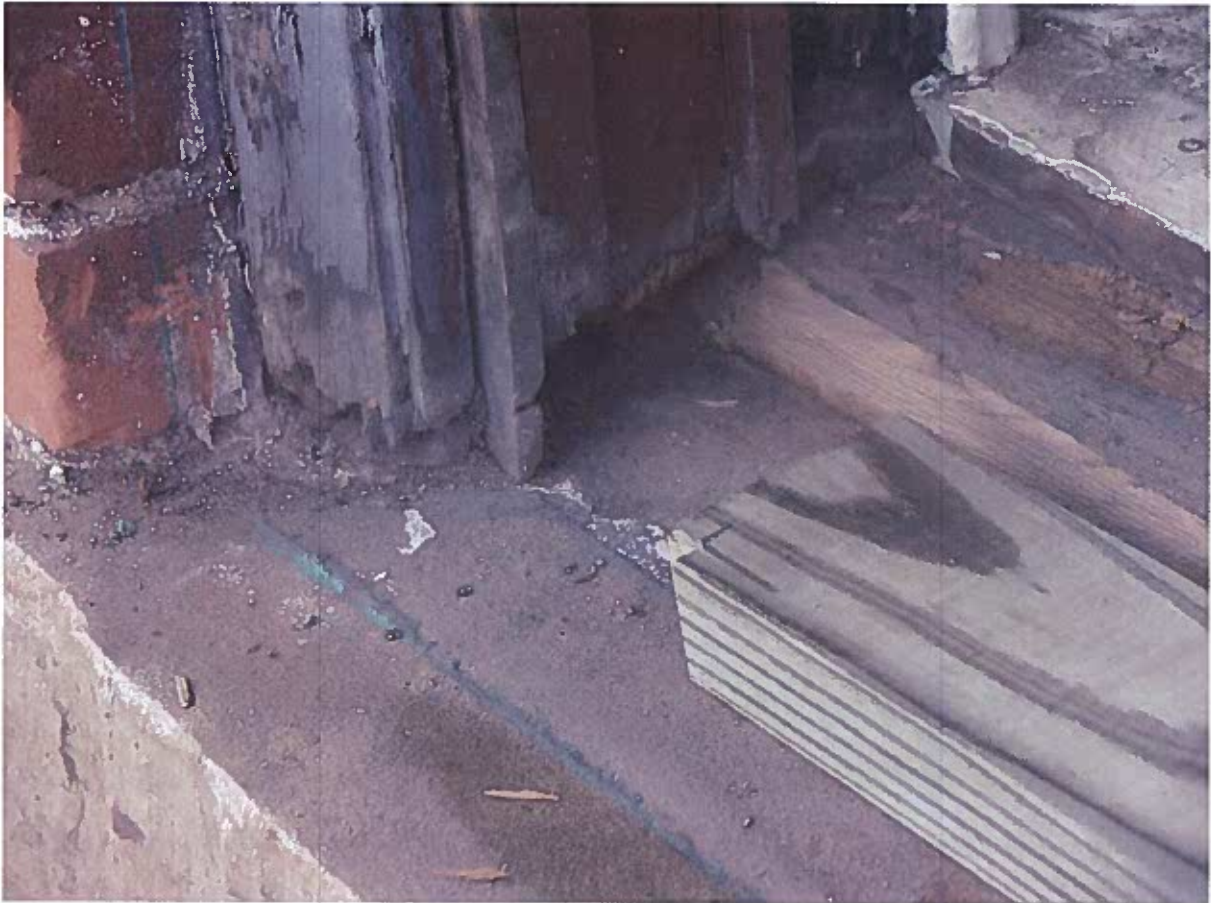
Figure 1: New pressure treated sill installed on Trolley Barn window 2004.
