**CERTIFICATE OF APPROPRIATENESS  
AND  
LANDMARK REHABILITATION LOAN AWARD NOTICE  
ISSUED: March 12, 2021  
EXPIRATION: March 12, 2022**

# WINDOW EVALUATION

**122 JACKSON AVENUE**

EVALUATION DATE: FEBRUARY 26, 2019

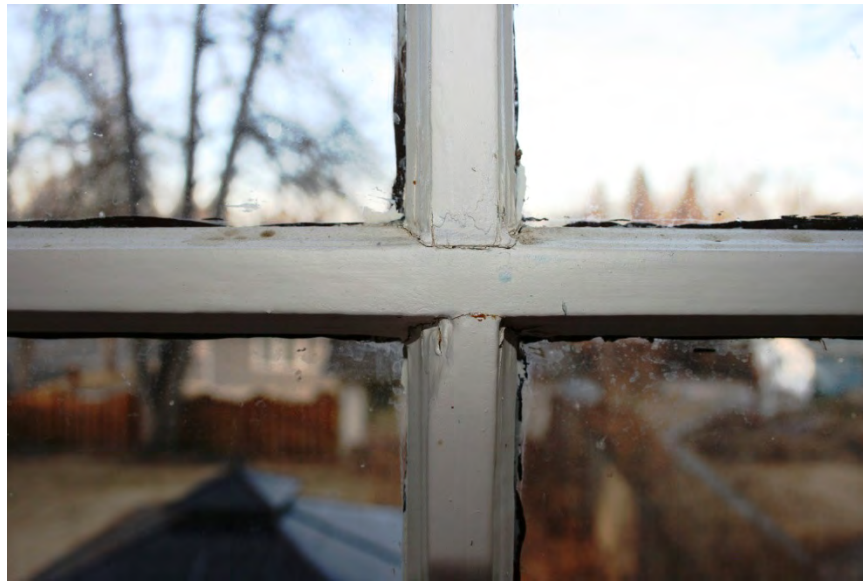
**Image 1: Window 2-19, note the wide muntin profile**

**Image 2: Window 2-1, note the narrow muntin profile. This matches all of the other historic windows in the house**

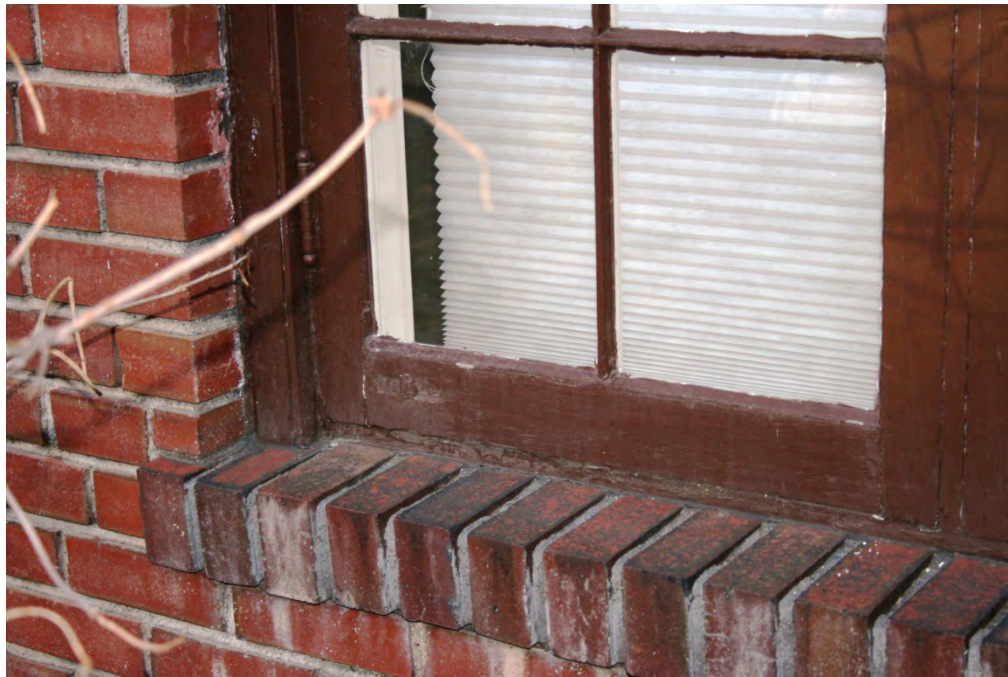
All of the windows exhibit typical conditions associated with deferred maintenance, including peeling paint, failed perimeter caulk, mild deterioration of the wood sill, deterioration of the bottom of the exterior wood trim, and glazing compound failure.

Image 3: Window 1-10, common exterior condition

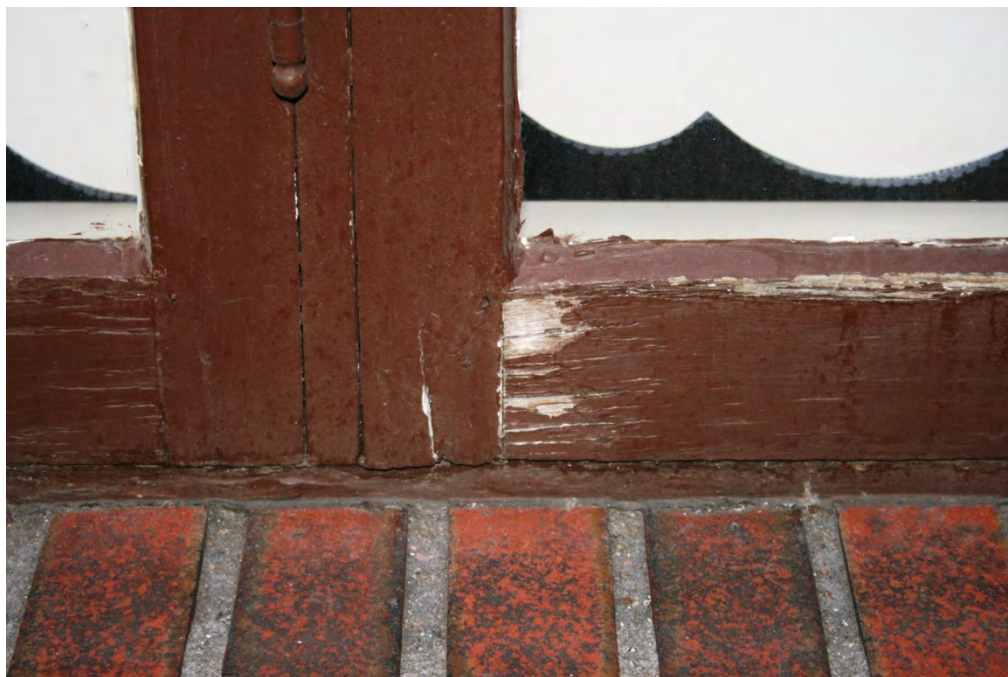
Image 4: Window 1-15, common exterior condition

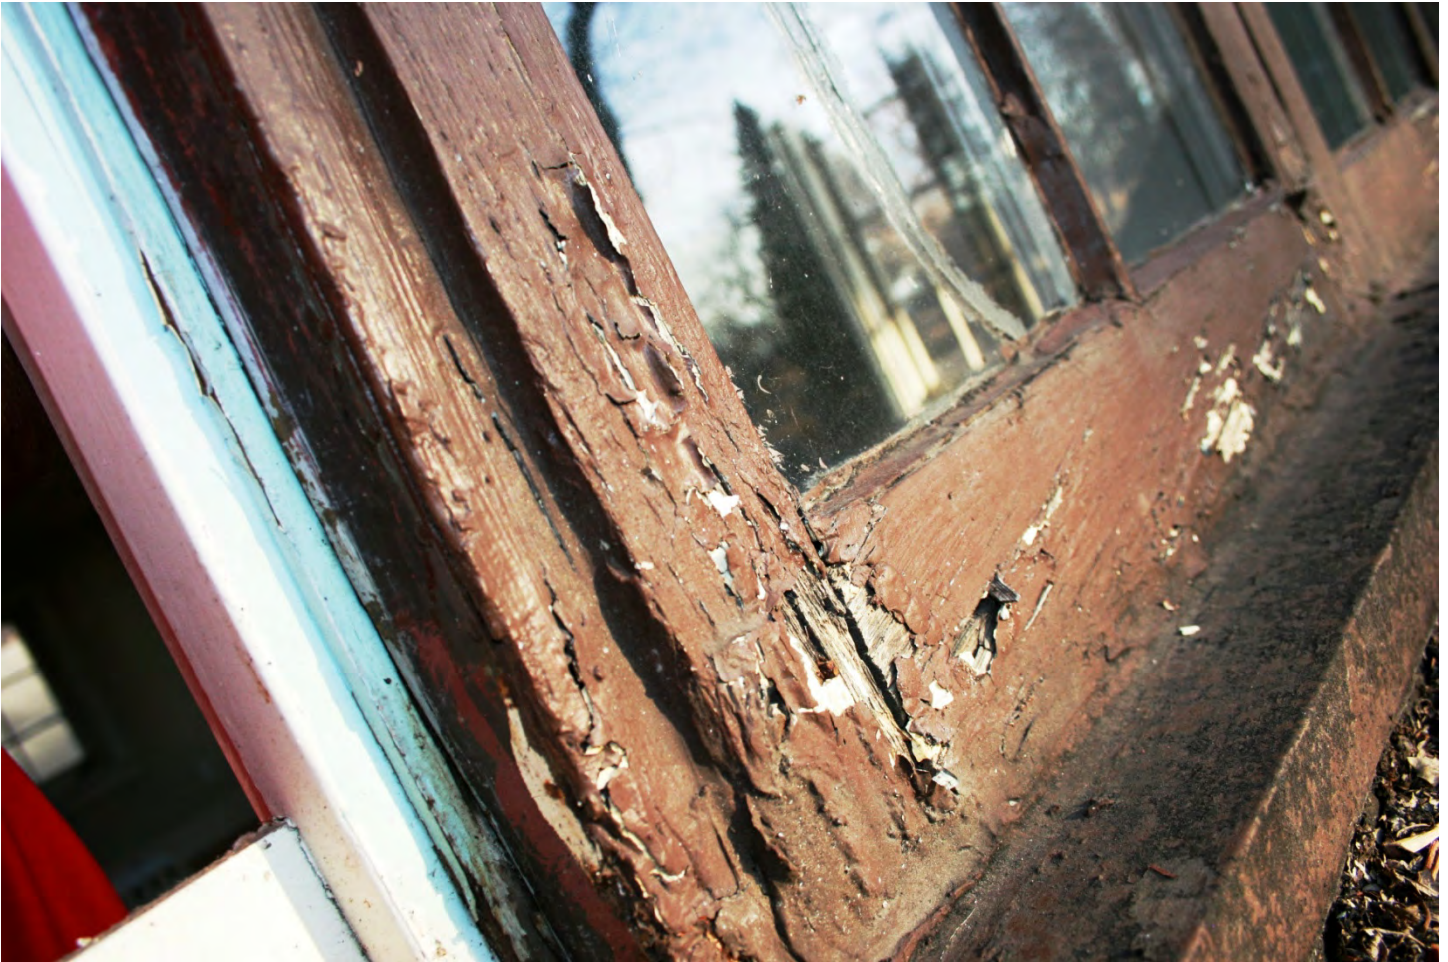
Windows in the second story master bedroom are in the worst condition. Windows 2-3 through 2-6 exhibit severe deterioration and would likely require replacement of multiple components to be returned to fully functional condition.

**Image 5: Window 2-4. The lower rail, portions of both stiles, and portions of the muntins will likely require replacement**

Windows 2-3 through 2-10 are of the greatest concern. These windows exhibit advanced deterioration and will require replacement of multiple components to be made functional again. However, they are also some of the most visible windows on the building

Windows 2-3 through 2-6 should be considered for replacement. If a replacement cannot be sourced that matches the original adequately then these windows should undergo a restoration to return functionality as best as possible. Guidance from the National Park Service regarding selecting appropriate replacement windows follows this section.

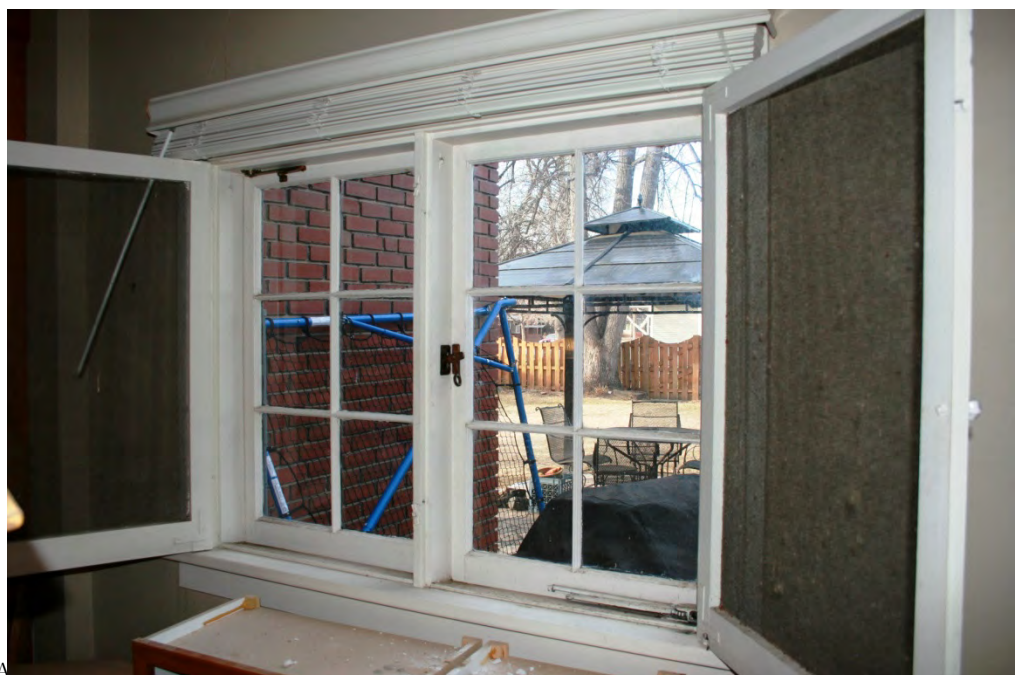
Windows on the first floor (1-1 through 1-27) varied in condition but many were operational and all could be restored to full functionality with a restoration program. There are hinged screens on many of the windows which could also be made more functional without the need for replacement. The hinged screens could also be substituted for storm panels in the winter to improve the energy efficiency of the window units without impacting the historic integrity of the home. Based on deterioration alone the first floor windows should be restored.

**Image 6: Windows 1-18\_1-19, example of hinged screens**

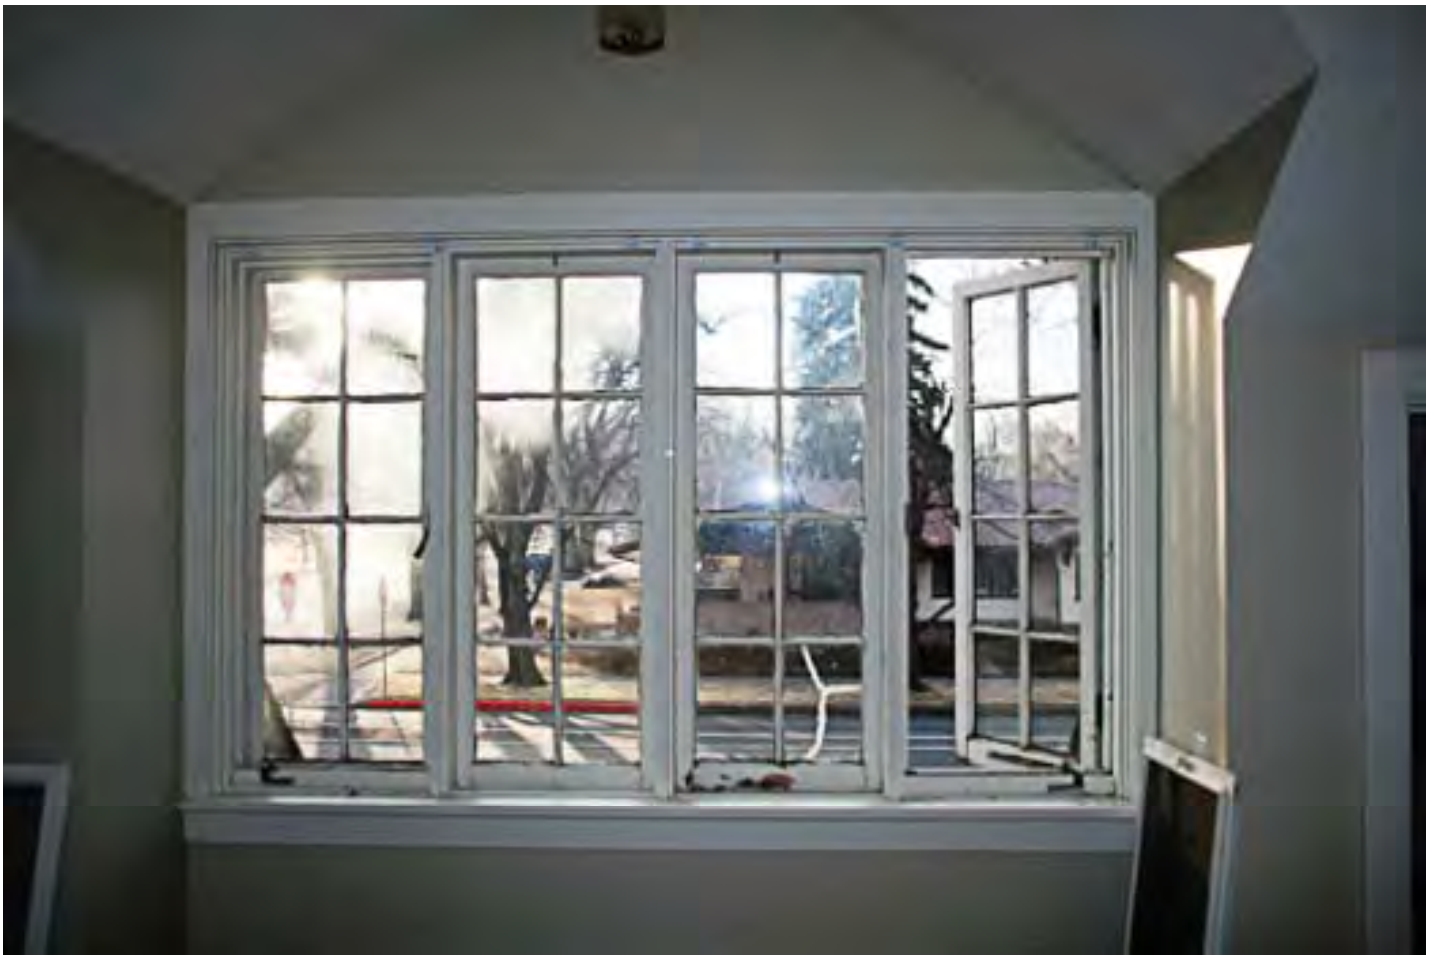
One windows 2-3 through 2-6 are sufficiently deteriorated to make the case for replacement. However, they are in a highly visible location on the home. If the owner can supply information for a replacement window that exactly mimics the original then a replacement of this group of windows may be acceptable. However, the public nature of these windows will dictate that the new windows meet the highest standards for visual matching. NPS guidance for selecting a replacement follows this section.
