Historic Preservation Services

Community Development & Neighborhood Services

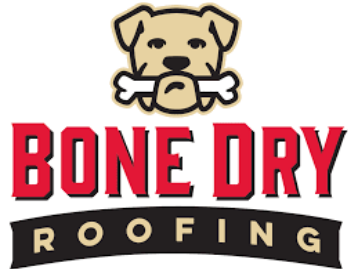
Jun 7, 2021 | 21 Photos

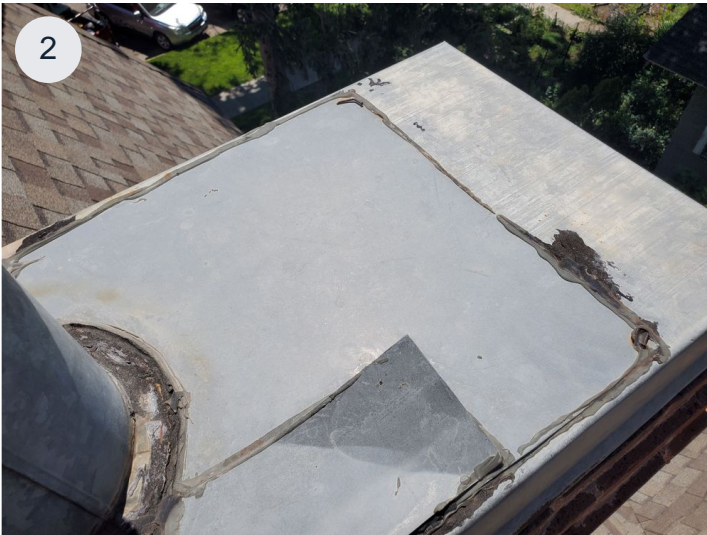
Project: Anne Marie Banchy
Date: June 4th, 2021, 10:56 a.m.
Creator: Randy Reed

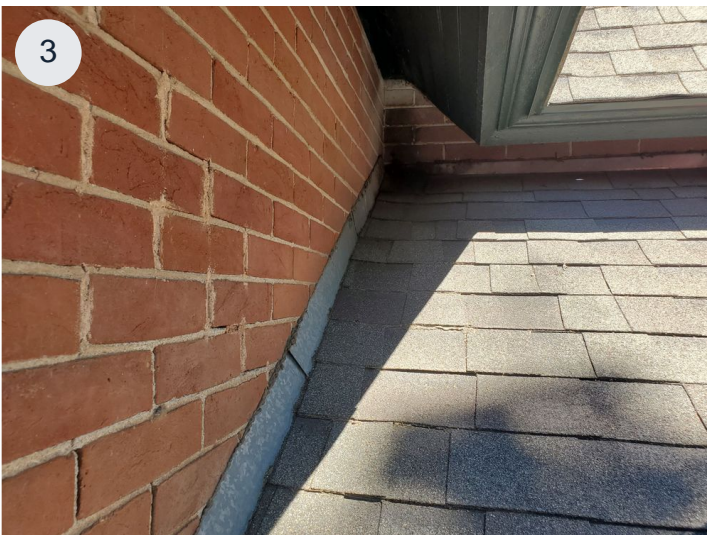
Project: Anne Marie Banchy
Date: June 4th, 2021, 10:56 a.m.
Creator: Randy Reed

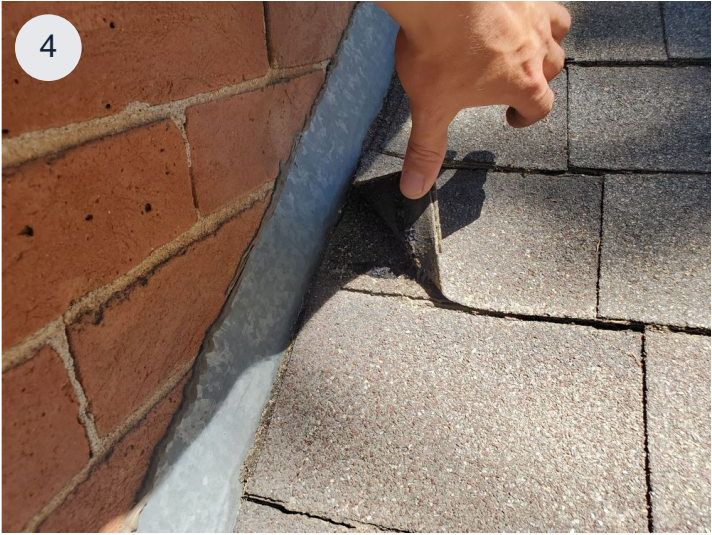
4 Shingles missing step flashing along all vertical running walls.

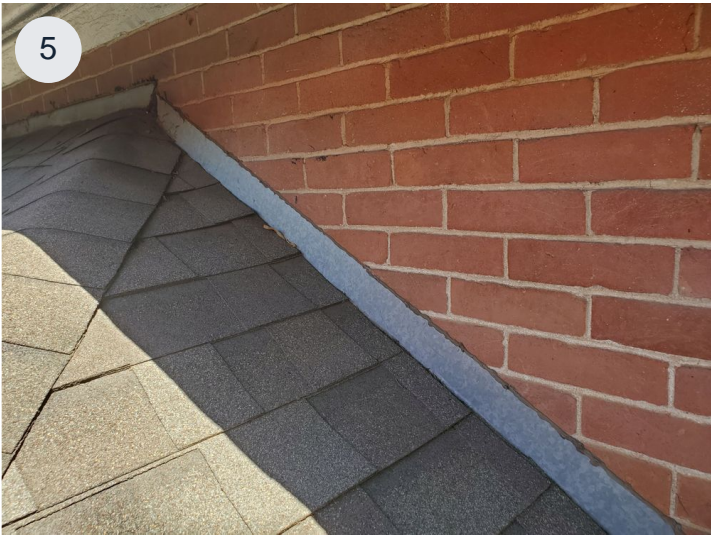
5 Missing step and counter flashing

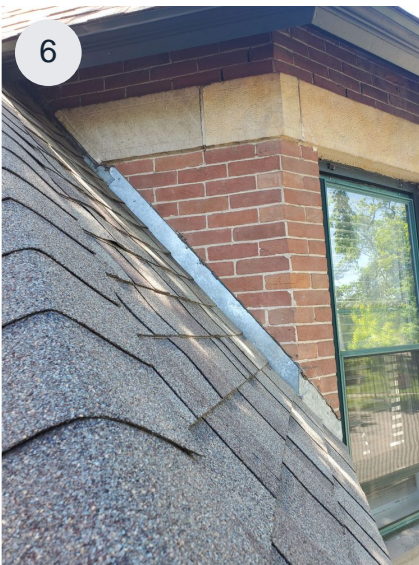
6 Missing step flashing and counter flashing

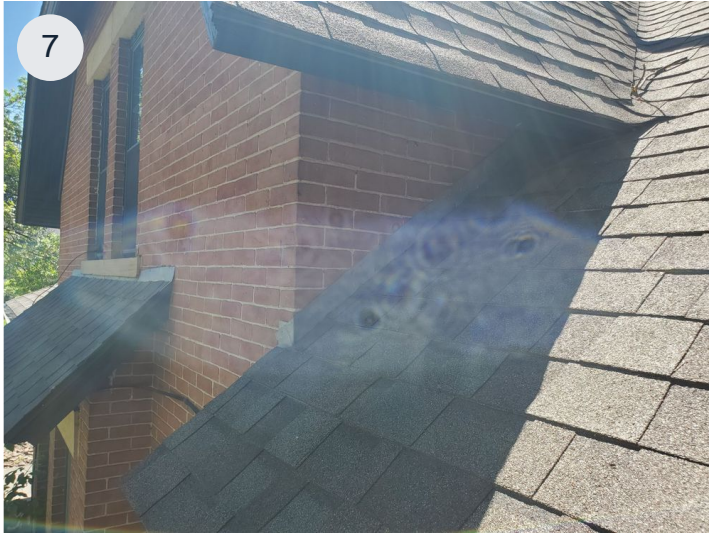
Missing step flashing and counter flashing

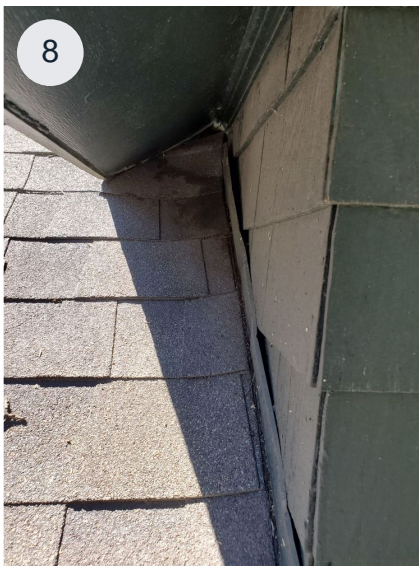
No step flashing behind siding, wall is flashed wrong allowing water to enter behind metal.

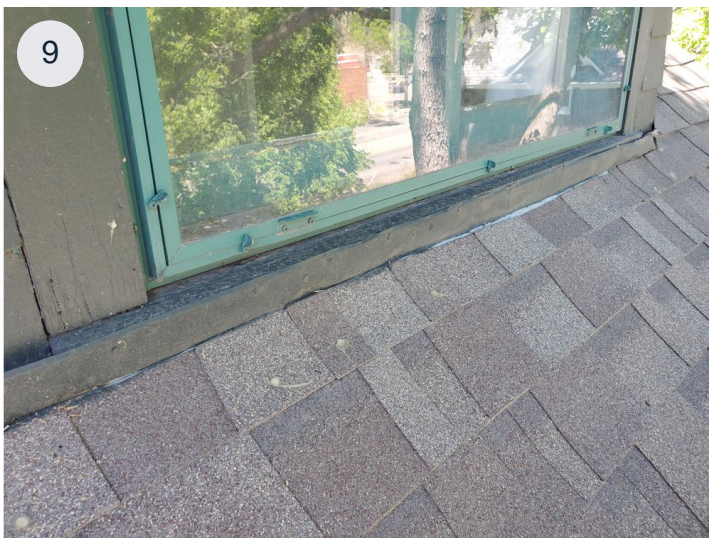
Window transition missing appropriate flashing

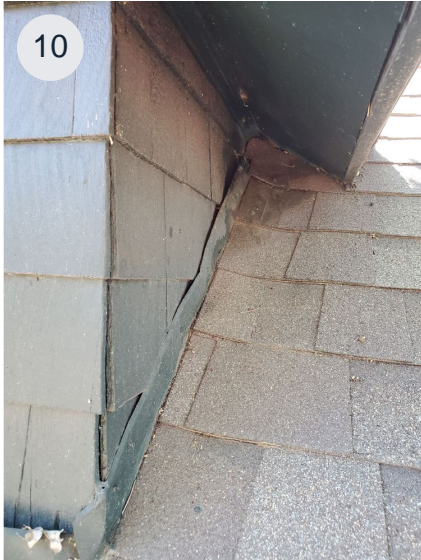
No step flashing behind siding, wall is flashed wrong allowing water to enter behind metal.

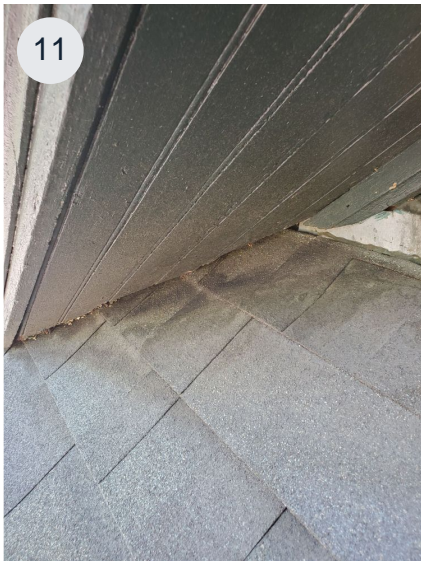
Missing metal "bird block" flashing

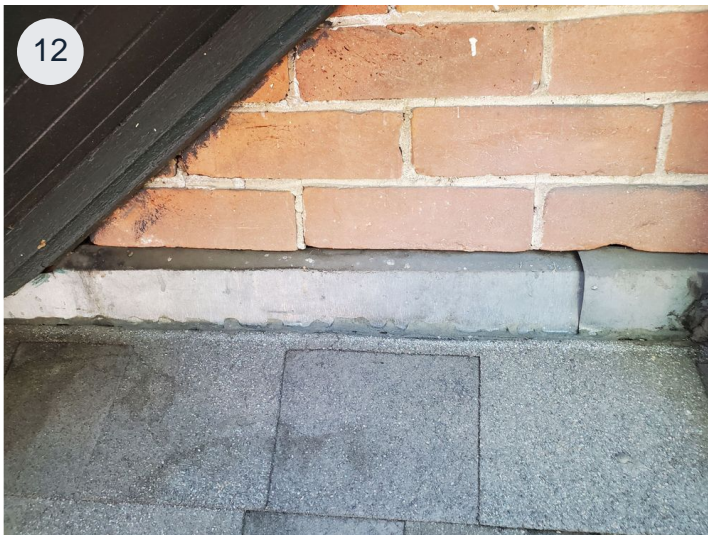
Horizontal wall missing counter flashing metal at headwall.

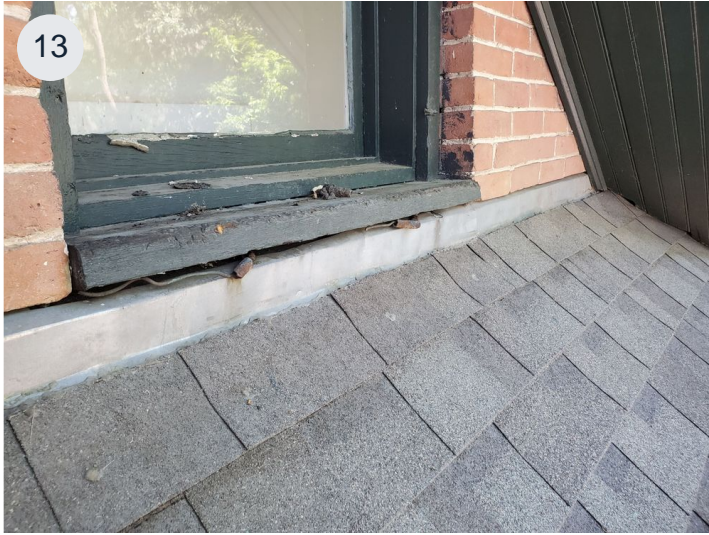
Window flashed improperly, missing counter flashing

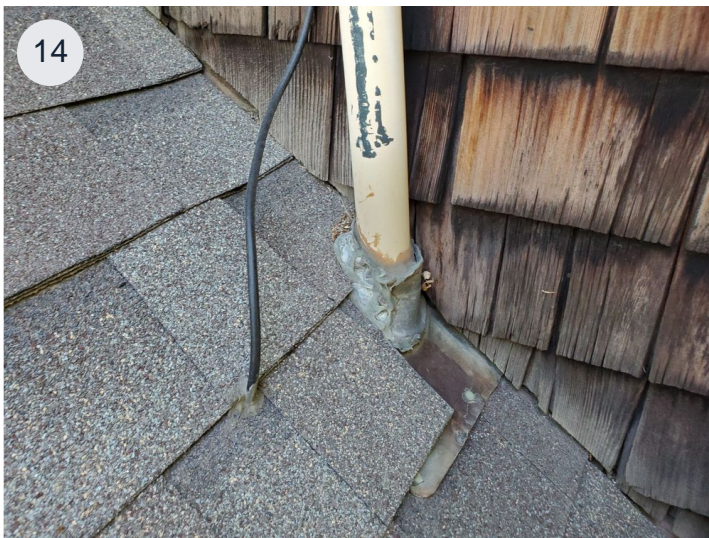
Metal pipe boot failing, water or electrical line through shingle and caulked.

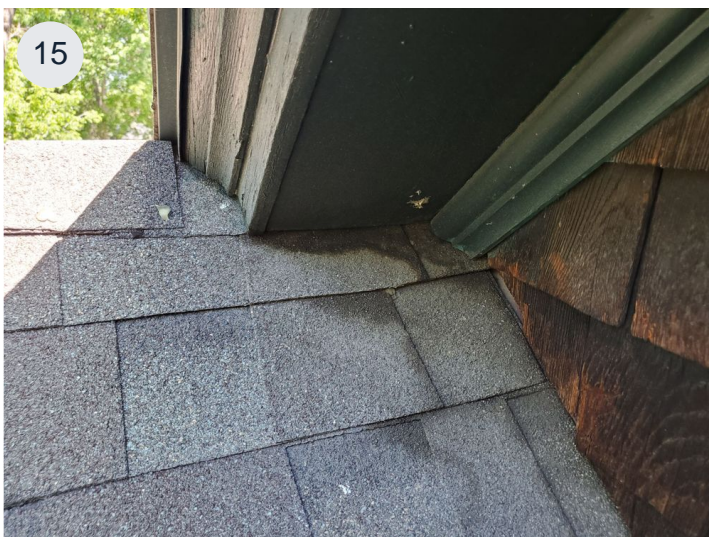
Add bird block flashing and step flashing at ridgeline transition

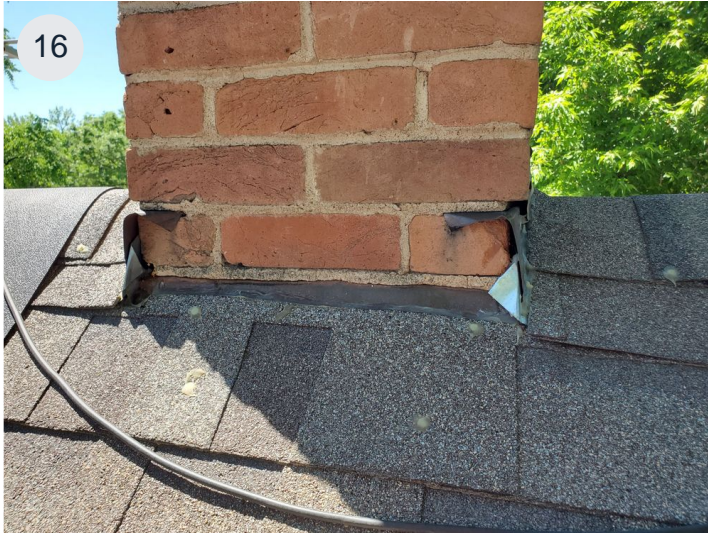
Chimney missing all appropriate counter flashing and front and back pans

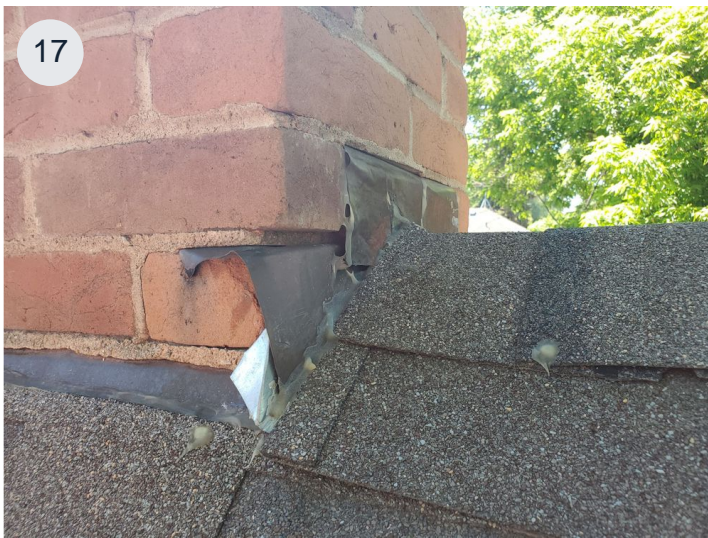
Missing step flashing and counter flash

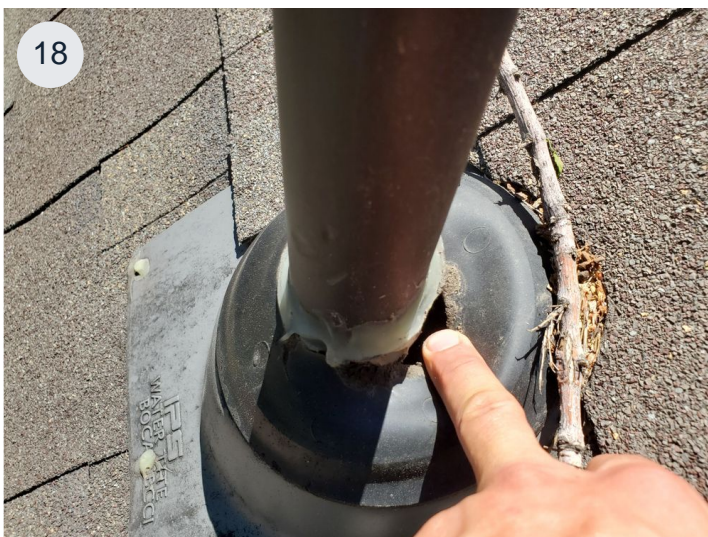
3" pipe boot old and failing, repairs not possible
Recommend replacement

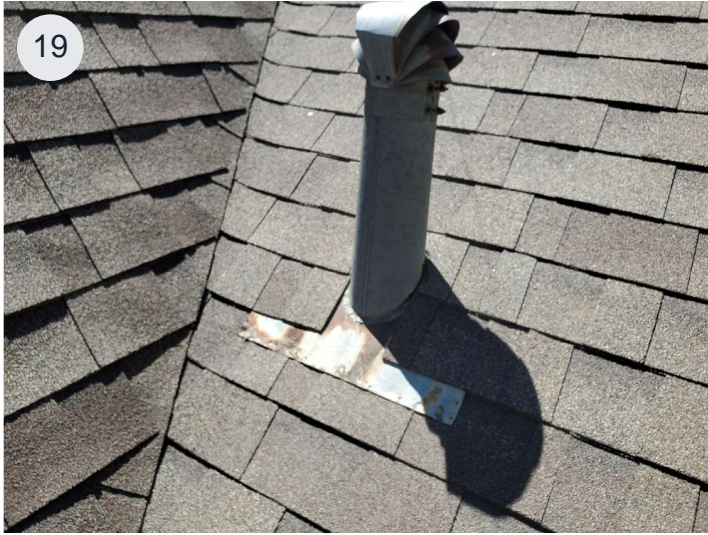
HVAC pipe base is rusting and starting to deteriorate metal.

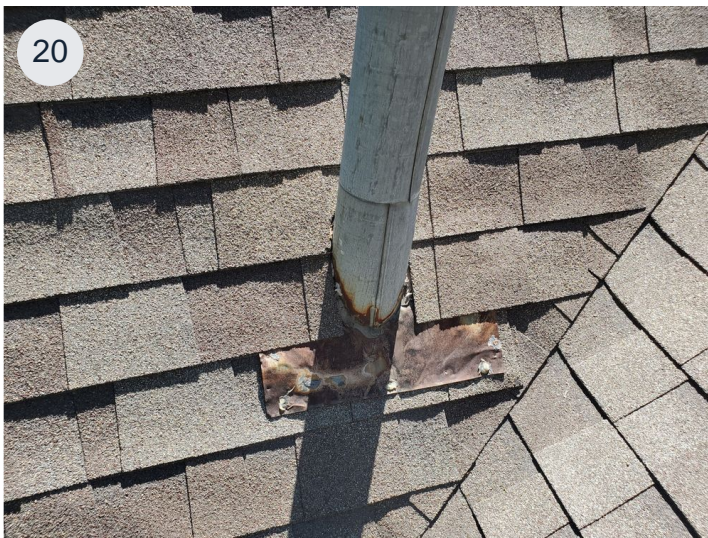
Customer believes this HVAC stack may be dead/inactive. After confirming status either replace HVAC base flashing or remove pipe and reshingle

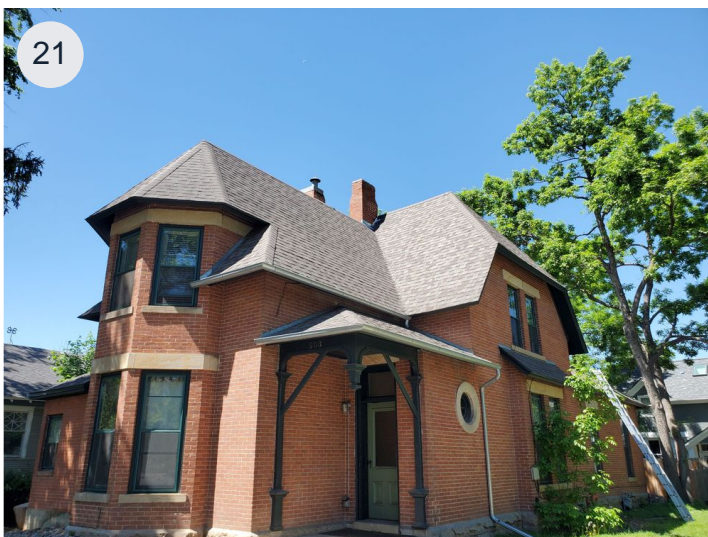
Project: Anne Marie Banchy
Date: June 4th, 2021, 11:12 a.m.
Creator: Randy Reed

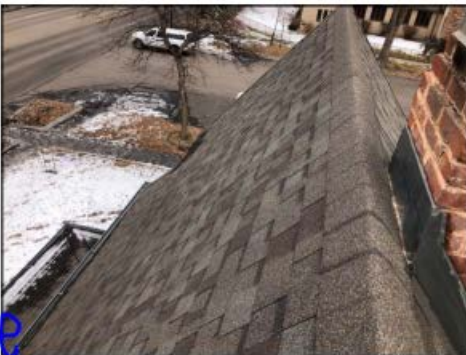
Description**Sloped roofing material:** • [Asphalt shingles](#)**Limitations****Roof inspection limited/prevented by:** • Lack of access (too high/steep)**Inspection performed:** • By walking on roof**Observations & Recommendations****RECOMMENDATIONS \ General****1. Condition:** • Roof images

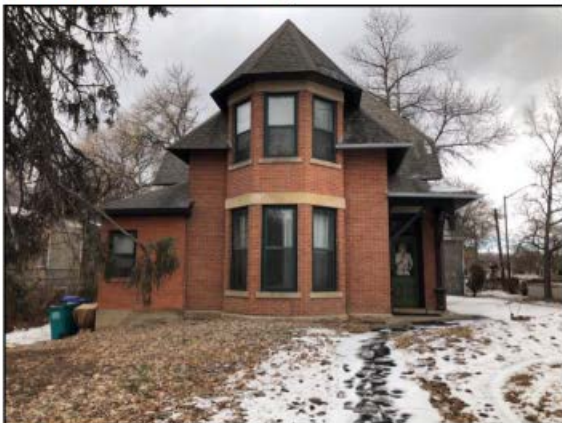
4. **Condition:** • Exterior images

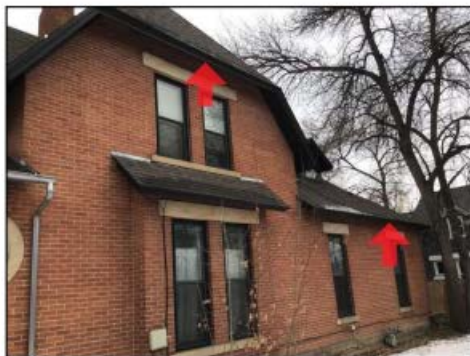
ROOF DRAINAGE \ Gutters

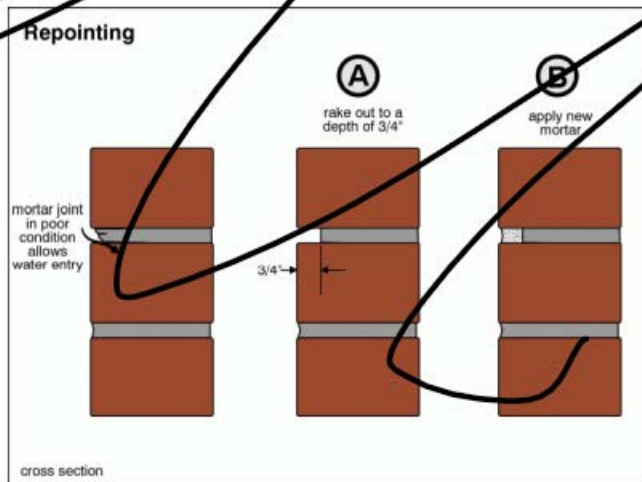
Implication(s): Chance of water damage to structure, finishes and contents

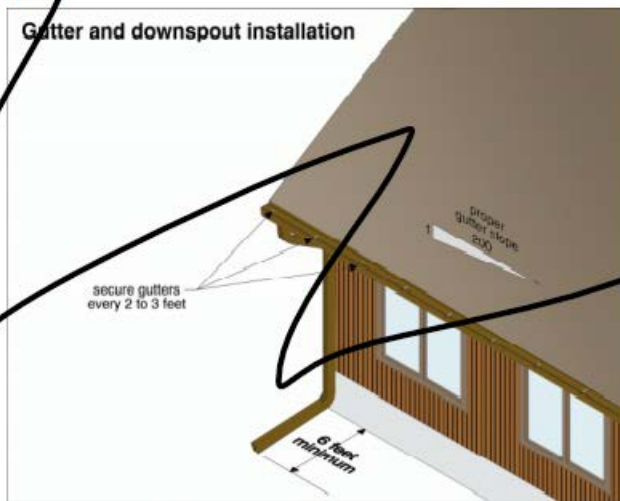
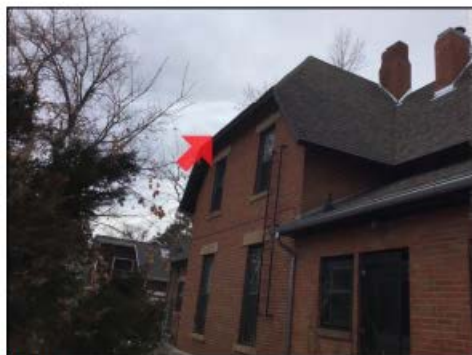
Time: As soon as possible
