CERTIFICATE OF APPROPRIATENESS

This letter provides you with confirmation that the proposed changes to your designated Fort Collins landmark properties, the Standard Block at 255 Linden and the Stover Drug Store Building at 261 Linden Street have been approved by the City's Historic Preservation Division because the proposed work meets the criteria and standards in Chapter 14, [Article IV](#) of the Fort Collins Municipal Code.

CONSTRUCTION
DOCUMENTS FOR THE
MASONRY, PARAPET
AND WINDOW
RESTORATION

LIMITED EXTERIOR FINISH INVESTIGATION
255 & 261 LINDEN STREET
FORT COLLINS, COLORADO

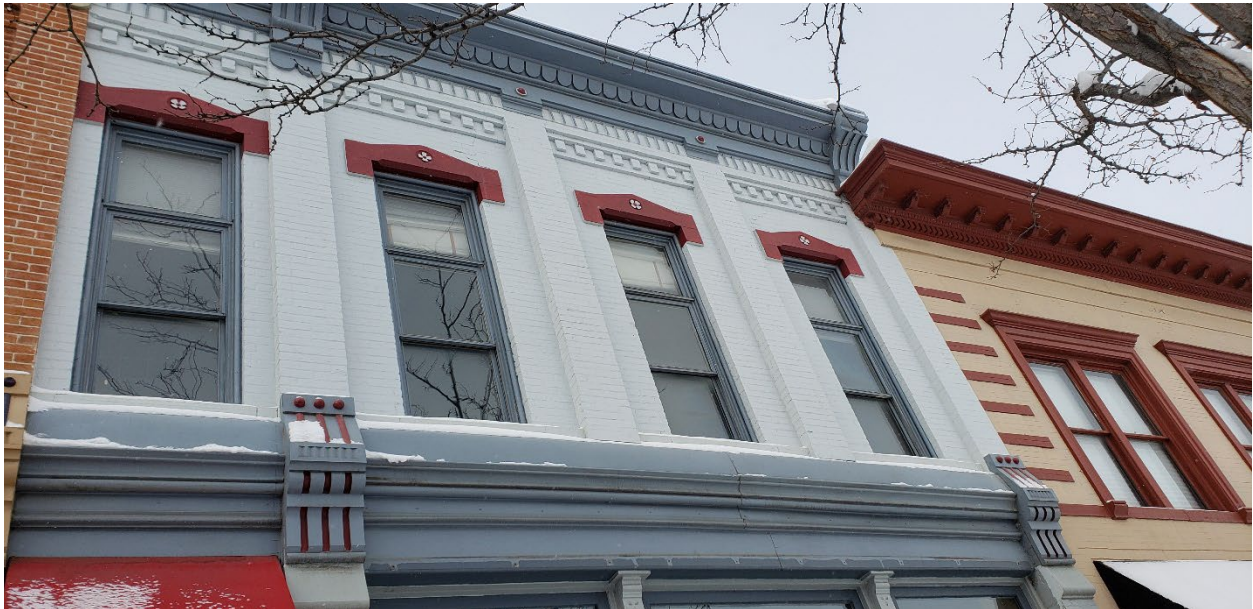
255 Linden/Standard Block – upper windows proposed for replacement.

- 1) Restore, repair, and rehabilitate existing wood windows, including sash upper windows and storefront picture windows, and replace four replacement windows (on upper floor of 255 Standard Block) consistent with project plans.

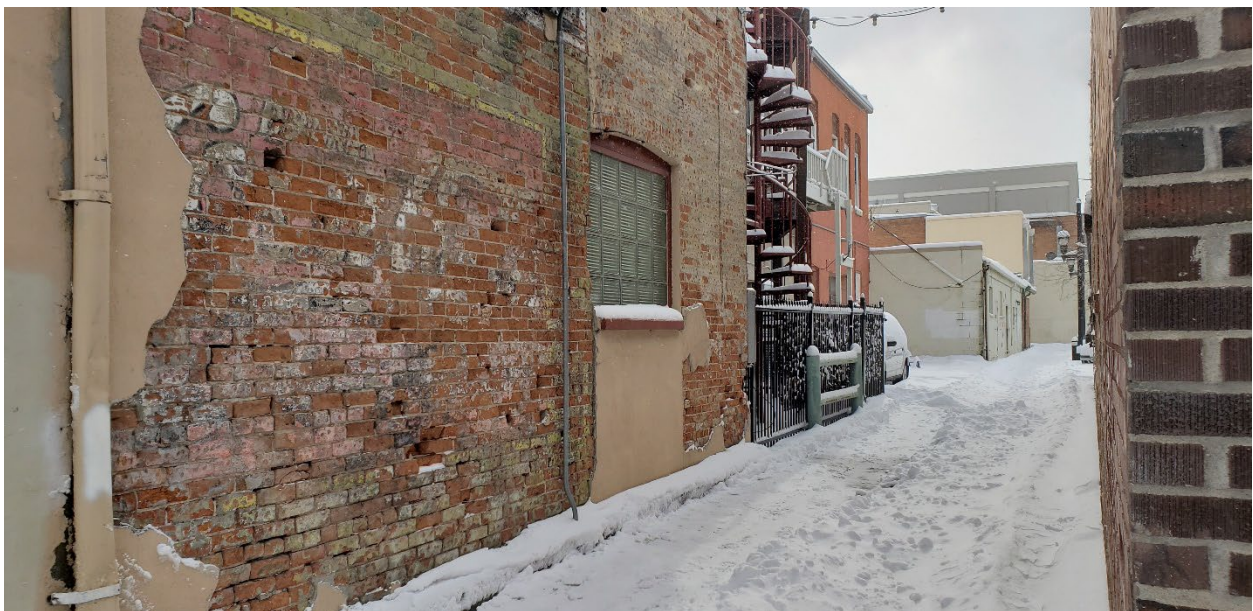
Rear/northwest alley of 261 Linden, showing deterioration of brick under stucco.

- 3) Repoint masonry, repair and replace exterior brick as needed, remove stucco as needed, and complete concrete repair as needed.
 - a. *Condition 2: Completed masonry repair should be consistent with National Park Service [Preservation Brief 2](#) on repointing mortar joints. Approach seems to meet this Brief but please consult if questions.*

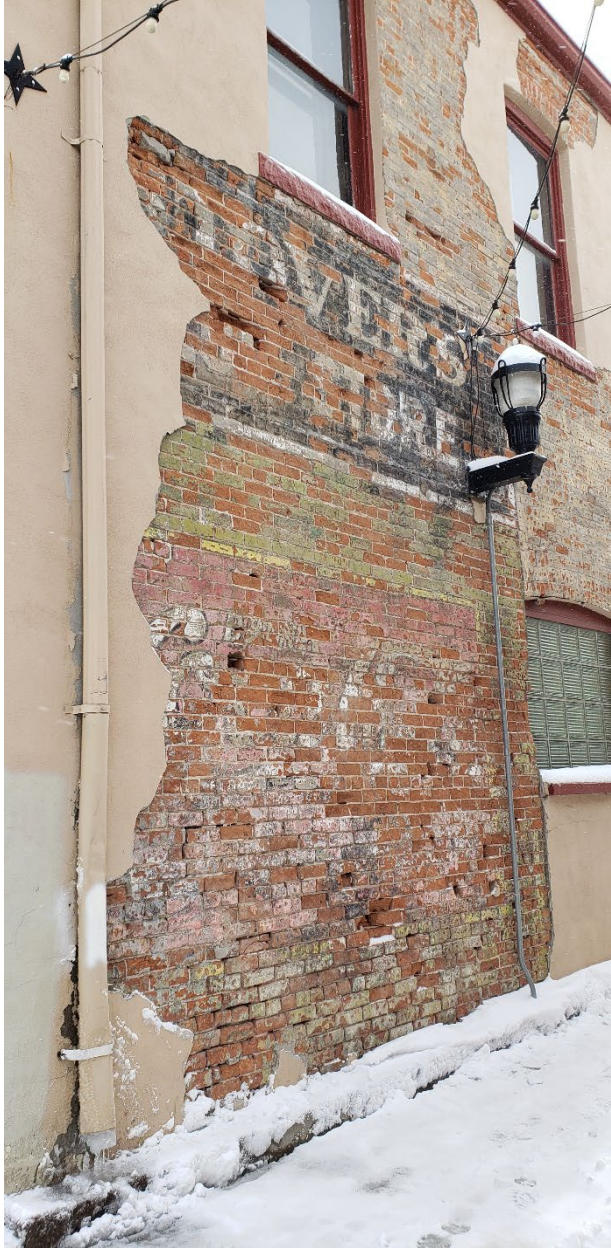
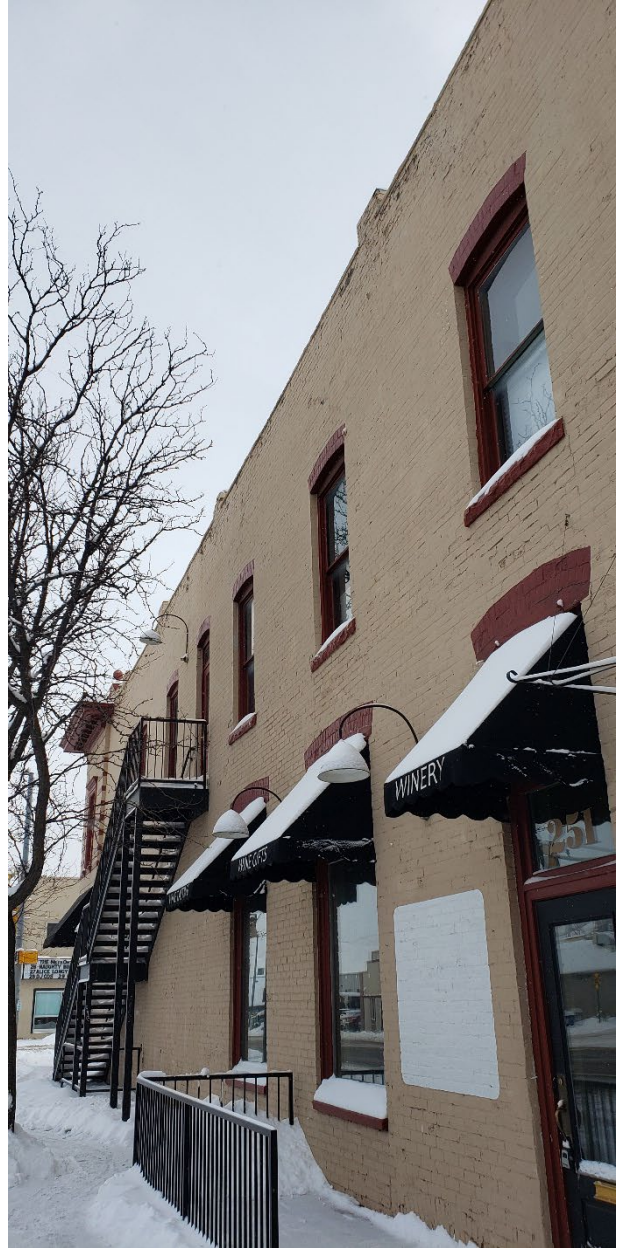
Rear/northwest alleyside of 261 Linden/Stover Drug (left) showing ghost sign.
Northeast/Jefferson Street elevation of 261 Linden.

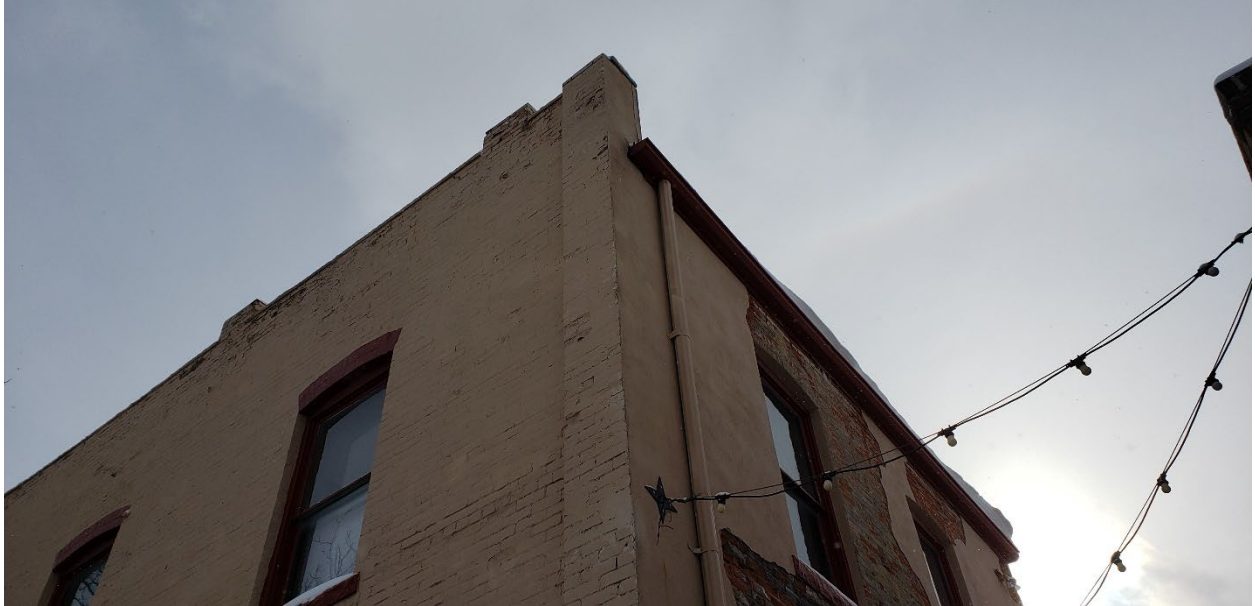
North corner of 261 Jefferson at upper story, showing masonry deterioration and sandstone cap.

- 4) Deconstruct/reconstruct upper masonry along northeast (Jefferson Street) elevation; remove historic sandstone parapet caps and install new sandstone caps to cover full wall.

- a. *Note 1: Phone conversation with Kevin Murray (contractor) February 2, 2022 – new sandstone caps will be installed with wider dimensions to address water infiltration into roof/wall system. Mason will set at angle to improve water shedding. If the originally-proposed concrete pre-cast is needed instead, this is also acceptable.*

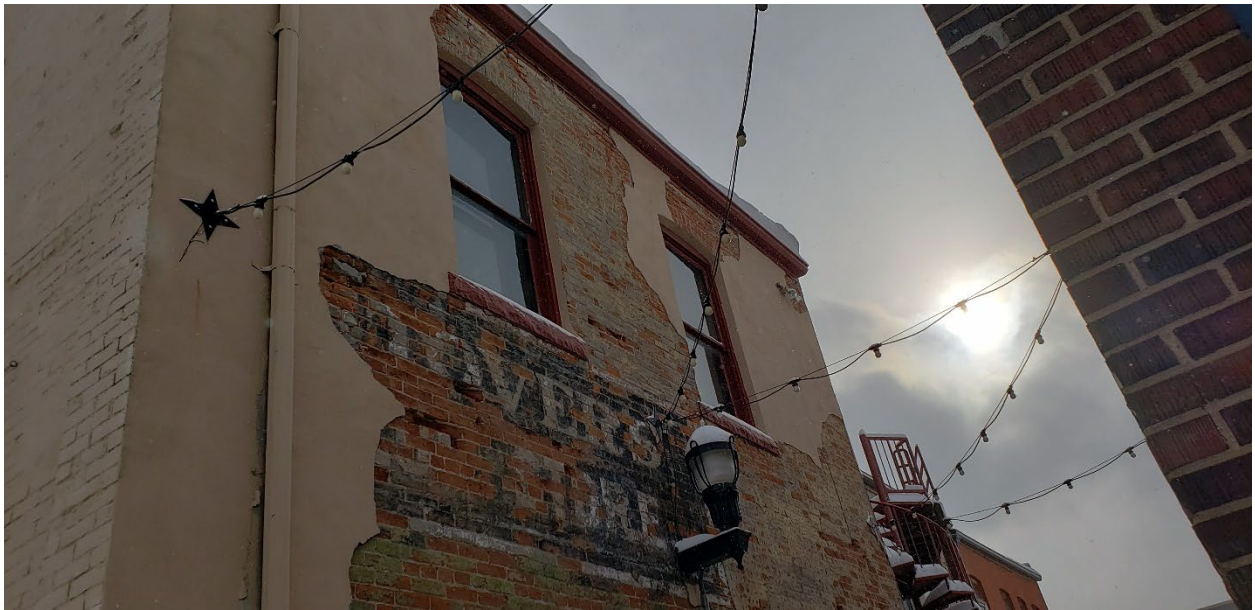
Northwest/alley side of 261 Jefferson upper story, showing masonry condition and ghost sign.

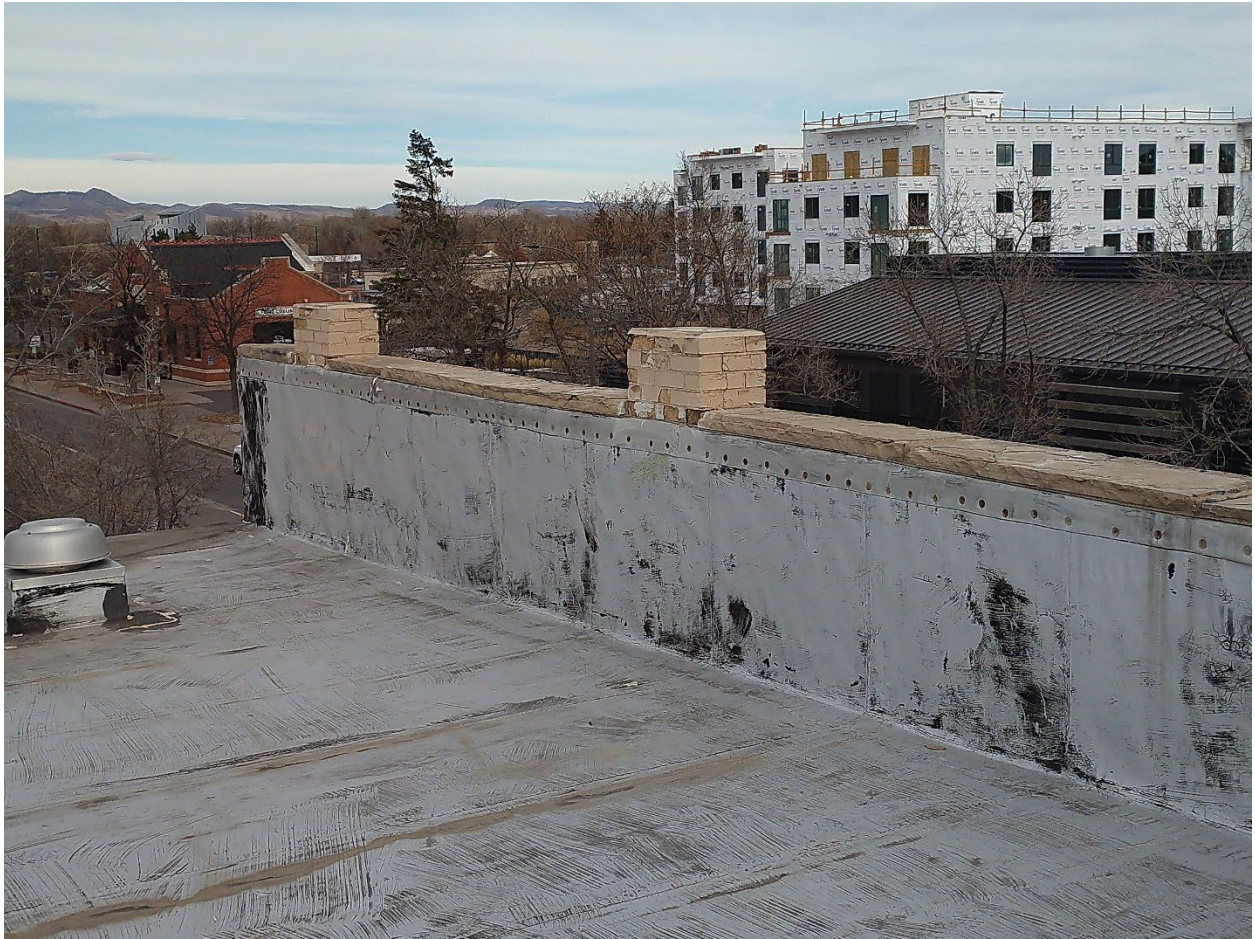
Showing Existing Sandstone Wall Cap on 261 Linden/Stover Drug Store along Jefferson Street face.

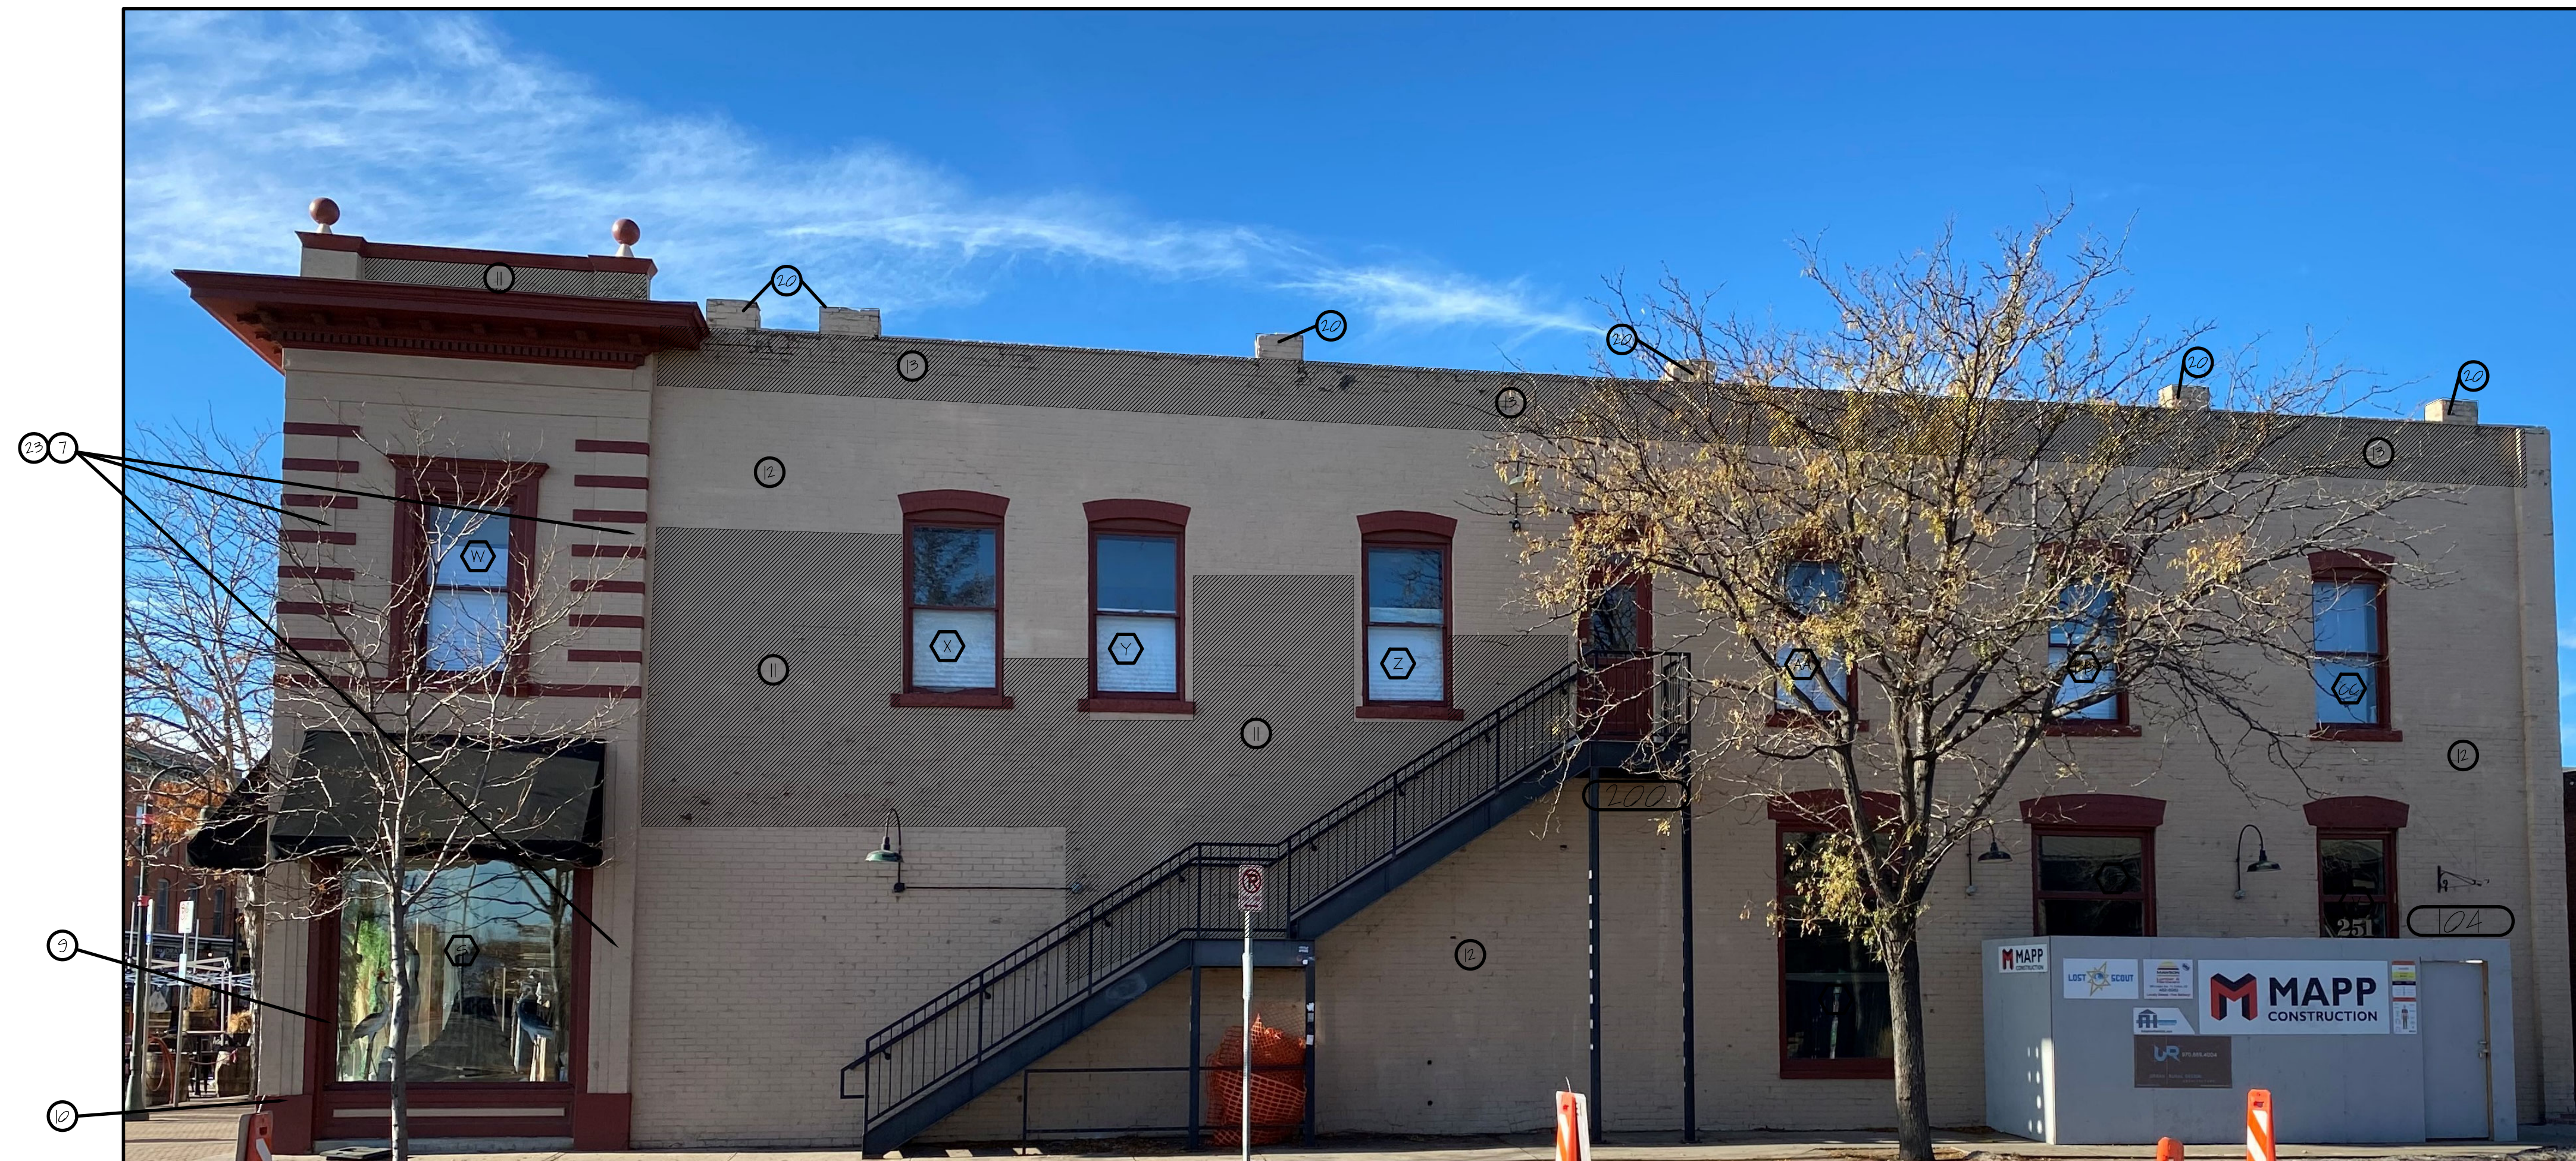
JEFFERSON ST. ELEVATION
3
A2.0
NTS

8	BOTTOM RAIL OF PICTURE WINDOW IS HEAVILY DETERIORATED AND SEPERATED WITH SEALANT PLACED IN SEPERATION. RESTORE BOTTOM RAIL AND TIGHTEN JOINTS TO MAKE WEATHER TIGHT, USING EPOXY CONSOLIDANT, NEW PINS AND/OR DUTCHMEN REPAIR.
9	BOTTOM AND INTERMEDIATE RAIL IS DETERIORATED AND SEPERATED WITH SEALANT PLACED IN SEPERATION. RESTORE TO MAKE WEATHERTIGHT, USING EPOXY CONSOLIDANT, NEW PINS AND/OR DUTCHMEN REPAIR.
10	GENTLY REMOVE PAINT TO RE-EXPOSE HISTORIC STONE. PAINT IS BUBBLING AND PEELING FROM MOISTURE INFILTRATION AT THE BASE AND CORNERS.
11	SERIOUS PAINT DETERIORATION WITH LARGE AREAS OF PEELING PAINT. REMOVE PAINT USING THE GENTLEST MEANS POSSIBLE TO SOUND LAYER OF PAINT. INSPECT BRICKS, RESET AND/OR REPLACE AS NEEDED WITH REPLICA BRICKS. REPOINT WITH REPLICA MORTAR.
12	GENTLY REMOVE PAINT FROM FACE OF BUILDING WHERE LOOSE, SPALLING OR CRACKED TO SOUND LAYER OF PAINT. REPOINT MORTAR JOINTS WITH REPLICA MORTAR AND REPAIR STEPPED CRACKING - ANTICIPATE PAINT REMOVAL ON 90% OF THE JEFFERSON ST. ELEVATION. REPAINT BRICK THE HISTORIC COLOR PER PAINT ANALYSIS.

13	REMOVE HISTORIC SANDSTONE PARAPET CAPS AND INSTALL NEW PRECAST SLOPED CONCRETE PARAPET CAPS. RE: 4/A2.1. REPAIR AND RECONSTRUCT PARAPET AS REQUIRED, USING REPLICA BRICKS AND MORTAR. REMOVE LOOSE PAINT WHERE IT EXISTS AND REPAINT PARAPET THE HISTORIC COLOR.
14	RECONSTRUCT EXTERIOR WYTHE AND PORTIONS OF THE INTERIOR WYTHE, REMOVING STUCCO AND DAMAGED BRICK. REUSE ANY BRICK THAT REMAINS INTACT DURING THE DEMOLITION. NEW BRICK TO MATCH THE HISTORIC AND REPOINT USING MORTAR ANALYSIS COMPLETED AND INCLUDED IN THESE DOCUMENTS.
15	EXISTING STUCCO TO REMAIN. FINISH OUT ANY EDGES THAT EXPOSE THE HISTORIC BRICK, CREATING A FINISHED CORNER. MATCH FINISH AND COLOR ON THE EXISTING STUCCO.
16	INSTALL 10'-0" OF NEW DOWNSPOUT AND CONNECT TO EXISTING DOWNSPOUT. EXTEND DOWNSPOUT DOWN THE WEST SIDE OF THE BUILDING (NORTH CORNER). CUT CONCRETE AND INSTALL NEW TRENCH DRAIN IN SIDEWALK TO DRAIN INTO THE STREET GUTTER. RE: 5/A2.1

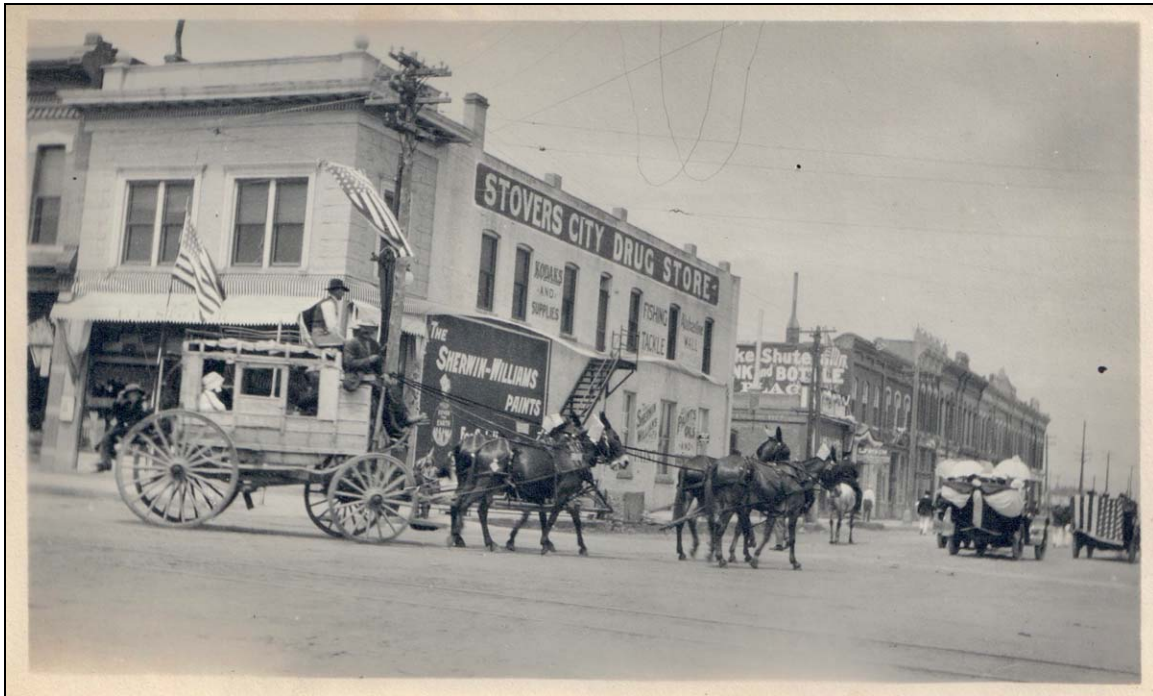
Figure 2: Circa 1914 photograph of 261 Linden Street showing painted brick facade.

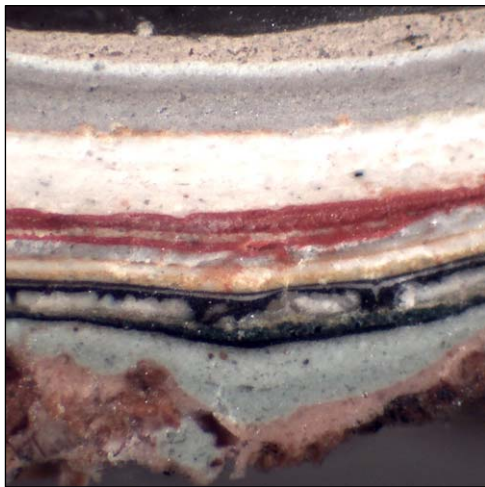
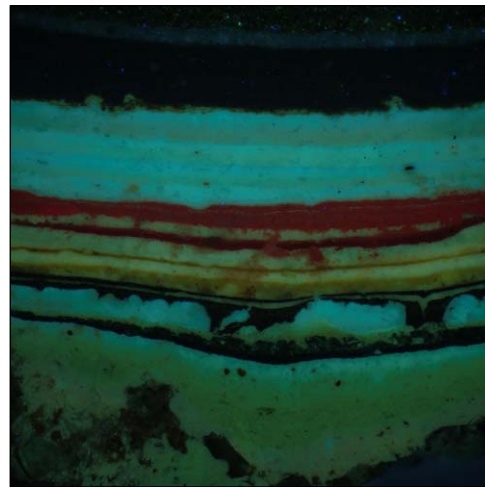
- A dirt layer is visible below the earliest finish indicating that the brick was originally left unpainted.
- Earliest retained finish is a matte sanded paint. Moderate yellowish-pink paint was sanded with a fine-grained clear and cloudy quartz.
- Several layers of paint are only visible part of the sample suggesting that these layers may be parts of painted signage such as that seen in the circa 1914 photo.
- Additional layers listed as finish may be possible signage, but these layers continued across the full surface of the cross section.

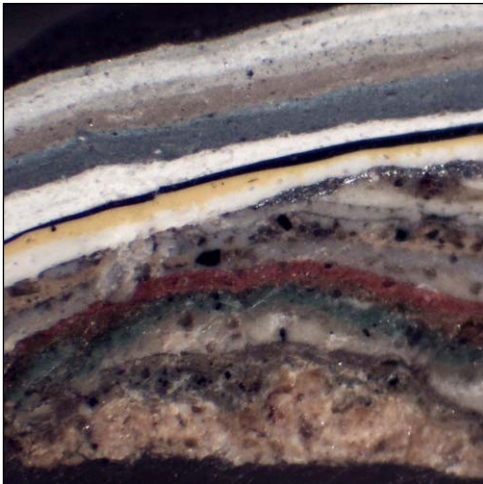
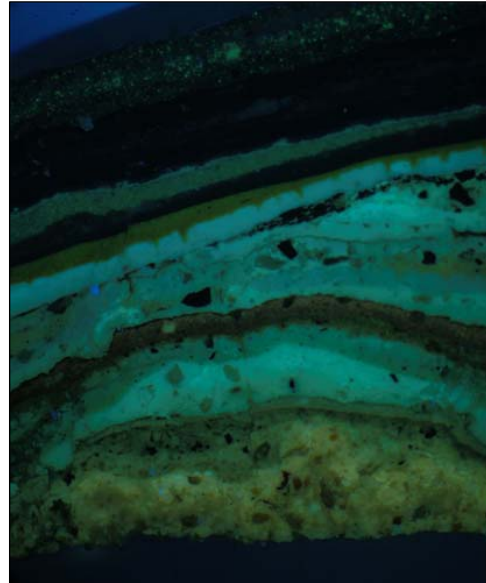
- Samples are heavily deteriorated
- Layers one through six are sanded paints which may be mimicking stone.
- The pale orange yellow paint at layer two is matte sanded with a fine-grained clear and cloudy quartz.
- The light olive gray paint at layers three and four are sanded with a fine-grained clear and cloudy quartz, but also with a fine grained, shiny black onyx.
