# COLORADO CULTURAL RESOURCES INVENTORY

## Loomis Addition Survey

### Historical and Architectural Reconnaissance Form

4. Street Address: **616 W OLIVE ST**
5. Municipality: **Fort Collins, Colorado**
6. County: **Larimer**
7. USGS Quad (7.5'): **Fort Collins**                      **NAD 83**                      **WGS84**
8. Parcel Number: **9711314003**
9. Parcel Information: **Lot(s): E 46 Ft of Lots 10, 11, 14 & 15**      Block: **269**                      Addition: **Loomis**
10. Acreage: **Not required**
11. PLSS information: **Not required**
12. Location Coordinates: **Lat: 40.584674135999997**      Long: **-105.08713370700001**      **WGS 84**

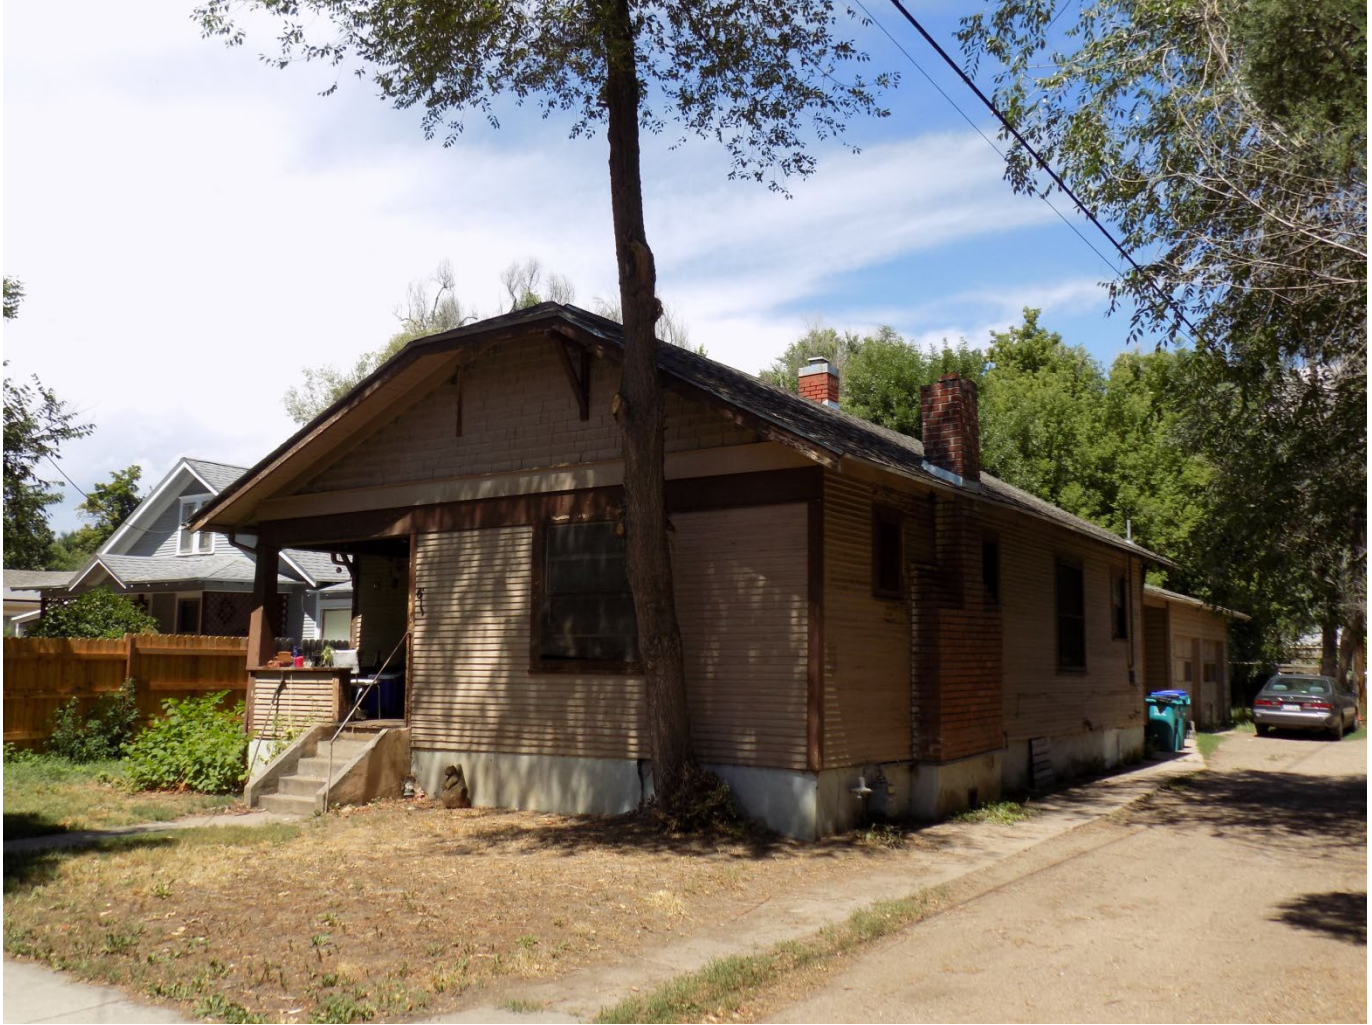
616 W Olive St., south façade and east side (Luke Anderson, August 2016)

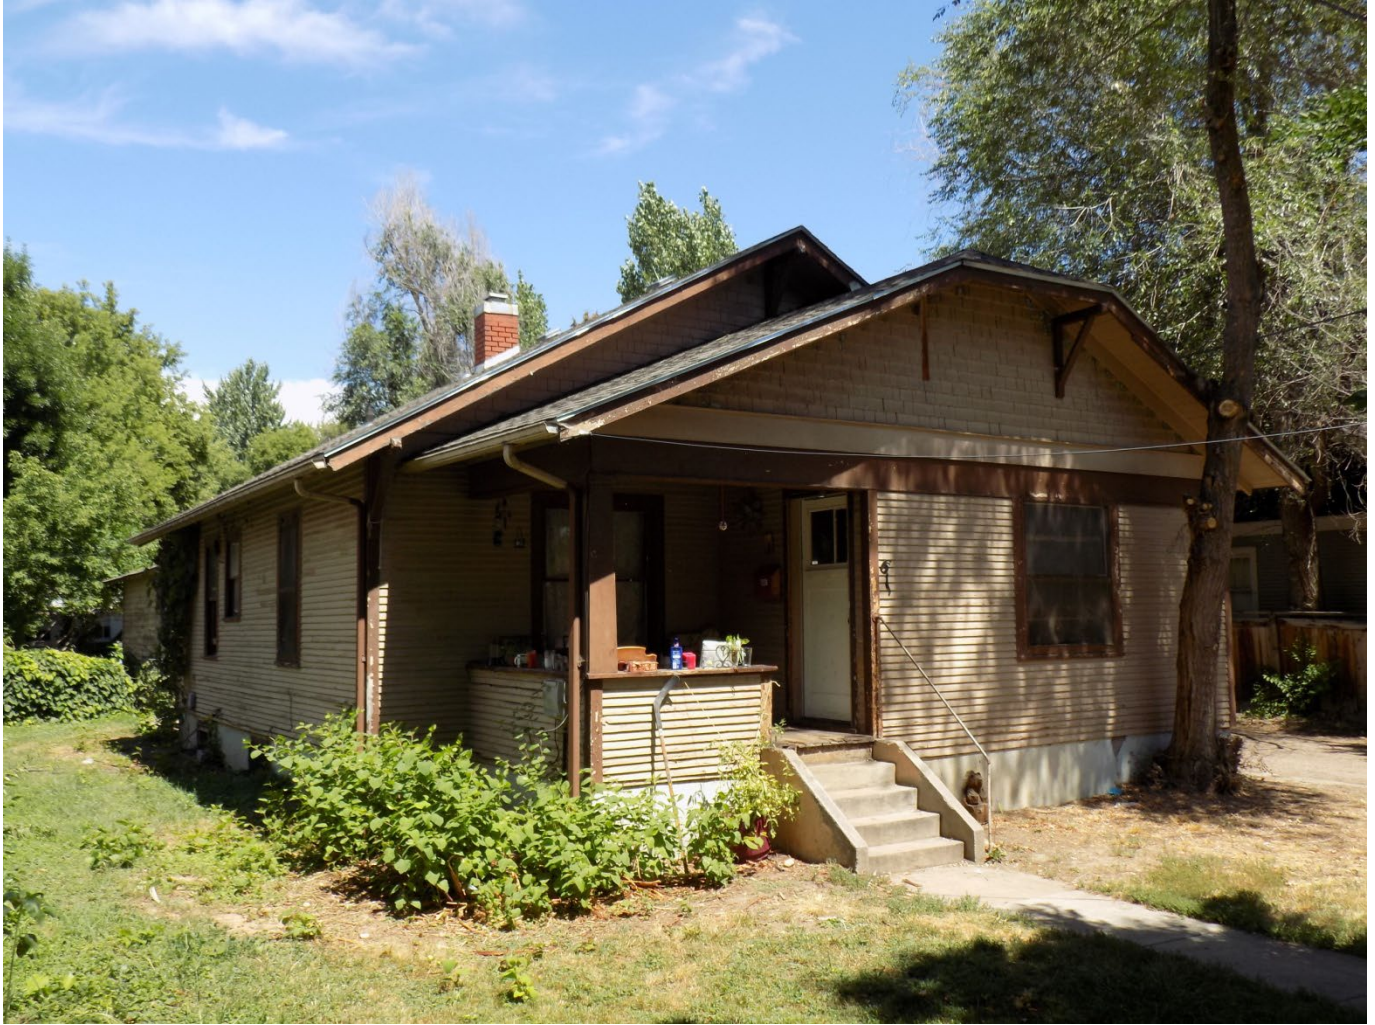
616 W Olive St., west side and south façade (Luke Anderson, August 2016)

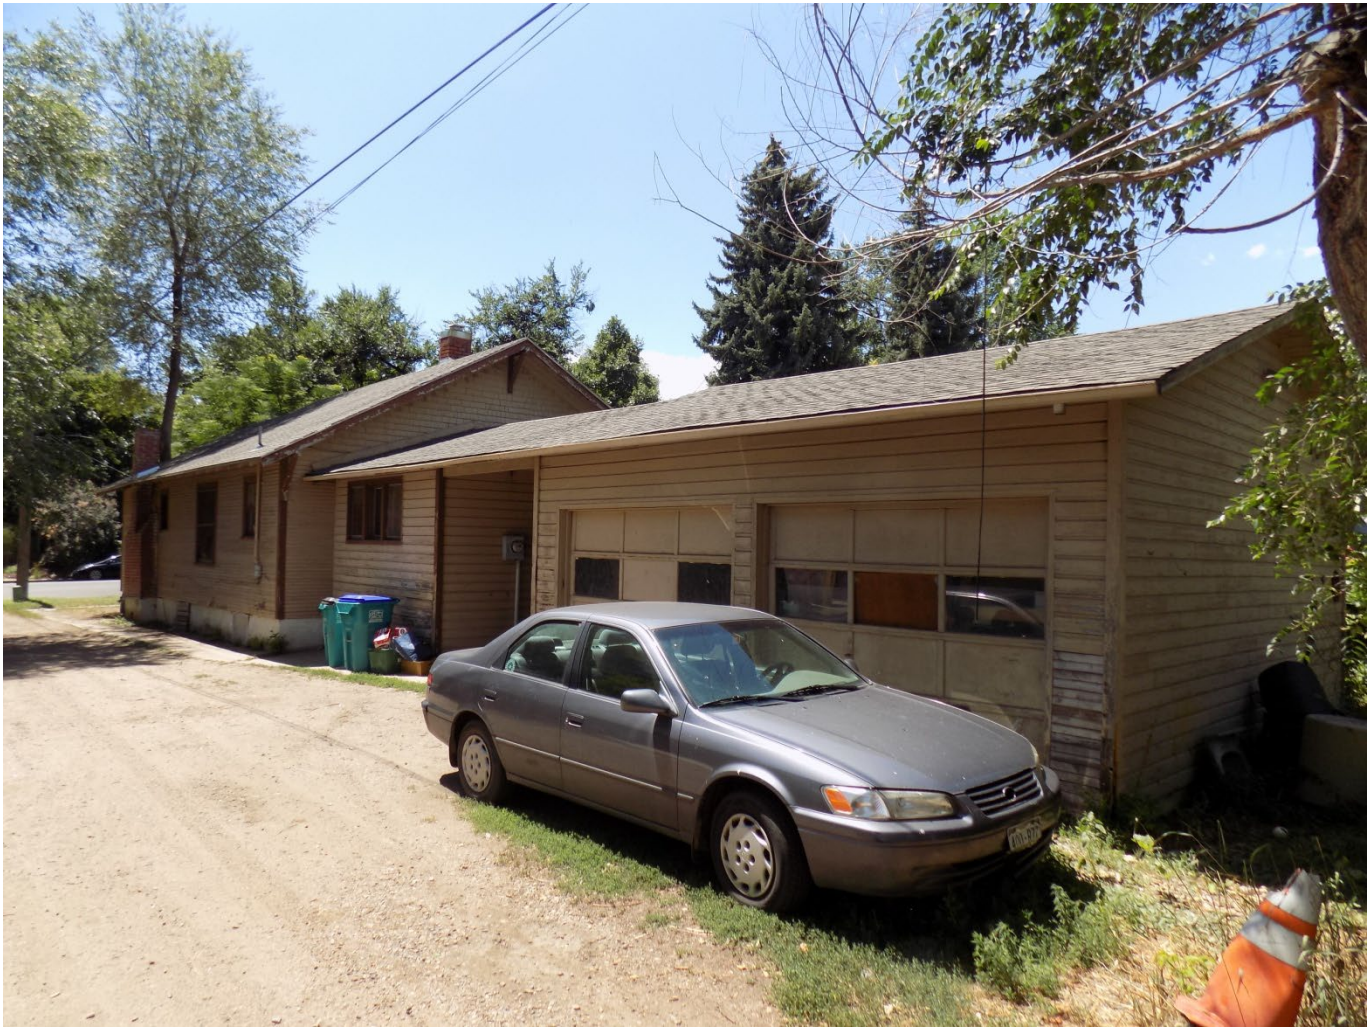
616 W Olive St., east and north sides showing rear addition, carport and garage (Luke Anderson, August 2016)
