**Historic Preservation Services**

**REPORT OF ALTERATIONS TO DESIGNATED RESOURCE**  
**Site Number/Address: 421 Mathews Street**  
**Laurel School National Register Historic District**  
**ISSUED: February 17, 2021**

This report is to document the summary of effects from proposed alterations to the Tomlin-Roberts Residence at 421 Mathews Street, pursuant to Fort Collins Municipal Code Chapter 14, [Article IV](#), made by the Landmark Preservation Commission at their February 17, 2021 meeting. A copy of this report may be forwarded to the Colorado Office of Archaeology and Historic Preservation.

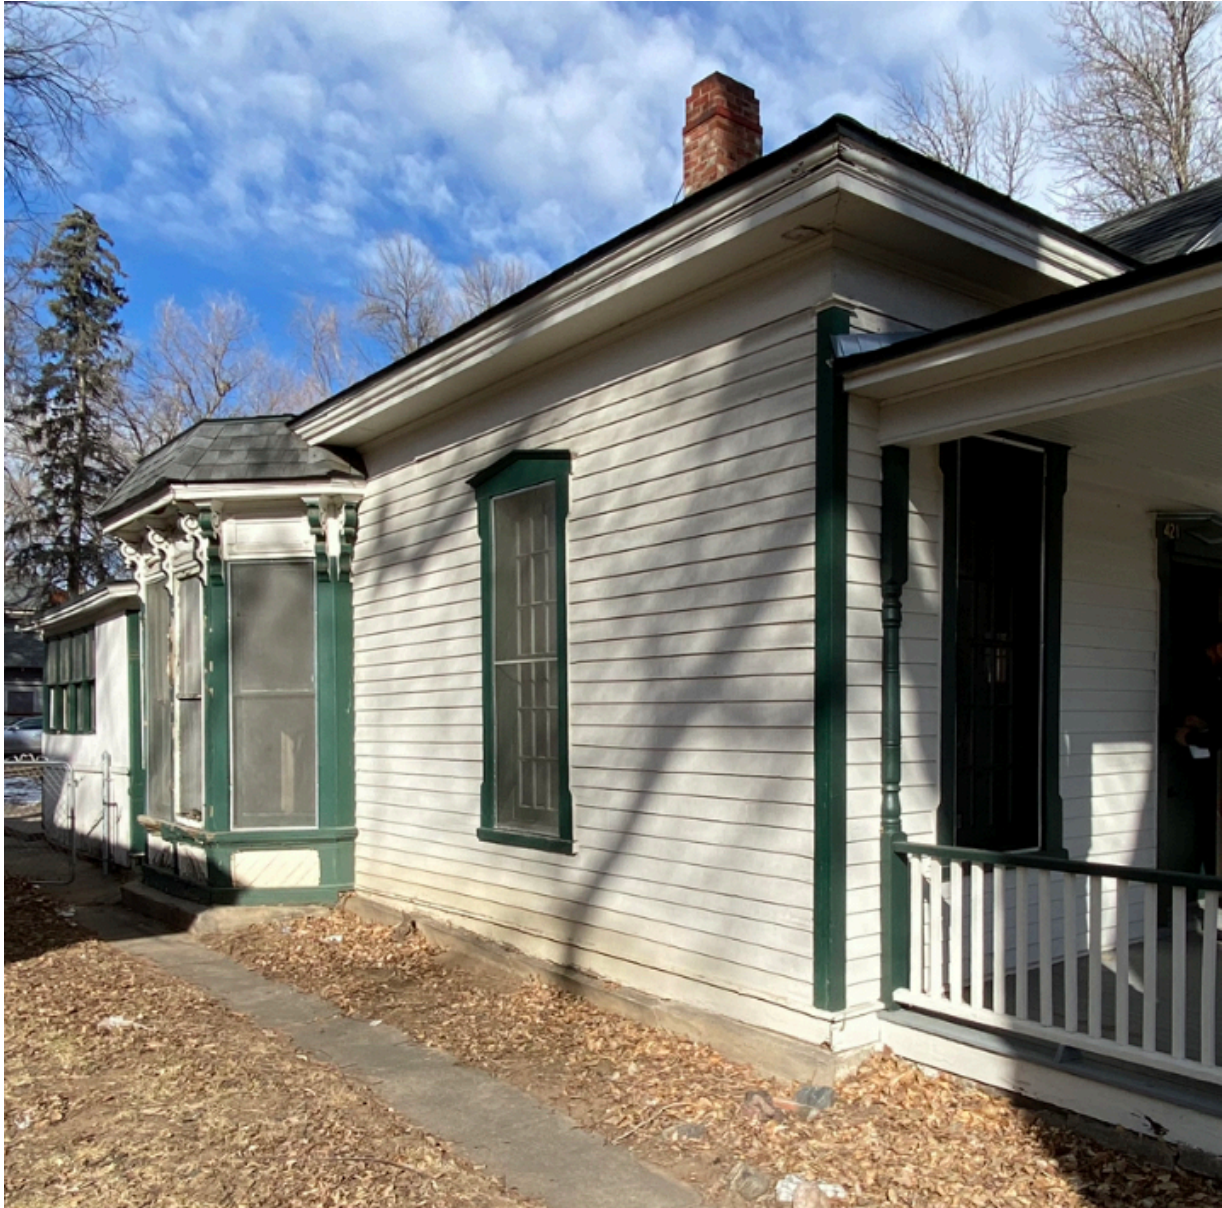
South elevation, showing distinctive bay window, looking northwest.

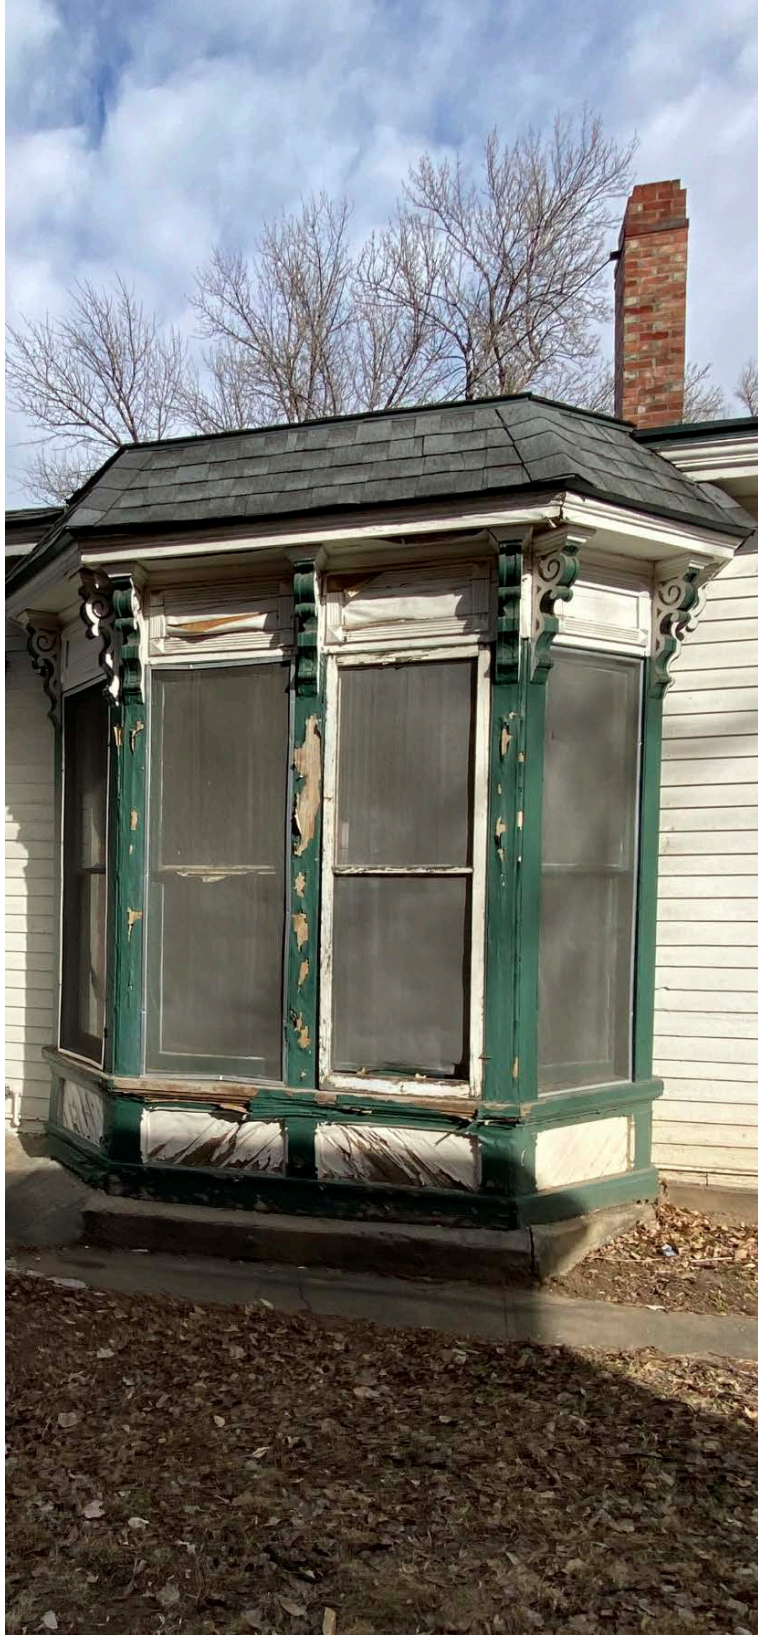
<p>4. South bay window replacement</p> <p>a. <i>The project will remove the distinctive canted bay window on the south elevation and replace it with a boxed bay window. This is a character-defining feature and its removal does not meet this Standard.</i></p> <p>5. Front porch replacement</p> <p>a. <i>The history of the front porch is unclear based on primary source documents, however, the existing front porch is compatible with the overall Edwardian/Victorian character of the house. The new proposed front porch removes the entire structure, replaces the lathe-turned posts with squared posts, and replaces the tongue-and-groove decking and reconfigures the decking from perpendicular to parallel with the façade, ultimately resulting in a porch that is not characteristic of this style of house. This project element does not meet this Standard.</i></p> <p>6. Reconstruction of the brick chimneys</p> <p>a. <i>Due to deterioration, the brick chimneys require deconstruction and reconstruction to ensure suitable mortar joints. This is a common repair to neglected masonry chimneys. However, the reconstruction of the prominent chimney on the north elevation is not in-kind and introduces a non-historic stone cap rather than reconstructing to match the existing configuration. This element does not meet this Standard.</i></p> <p>7. Demolition of shed at southwest corner of lot</p> <p>a. <i>This shed does not appear on any Sanborn maps through 1943 and may have been salvaged and moved to the property at a later date. It is not considered an historic resource for the purposes of this review.</i></p>

South bay window

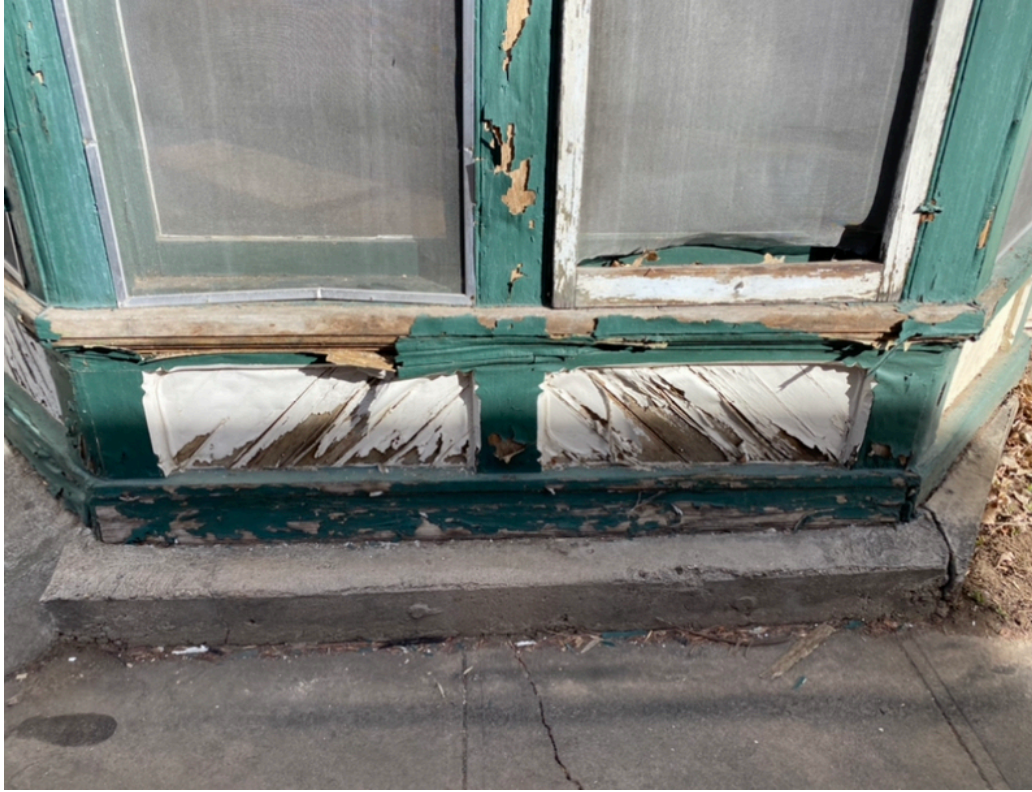
Base of south bay window

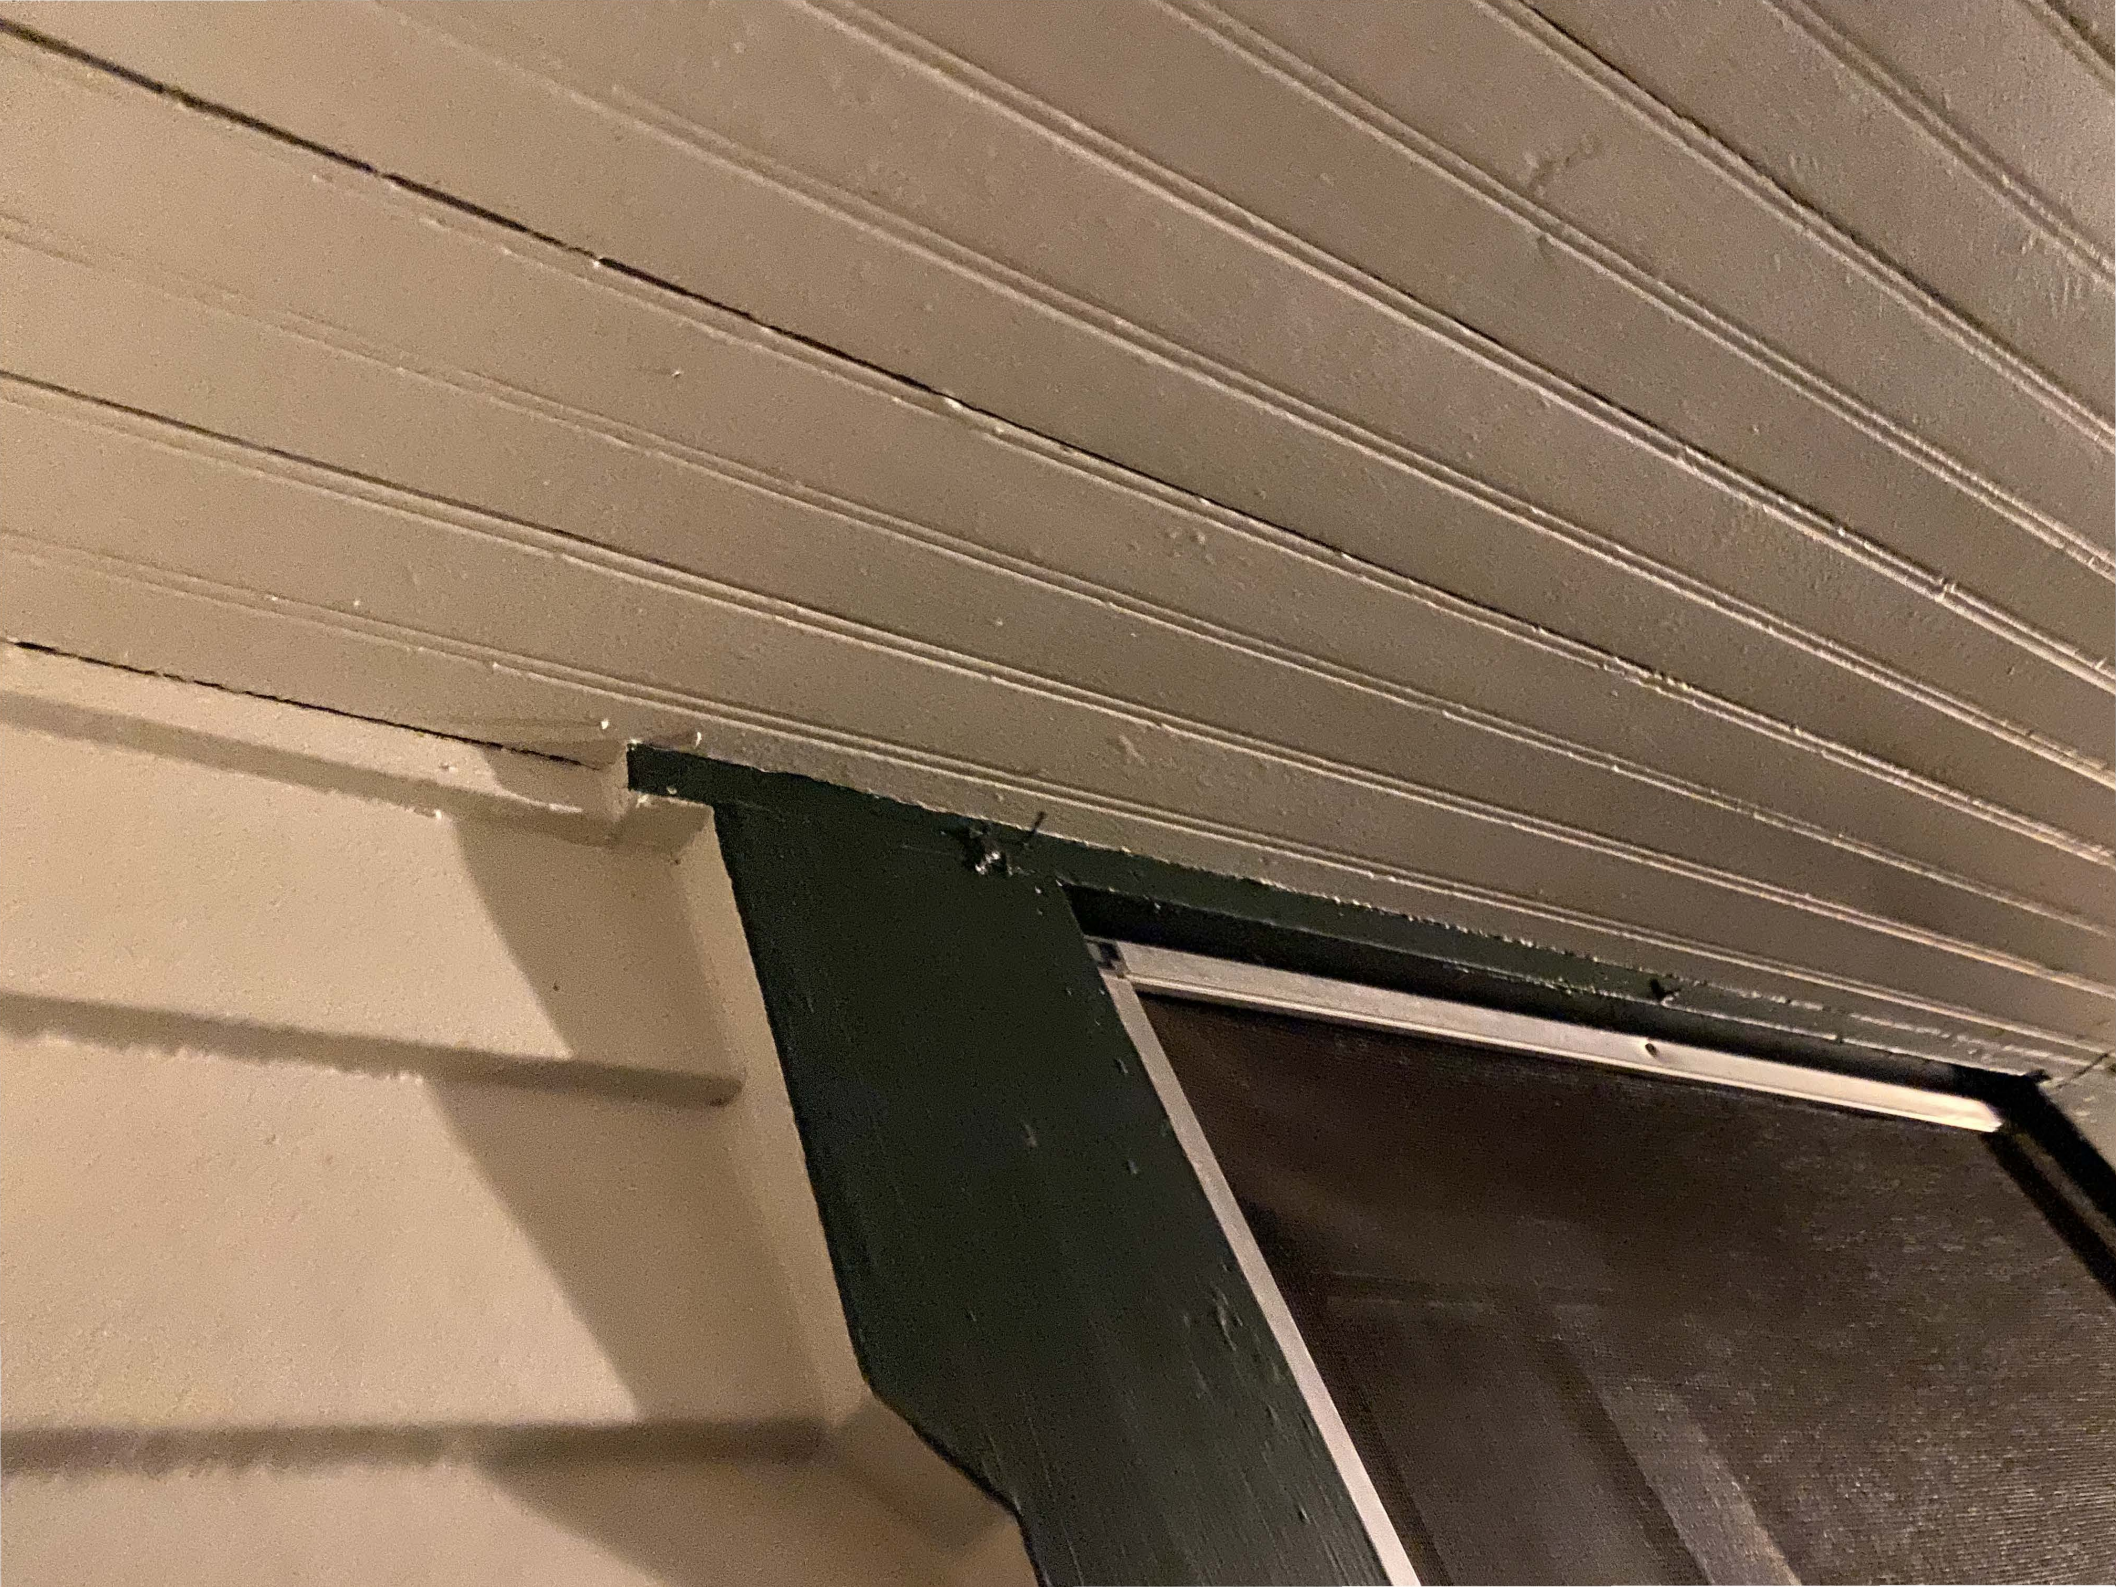
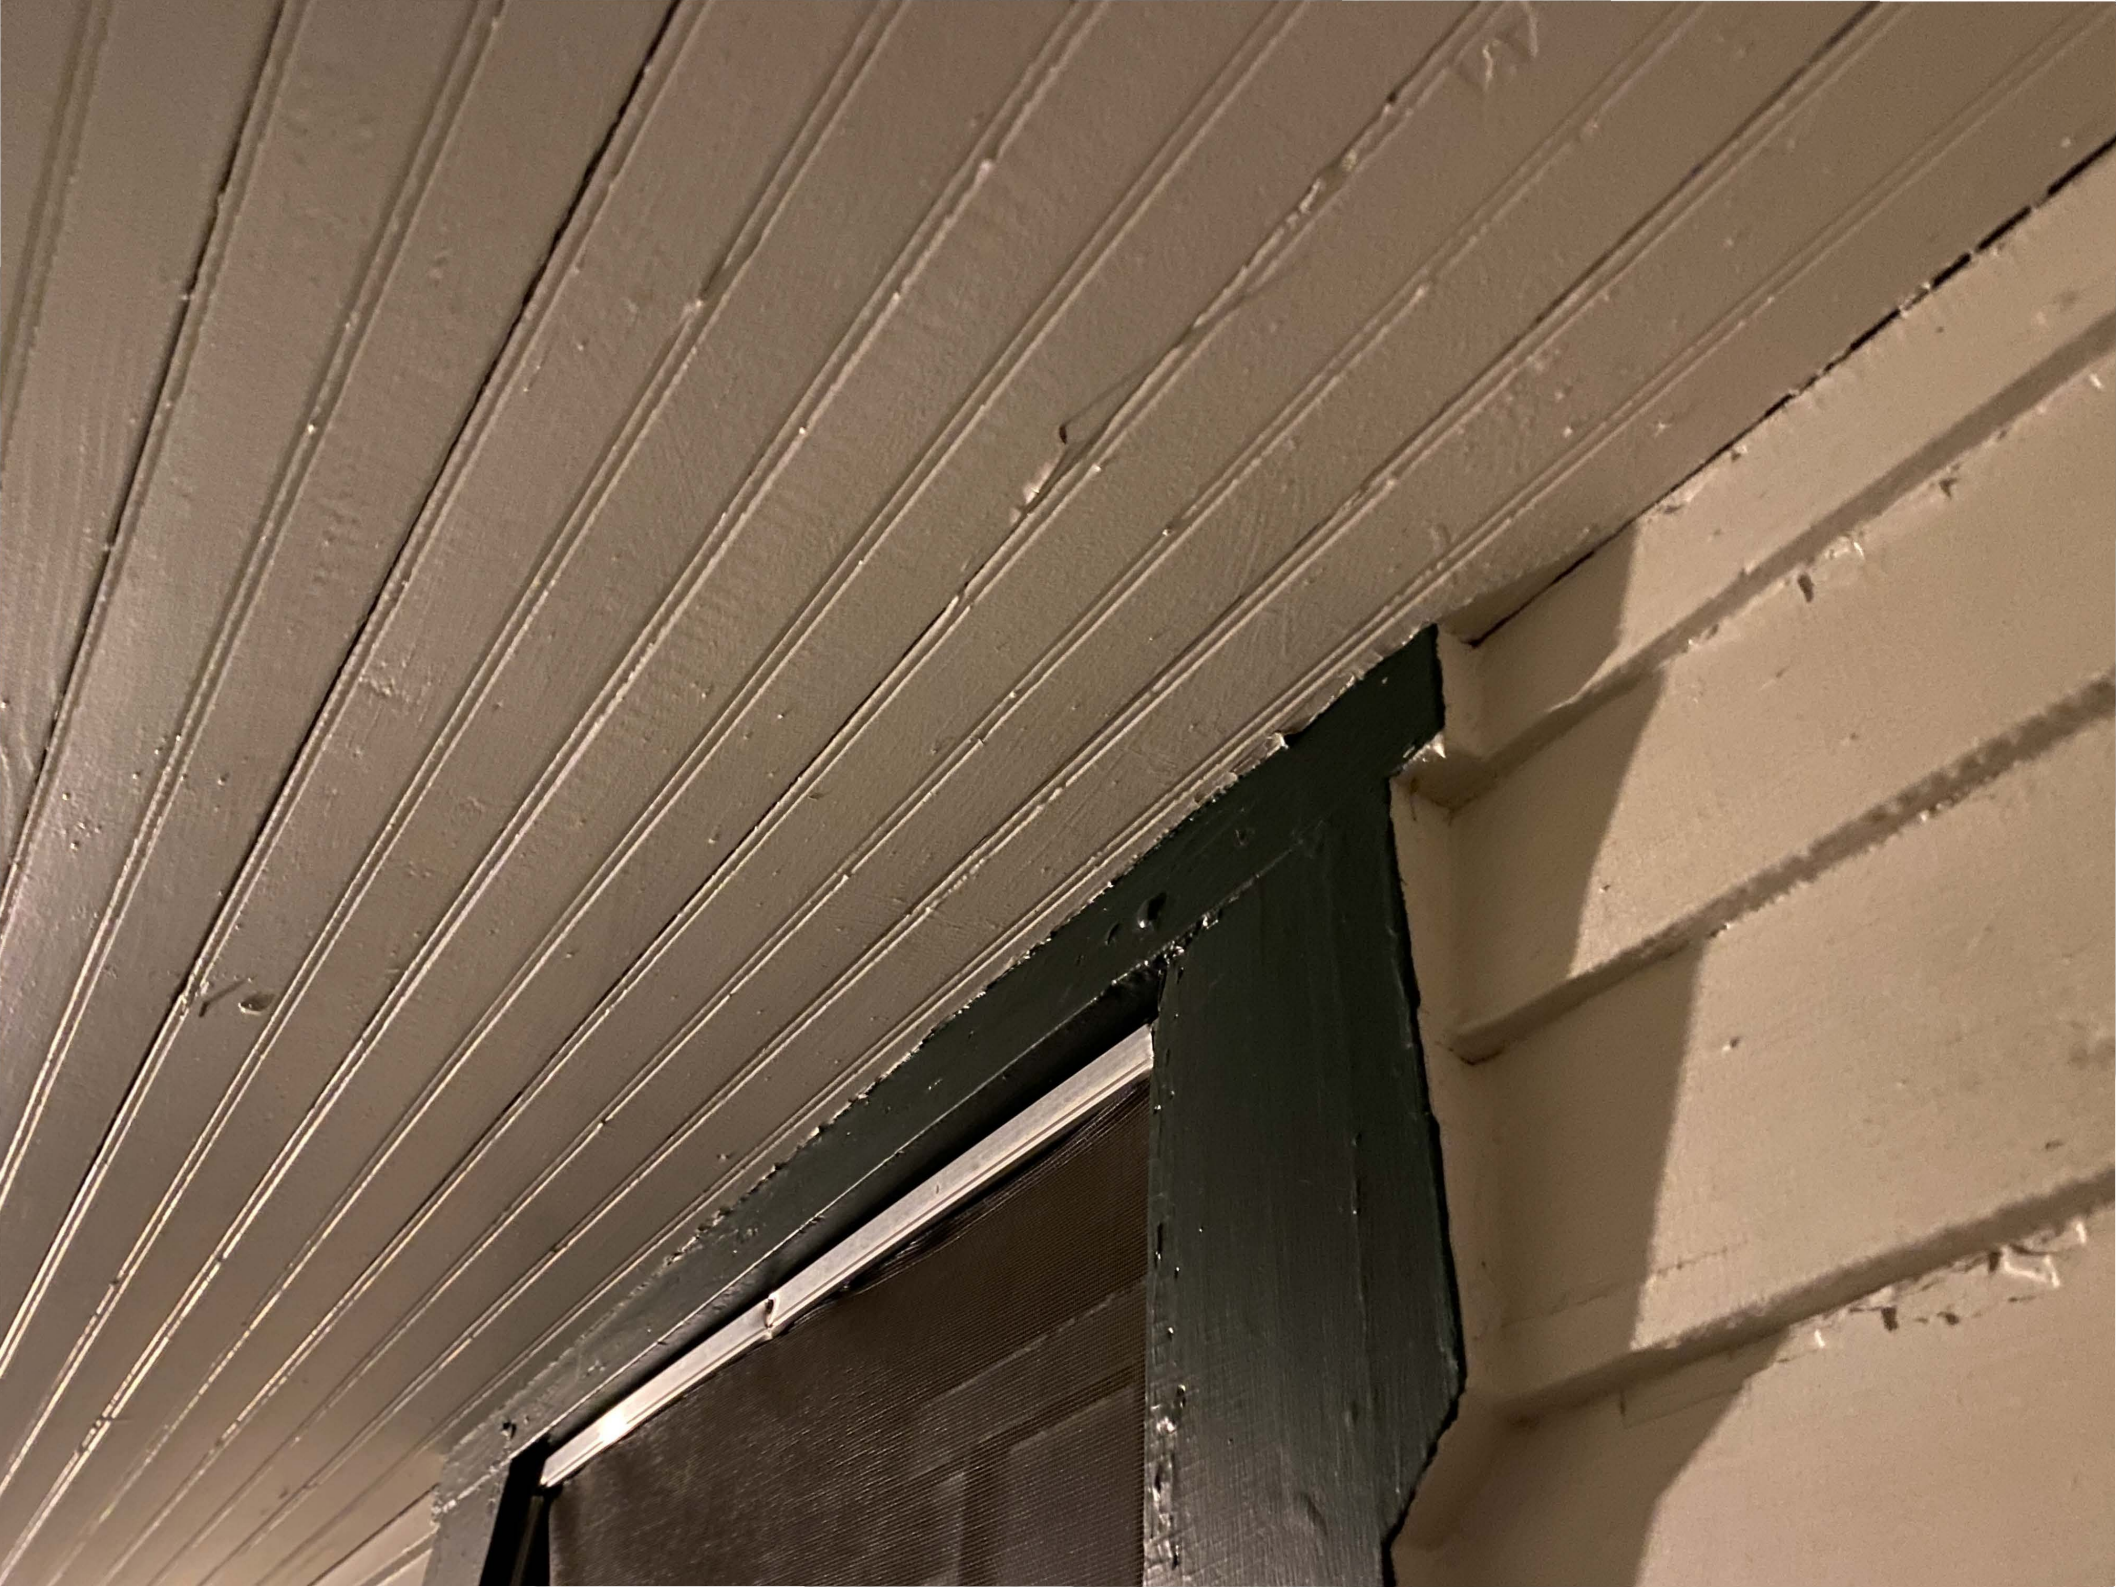
I will be reusing the Window Surrounds minus the ones at the front windows due to the install of the front porch that were cut down to fit the front porch. I will have to replace the top trim piece as shown on photos 1 and 2.
