**Historic Preservation Services**

**REPORT OF ALTERATIONS TO DESIGNATED RESOURCE**  
**Site Number/Address: 421 Mathews Street**  
**Laurel School National Register Historic District**  
**ISSUED: February 17, 2021**

This report is to document the summary of effects from proposed alterations to the Tomlin-Roberts Residence at 421 Mathews Street, pursuant to Fort Collins Municipal Code Chapter 14, [Article IV](#), made by the Landmark Preservation Commission at their February 17, 2021 meeting. A copy of this report may be forwarded to the Colorado Office of Archaeology and Historic Preservation.

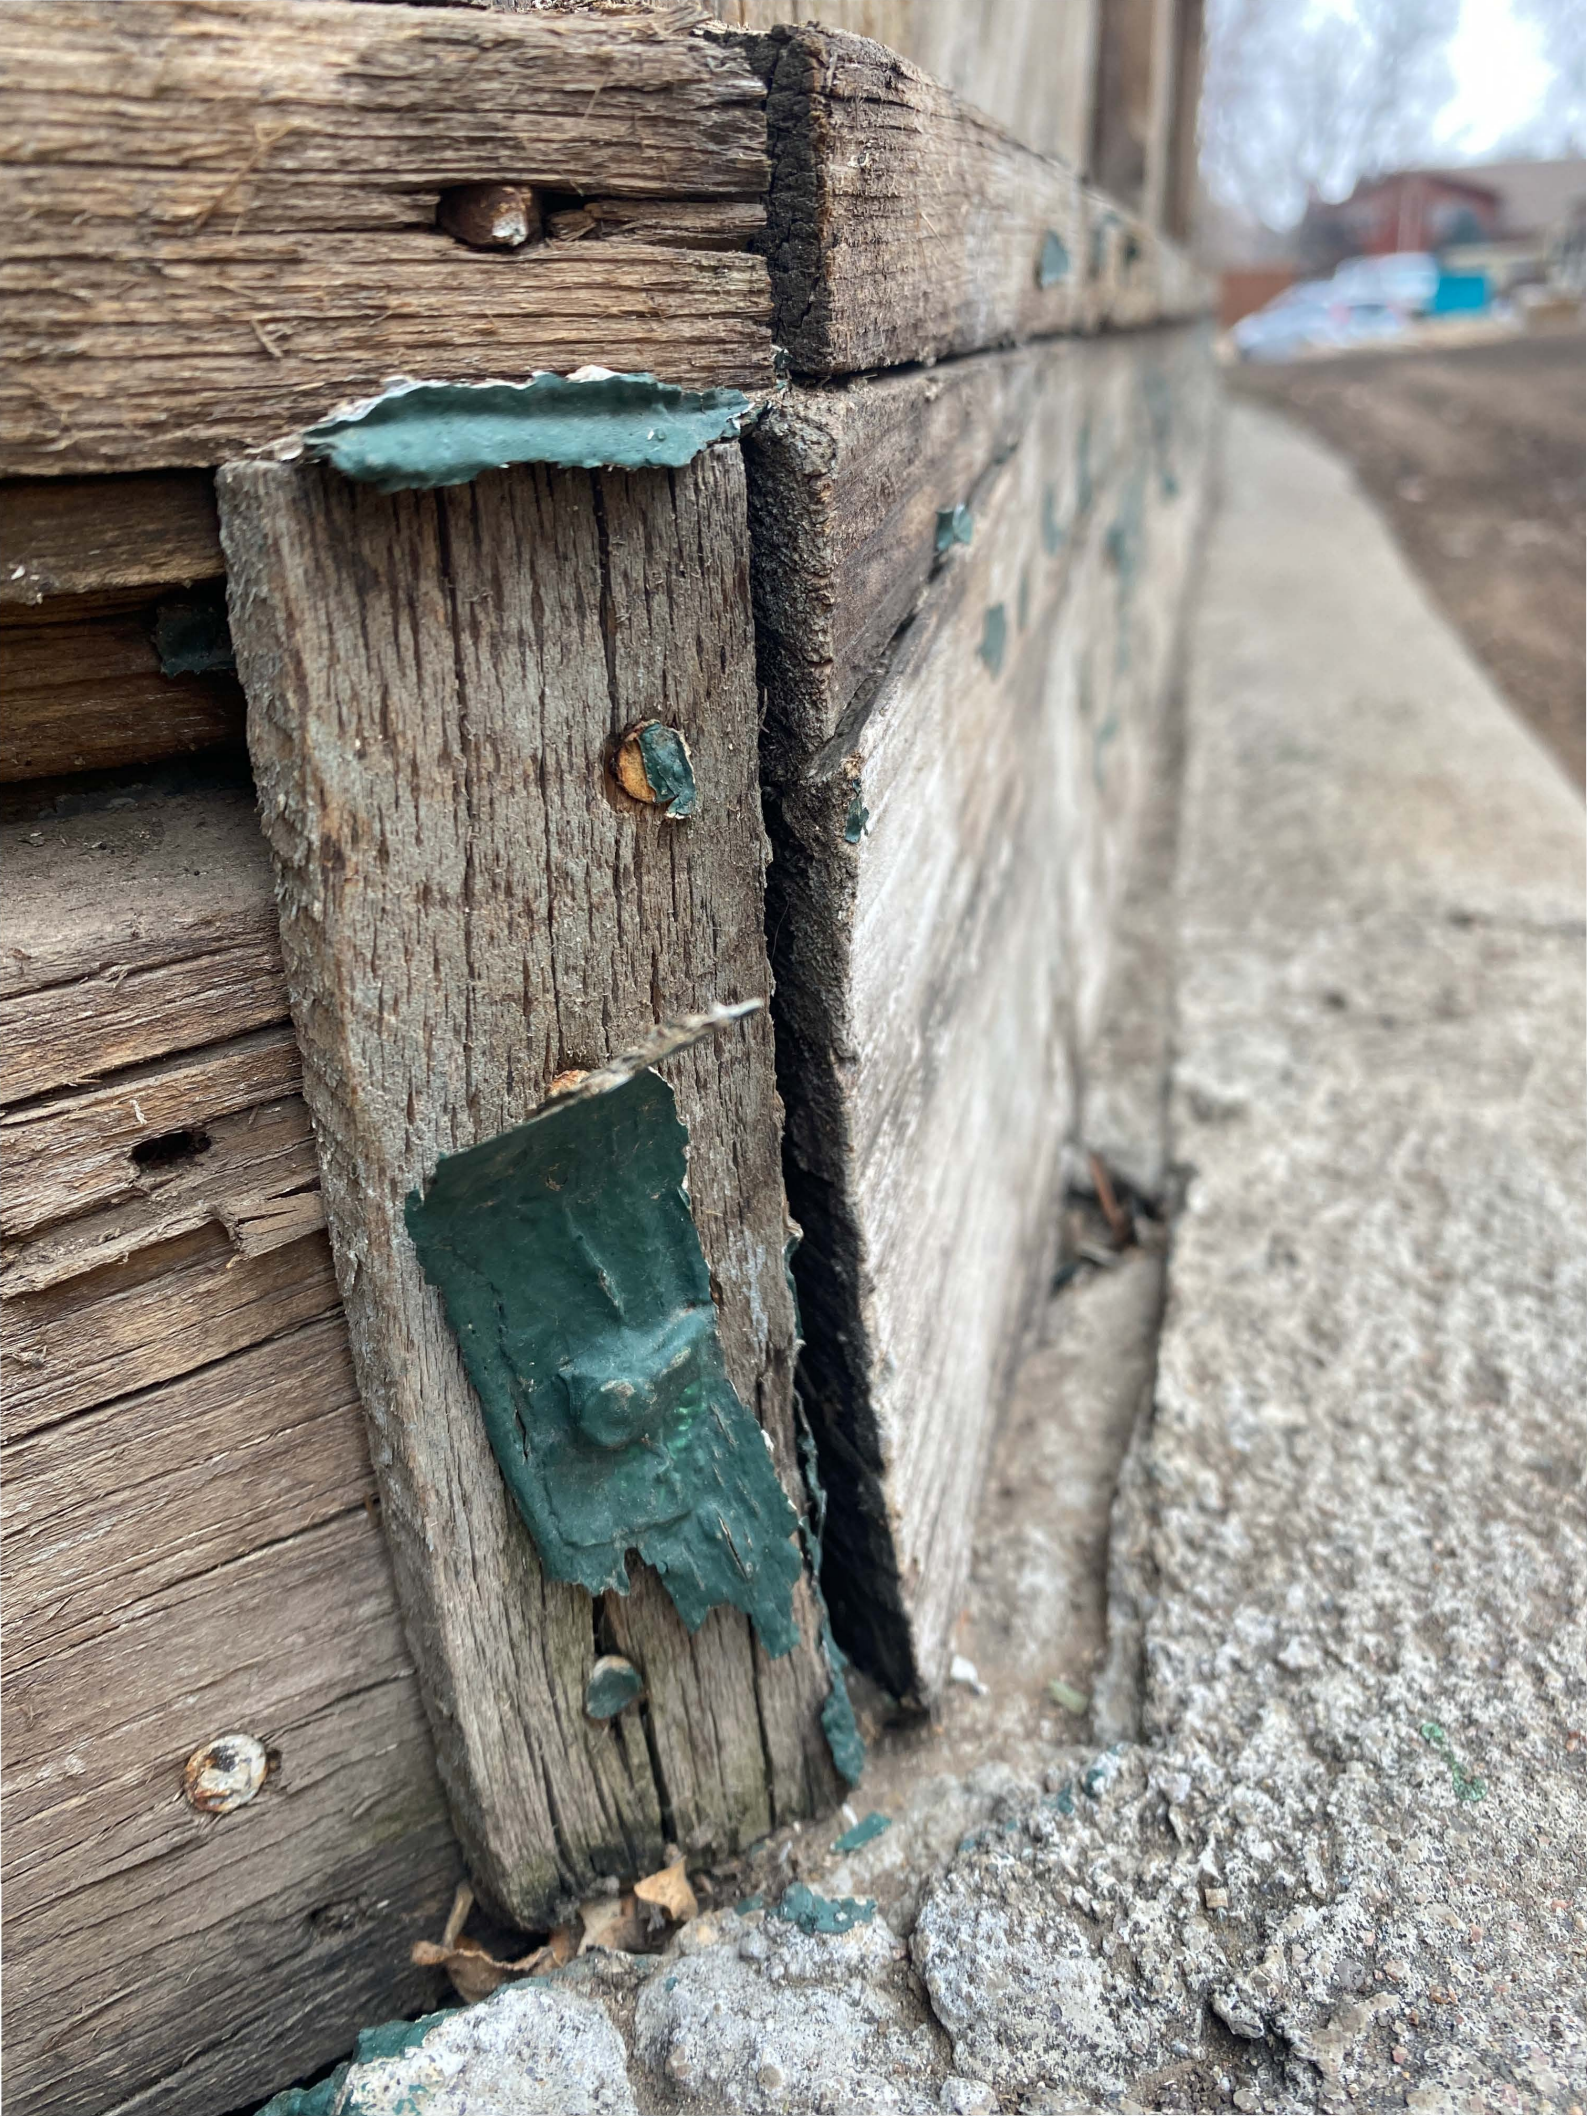
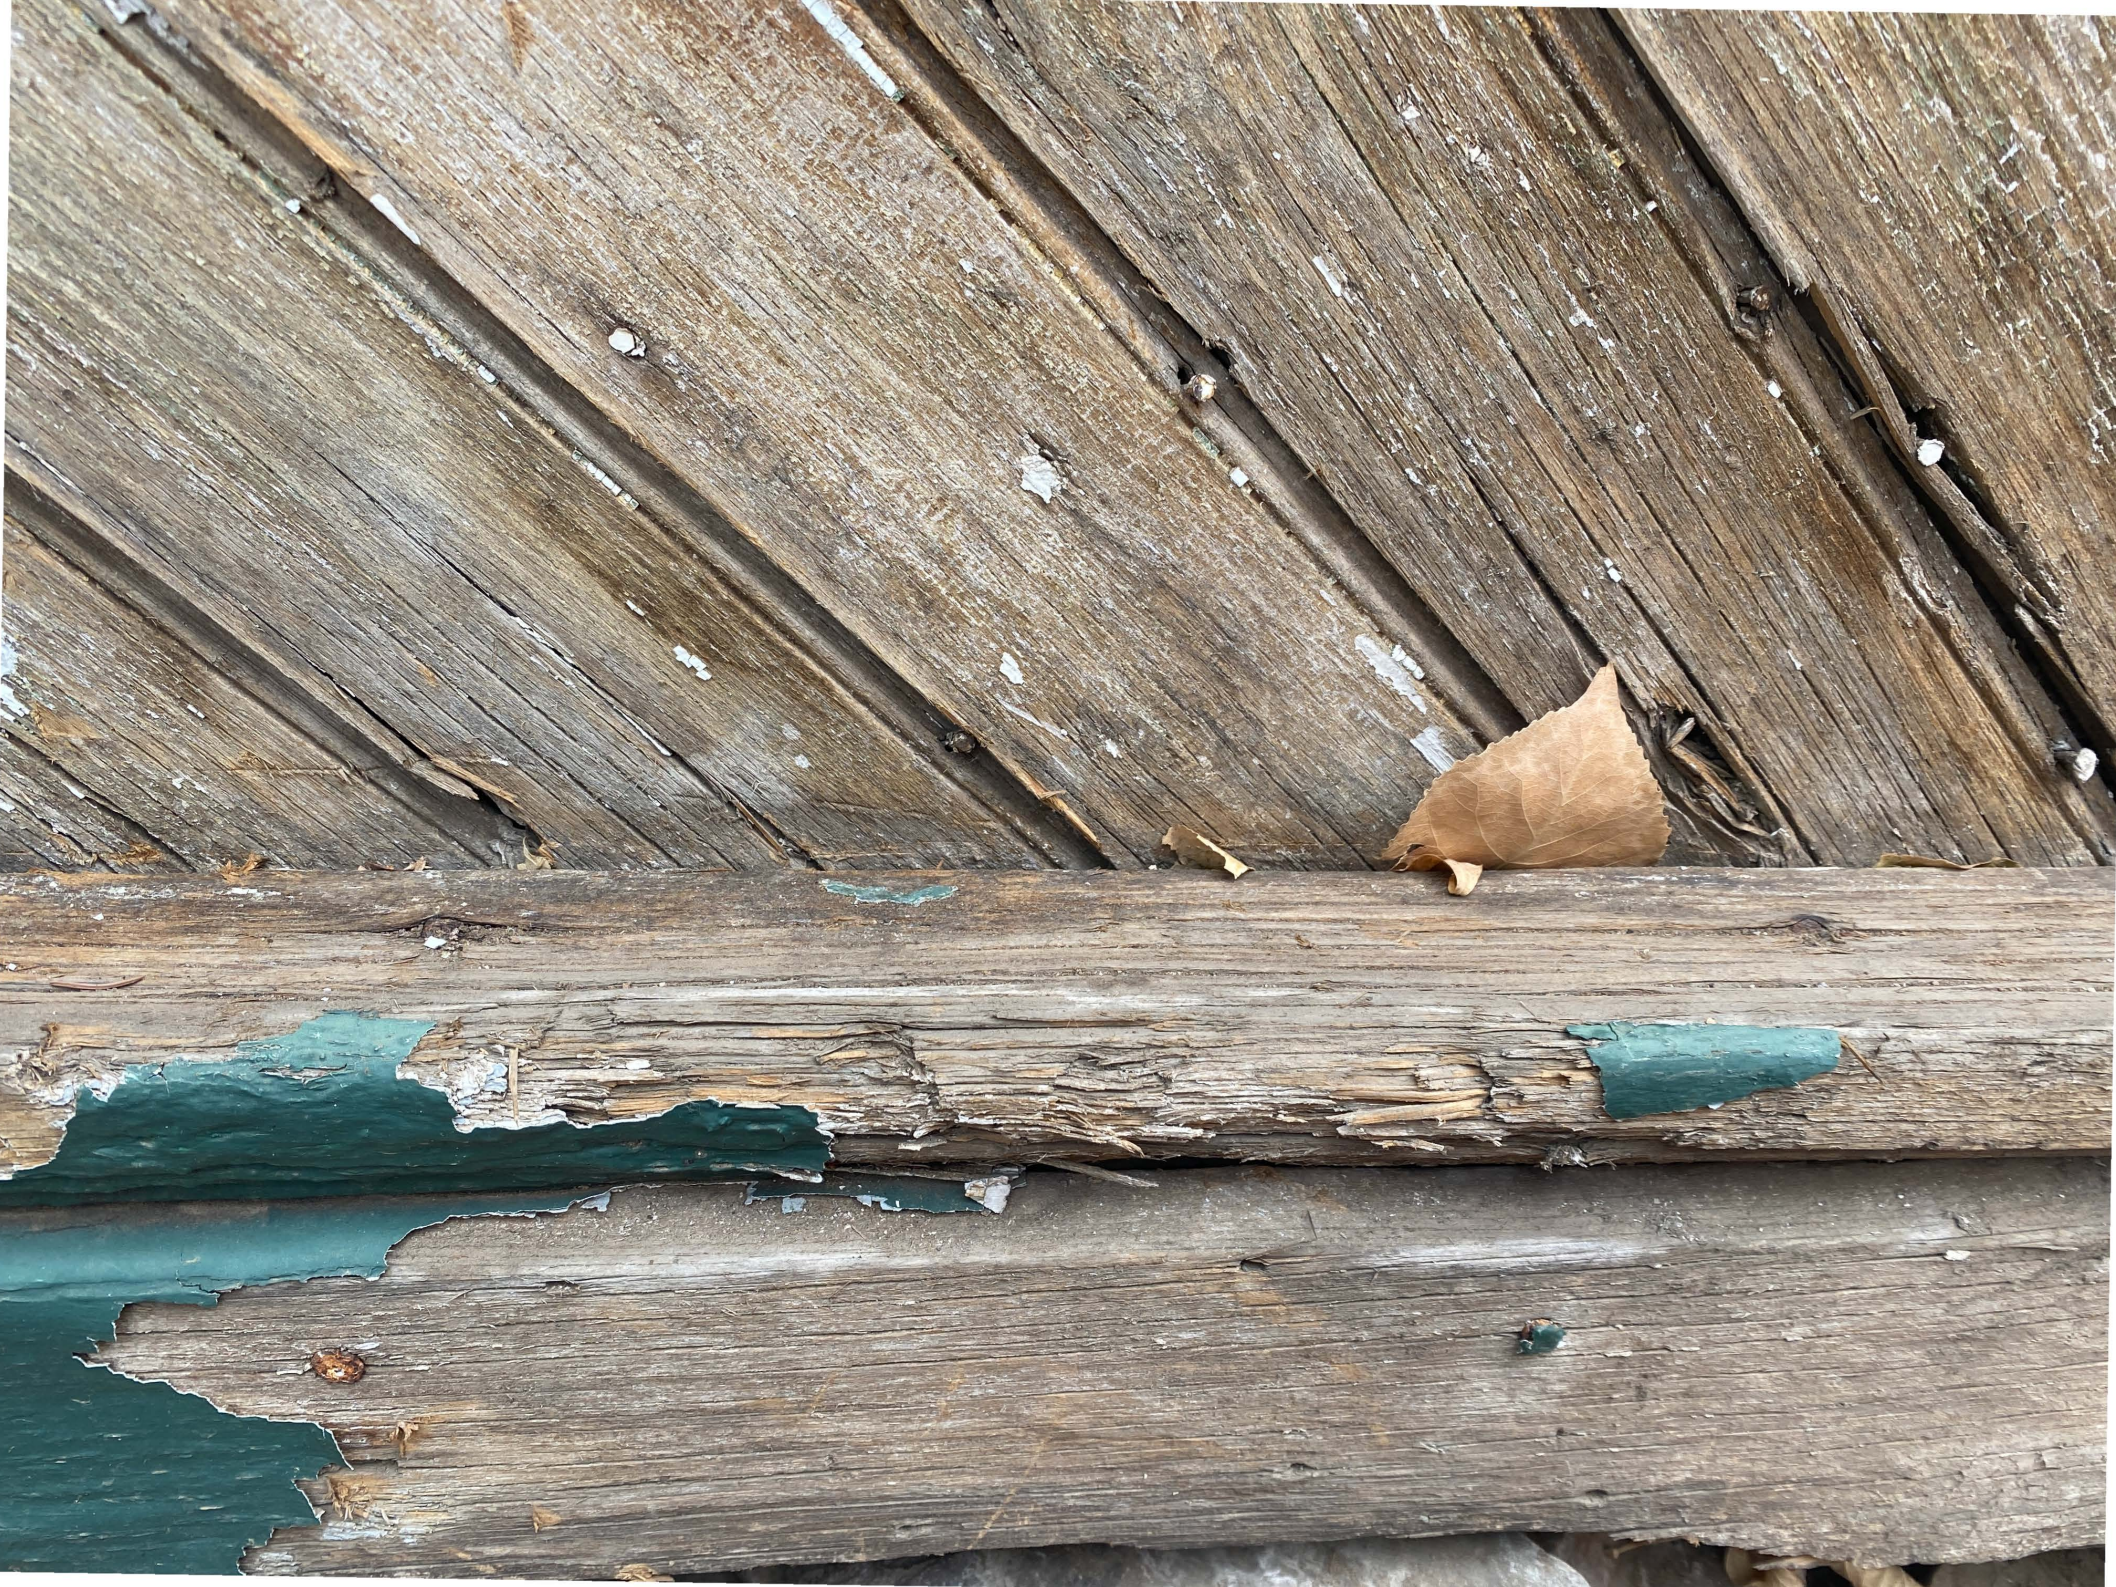
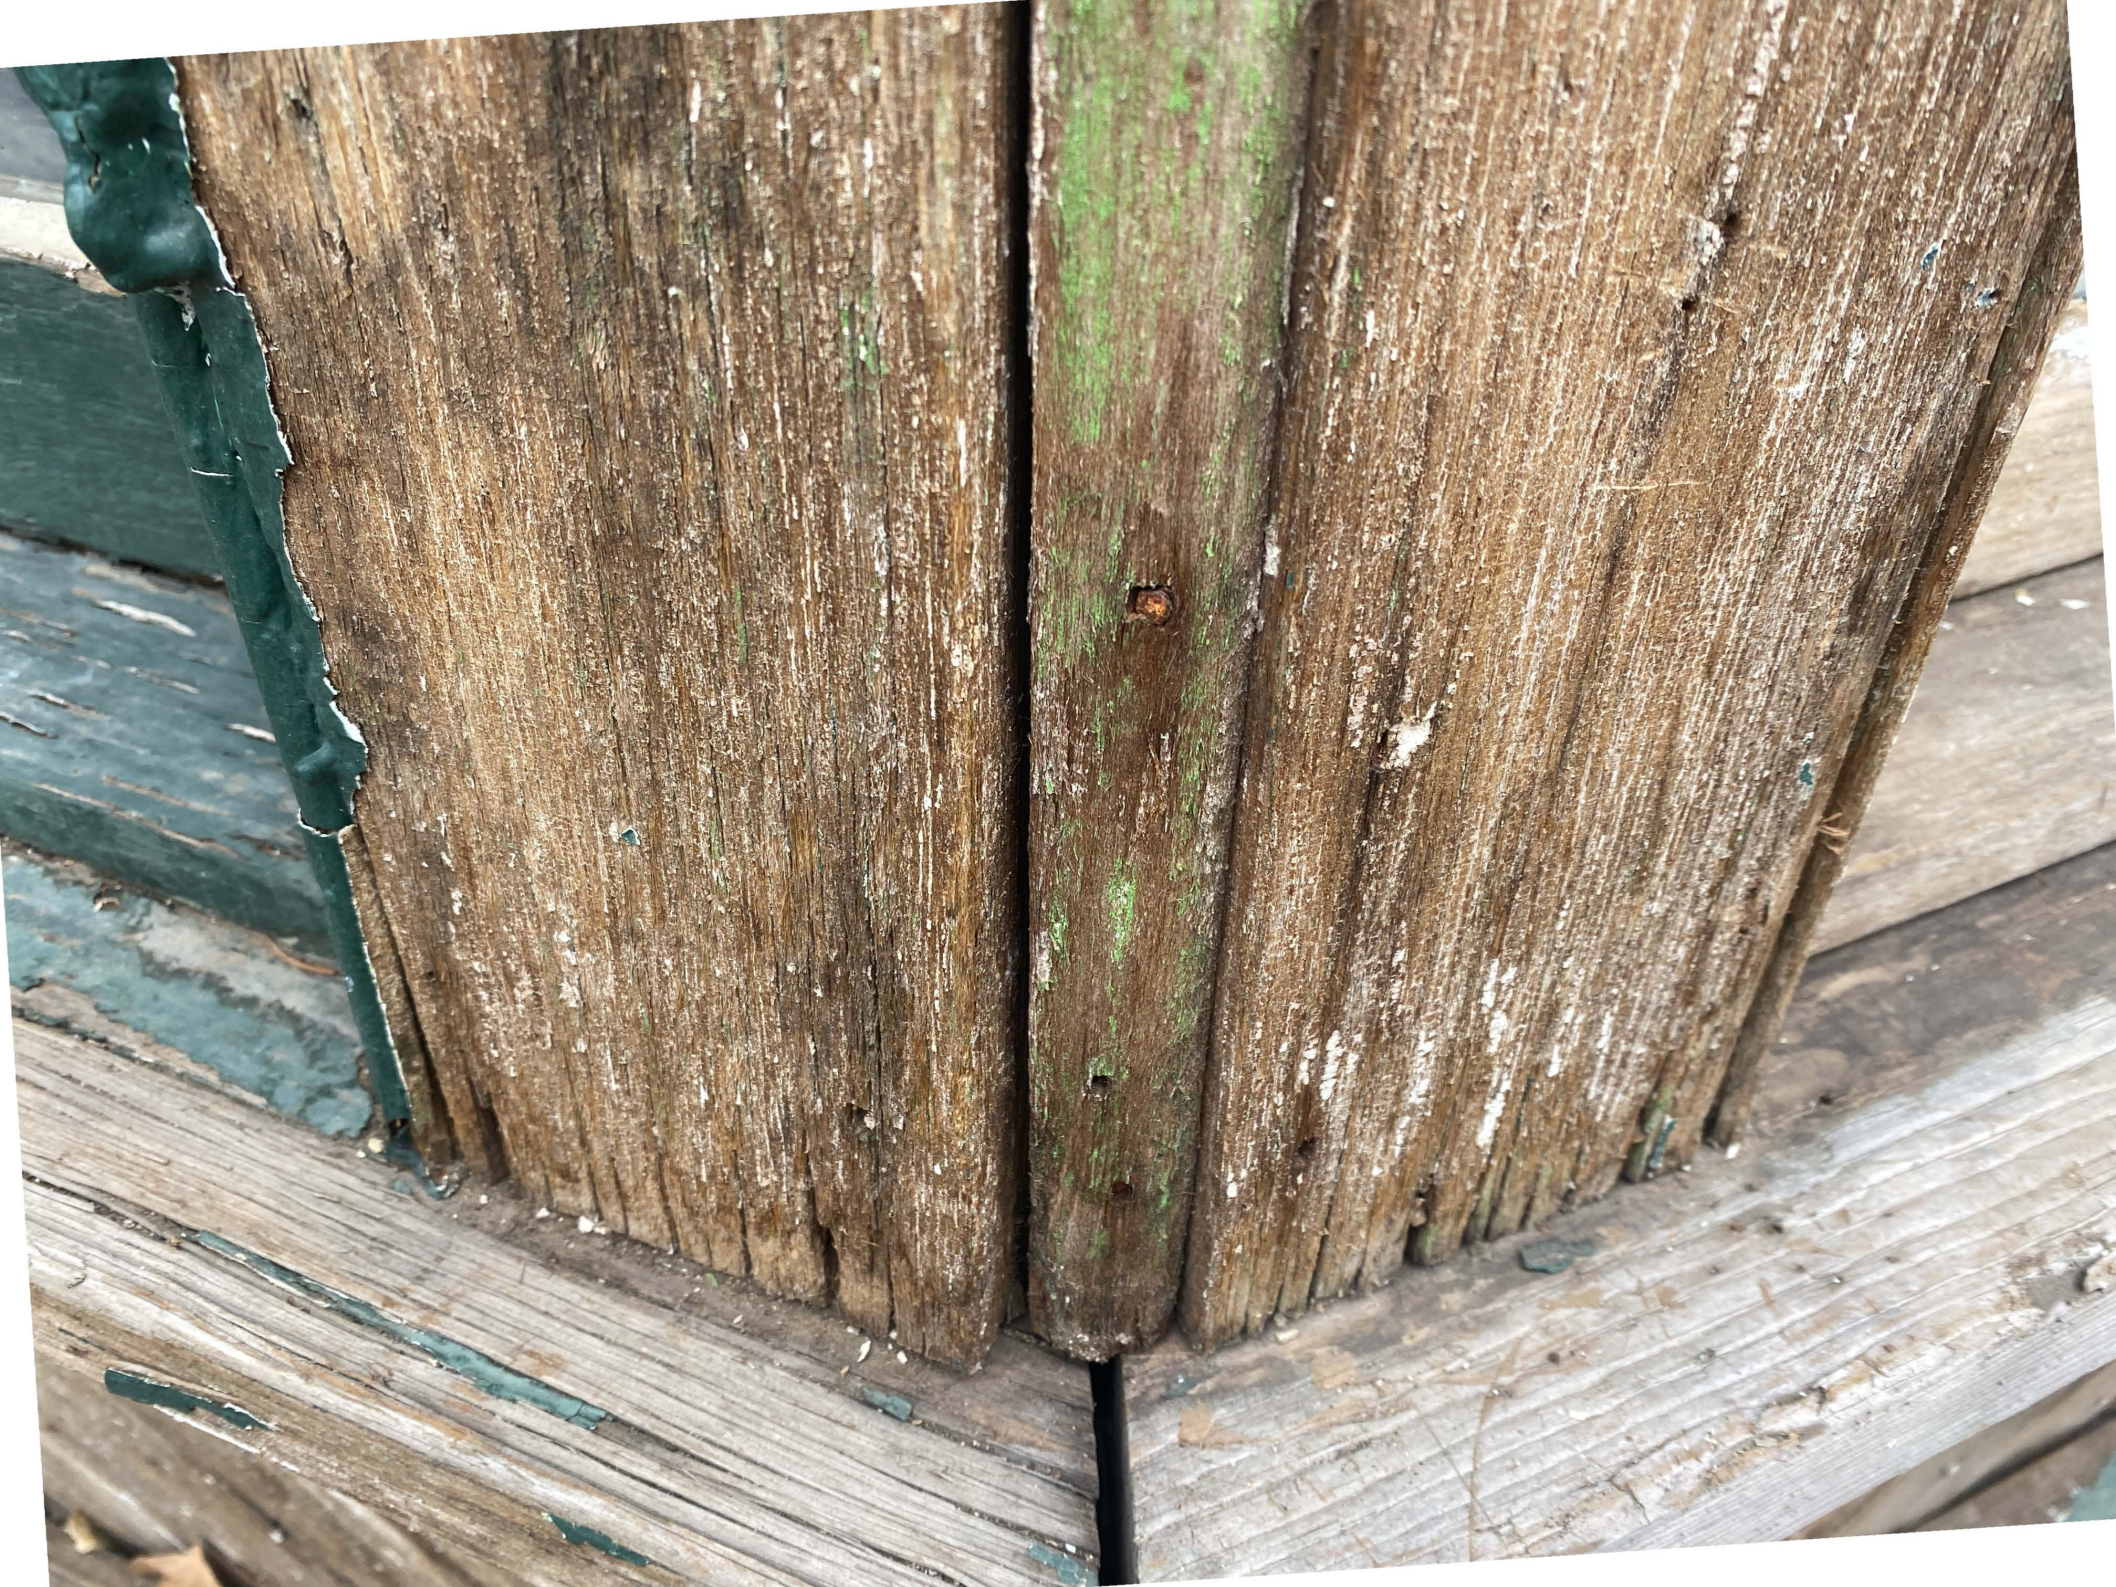
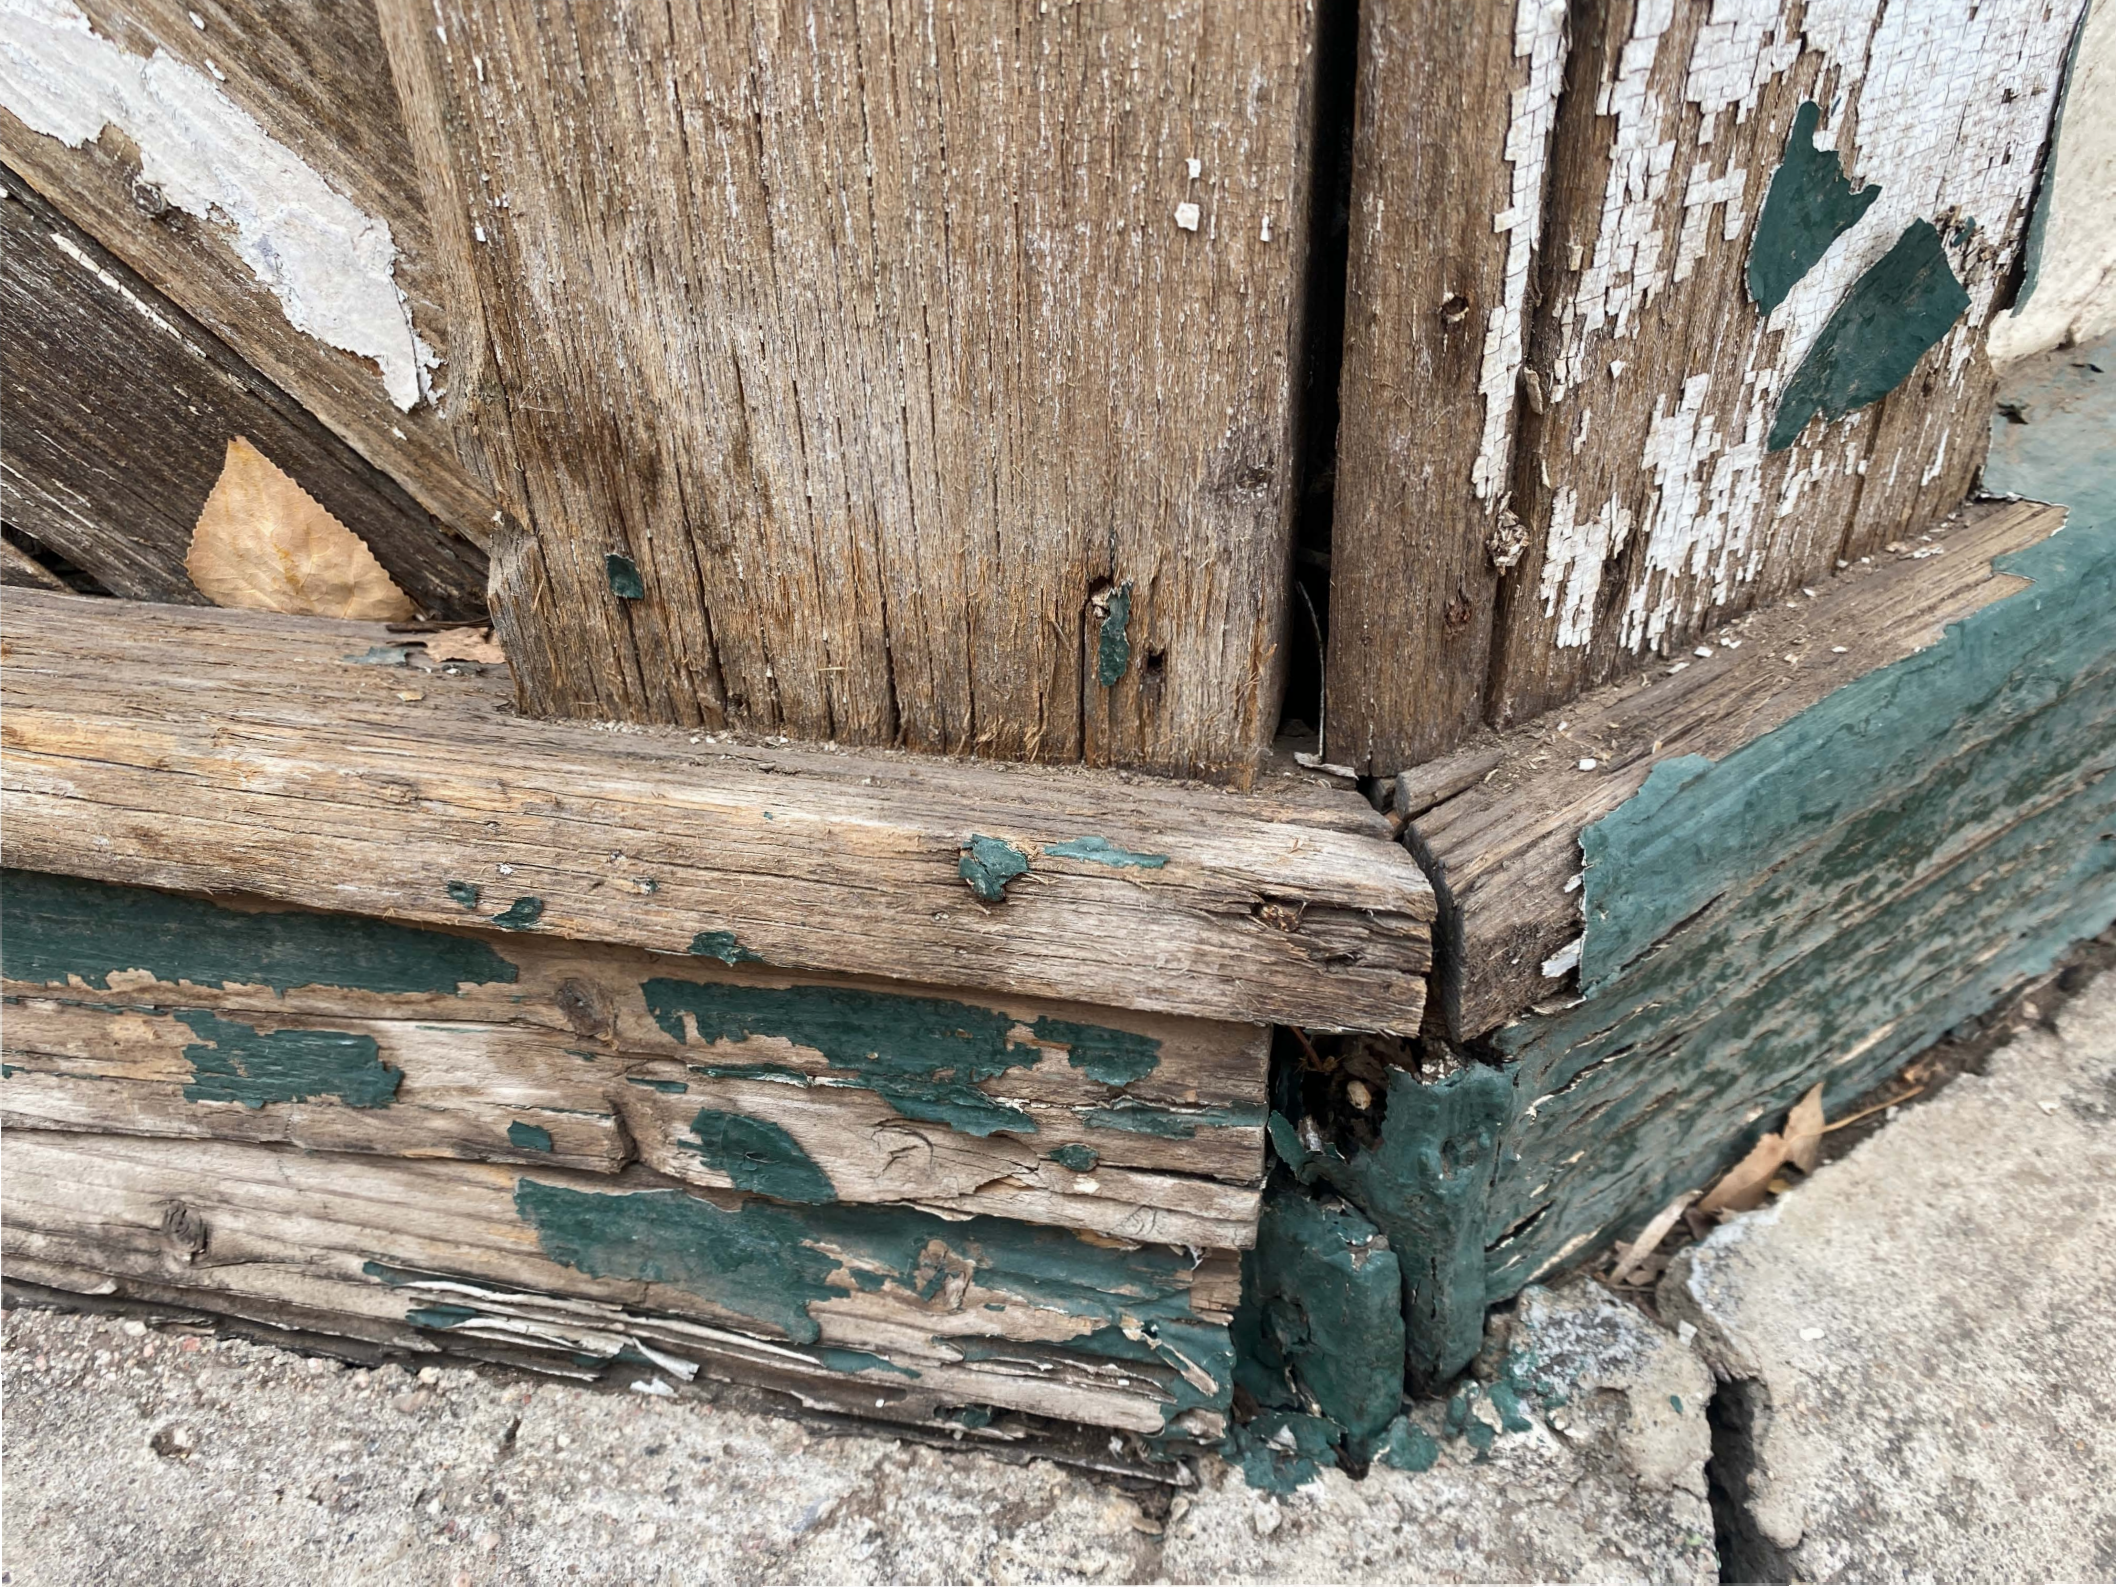
I have explored and peeled the paint away. Please see photos 4 ,5 ,6 and 7 of the damage to the bay window. I will be salvaging some of the trim around the windows to use for the new window exterior trim. Keep in mind that this entire bay window has fallen roughly 2" from side of the house to the outside edge of the house. This has to be pulled out and resupported.
