REPORT OF ALTERATIONS TO DESIGNATED RESOURCE Site Number: 313 Edwards Street, Fort Collins, 5LR.2430 Laurel School National Register Historic District ISSUED: September 30, 2019

This report is to inform History Colorado of proposed alterations to the Maxon House, 313 Edwards Street, Fort Collins, CO 80524, a contributing building in the Laurel School Historic District (NRHP).

The alterations include: Increase rear roof height by 16" or more to accommodate a ³/₄ bathroom on the interior, as well as 2 new window openings, a dormer on the rear elevation, and two skylights.

Colorado Cultural Resource Survey Architectural Inventory Form

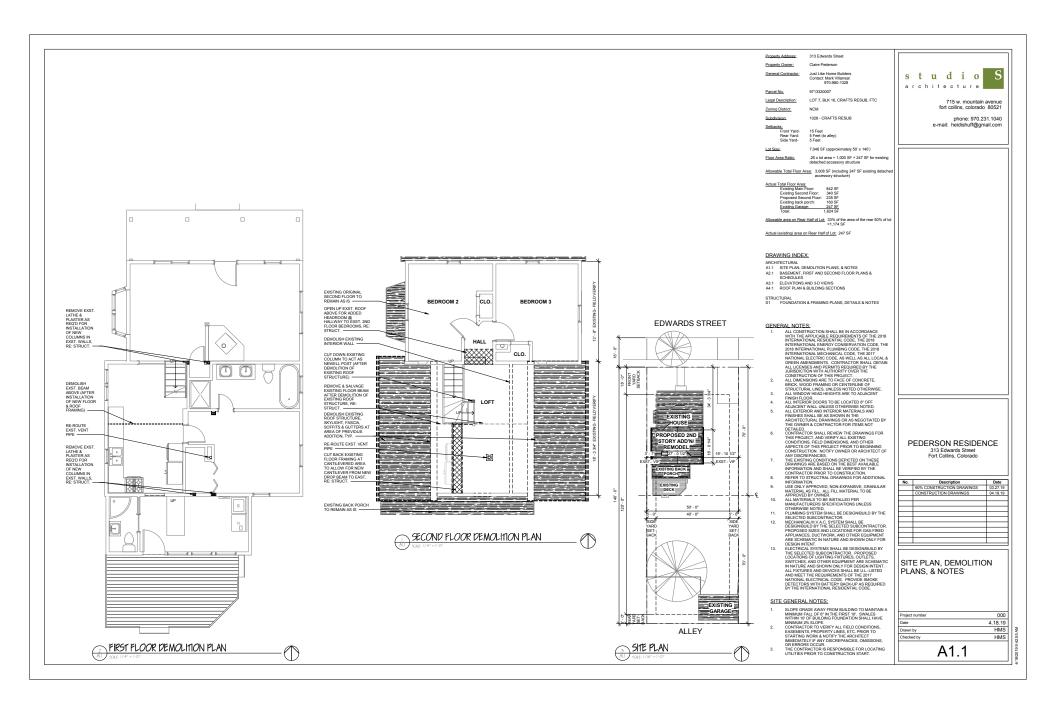
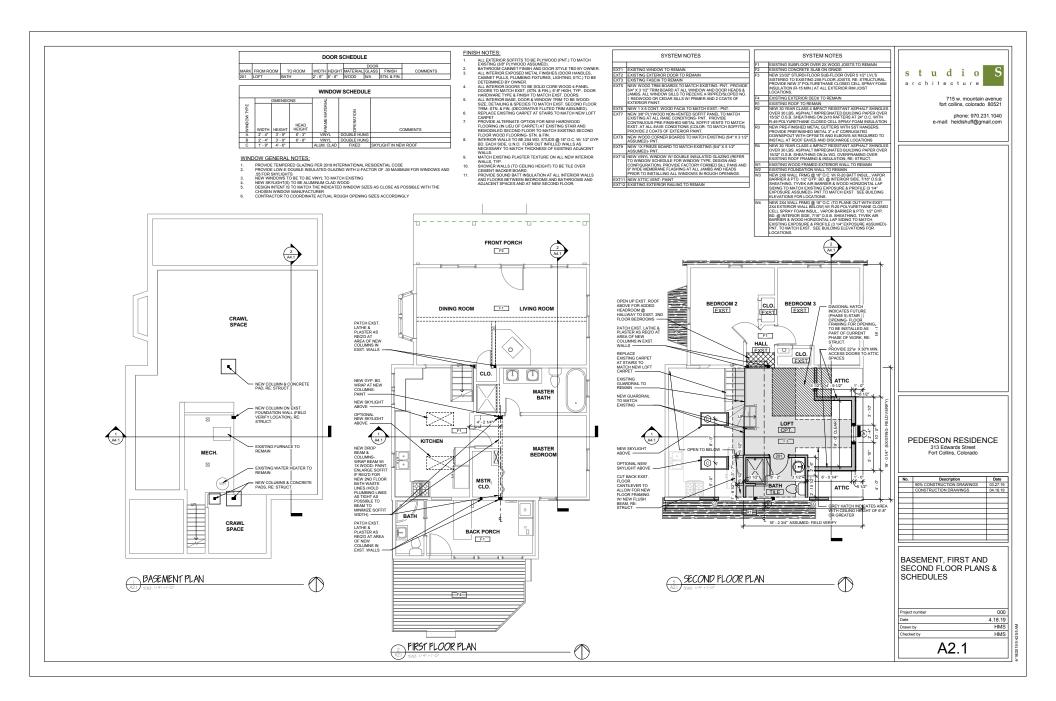
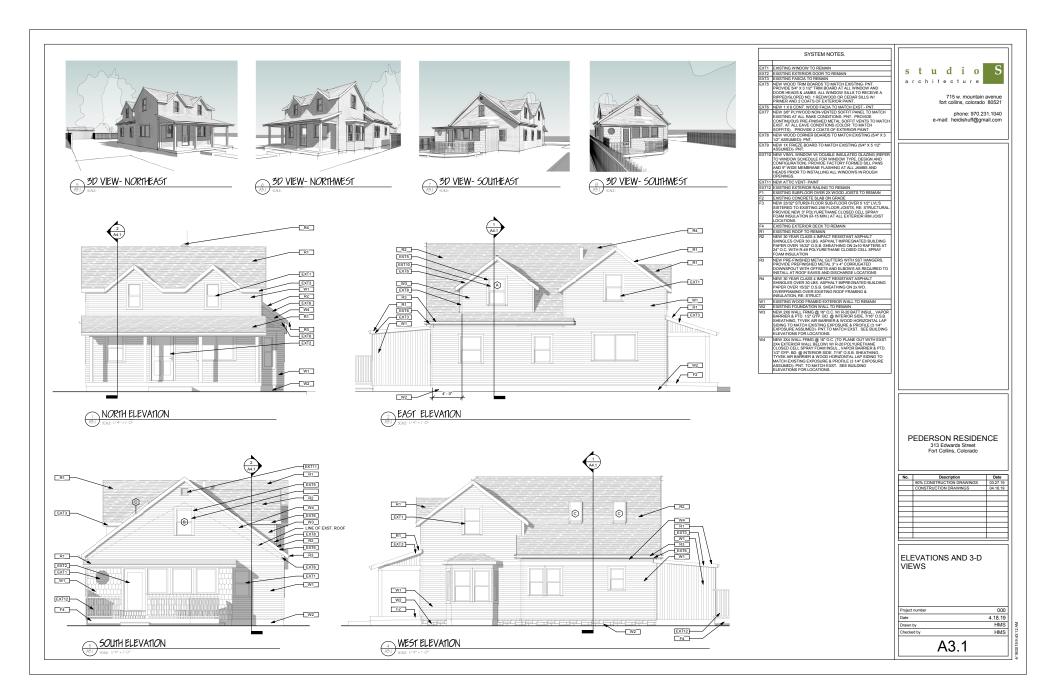
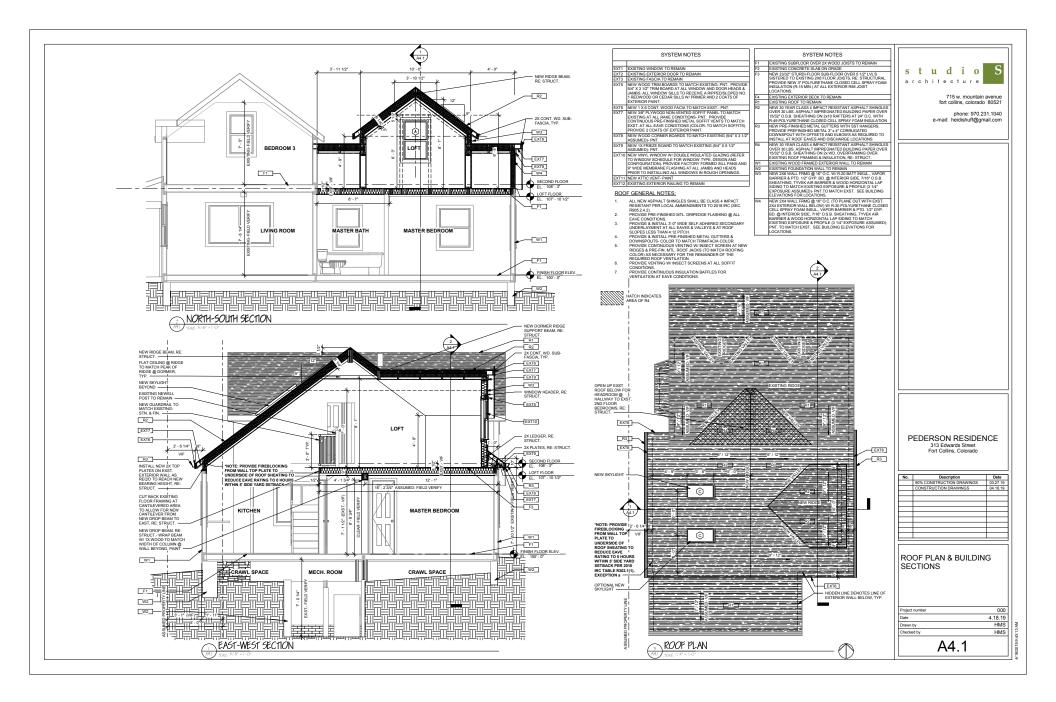
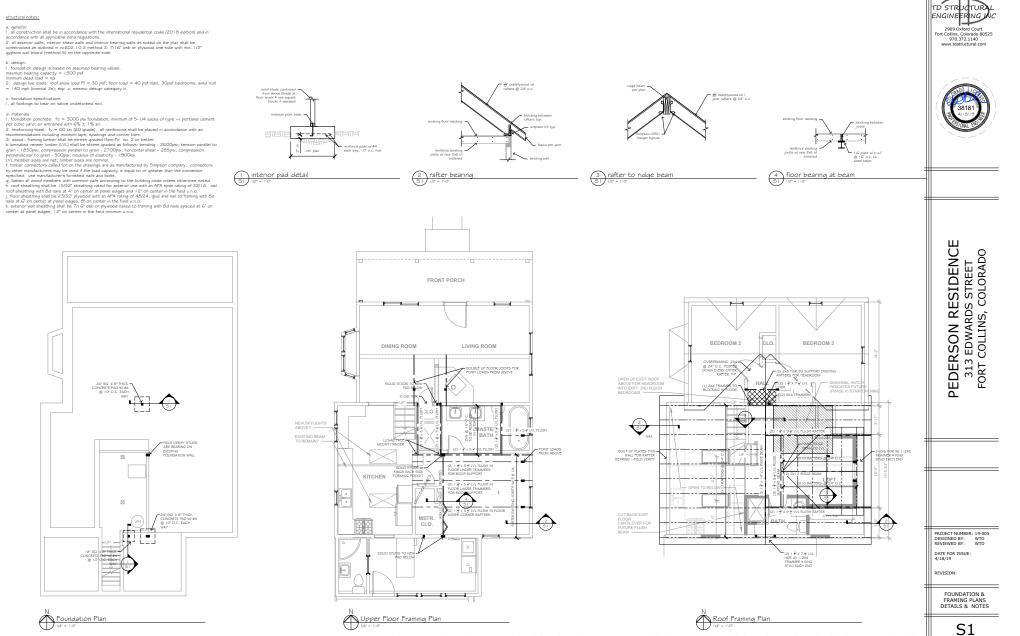
\checkmark	Demolish a portion of the existing roof at the previous rear addition (immediately behind the original house built in 1902) in order to provide code required headroom @ top of existing stairs
	terials of work (e.g. current/proposed materials of porch, windows, siding, roof, etc.) specific about materials. What kind of wood? Exposure of siding? new 2x10 roof rafters w/ class 4 impact-resistant asphalt shingles at new (steeper pitched) rear roof
✓	new 2x6 stud walls w/ painted wood siding (3 1/4" exposure) and trim to match existing at new east dormer
	new vinyl windows to match existing at new east dormer and existing south gable end wall
 Image: A start of the start of	new aluminum clad wood skylights at west side of raised rear roof (similar to existing skylight)
 Image: A start of the start of	new painted aluminum attic vent at south gable end wall

c. foundation specifications
 I. all footings to bear on native undisturbed soil.

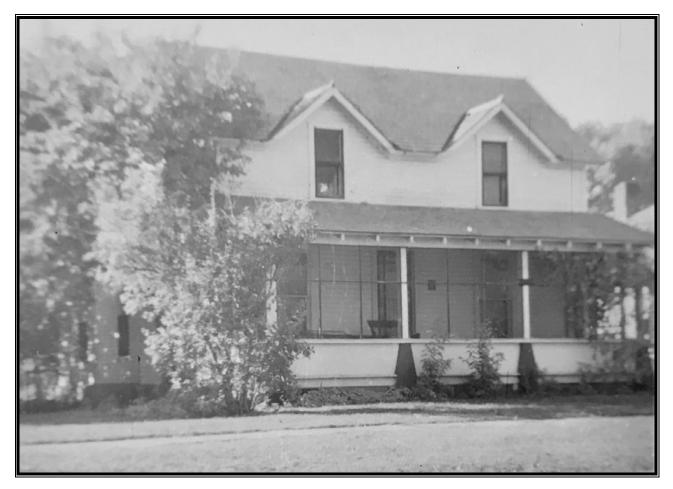
Historic View of the House, 1948 Fort Collins Museum of Discovery, Historic Assessor's Card View to the Southwest

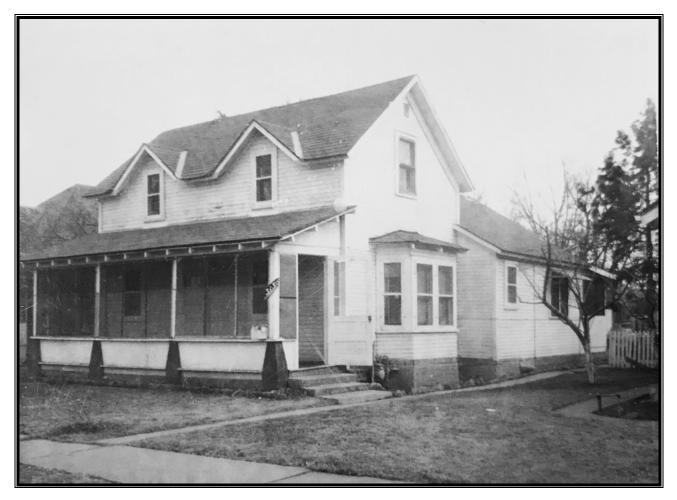
Historic View of the House, 1969 Fort Collins Museum of Discovery, Historic Assessor's Card View to the Southeast

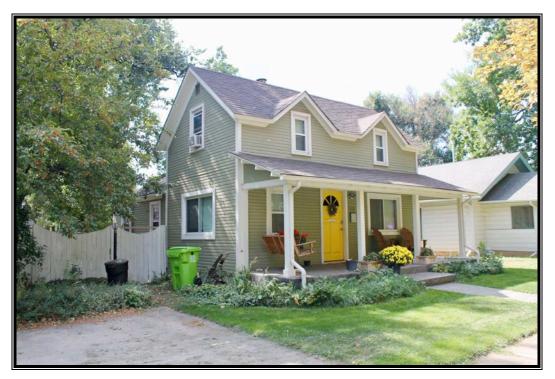
Front of the House, View to the Southwest

<u>North Wall (front)</u>: The façade of the house is symmetrical and has a full-width open porch. This rests upon a raised concrete foundation and is reached by way of a concrete step up from the front sidewalk. Four square wood posts support the outer edge of the porch's shed roof, which is finished with exposed rafter ends and composition shingles. Slightly off-center on the primary wall of the building is the main entrance, which has a wood panel door with an arched light. To the east of that is a one-over-one double-hung sash window and to the west is a two-light sliding window. Above the porch roof are two wall dormers, each containing a small narrow one-over-one double-hung sash window. All of the windows have what seem to be wood frames and surrounds. The doublehung windows appear to be original and are covered by storm windows.

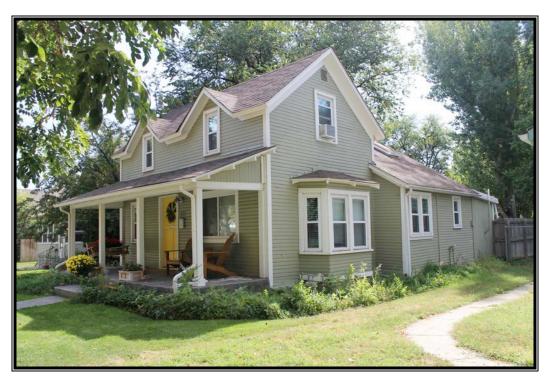
Front of the House, View to the Southeast

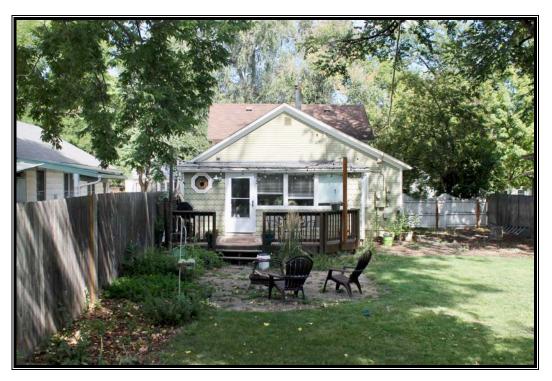
Rear of the House, View to the North

<u>South Wall (rear)</u>: The rear wall of the house holds the building's only other entrance, which provides access into an enclosed porch. The porch walls are finished with wood siding with scalloped lower edges. Its shed roof is covered with standing seam metal panels. The entrance contains a storm door (the primary door inside that could not be viewed). To the east of the entry is a band of three single-light windows, and to the west is a small octagonal window. Outside the porch is a non-historic open wood deck with a wood rail. The small area of exposed wall on the main body of the house east of the porch appears to hold a window that may be boarded closed.

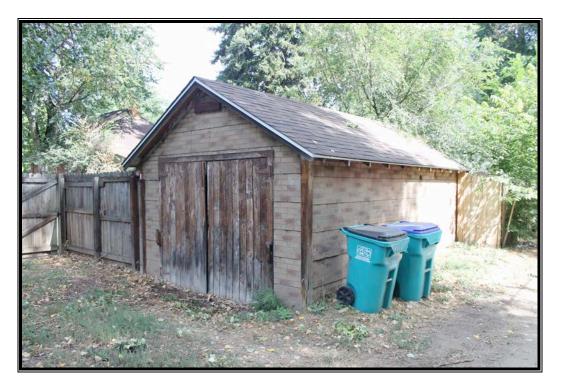
View of the Garage from the Alley, View to the Northeast

24. Associated Buildings, Features or Objects: Garage – This small wood frame building with a footprint of 12' x 20' is located in the southeast corner of the property along the rear alley. Facing toward the west, its west wall holds a pair of early wood swinging doors that permitted vehicular access. On the north wall facing the house is a pedestrian entrance containing a wood panel door. East of that is a two-light window with wood frames. The building's exterior walls are finished with rolled asphalt with a faux brick pattern. The garage has a gabled roof with asphalt shingles and exposed rafter ends.

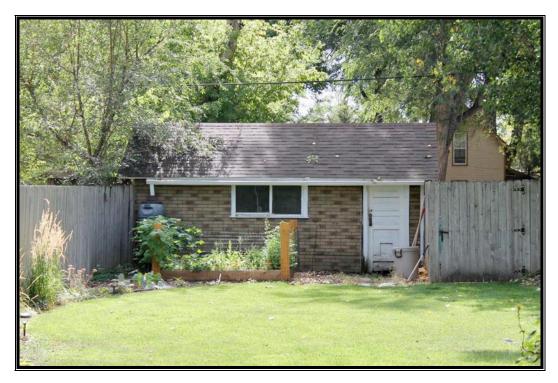
View of the Garage from the Rear Yard, View to the South
