**CERTIFICATE OF APPROPRIATENESS  
AND  
LANDMARK REHABILITATION LOAN AWARD NOTICE  
ISSUED: March 12, 2021  
EXPIRATION: March 12, 2022**

# WINDOW EVALUATION

**122 JACKSON AVENUE**

EVALUATION DATE: FEBRUARY 26, 2019

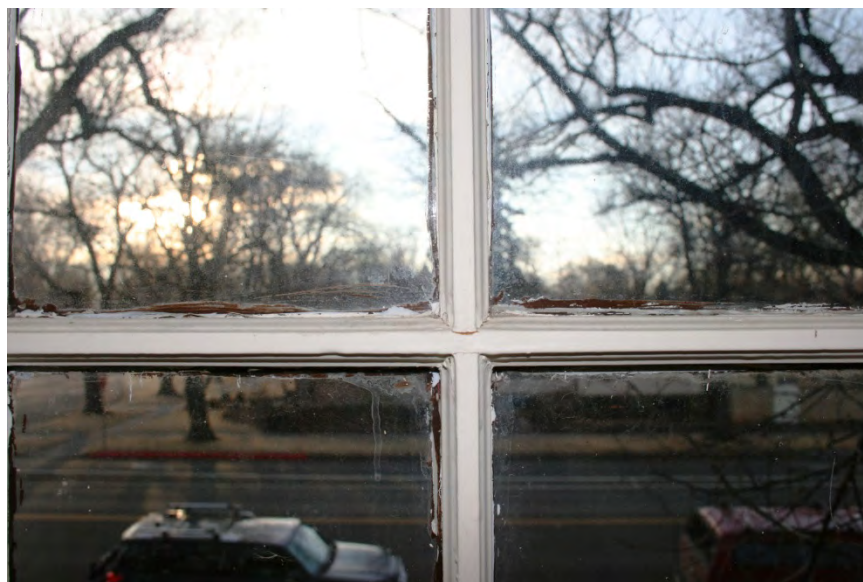
**Image 2: Window 2-1, note the narrow muntin profile. This matches all of the other historic windows in the house**

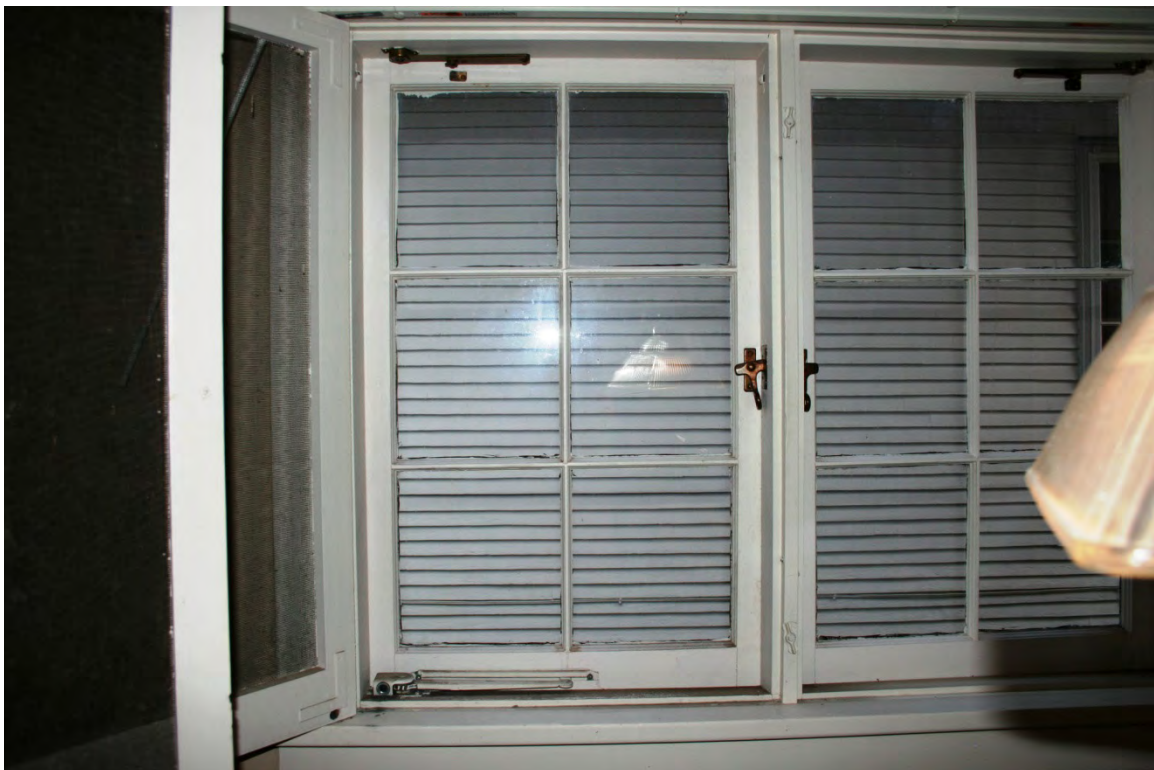
**Image 7: This window has what appears to be the original hinging hardware at the head of the jamb.**

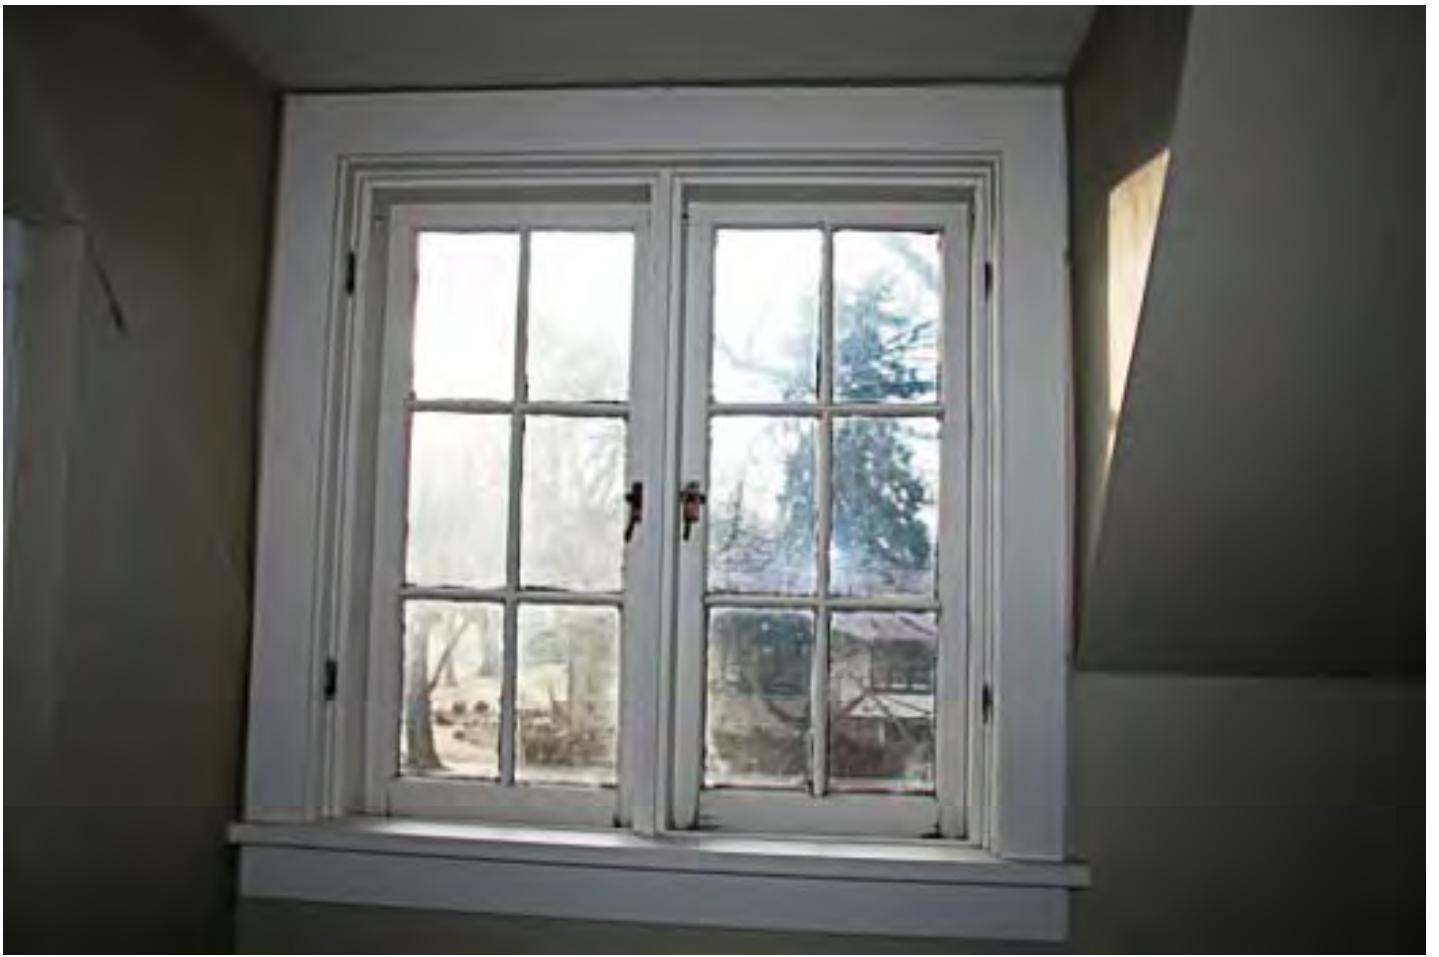
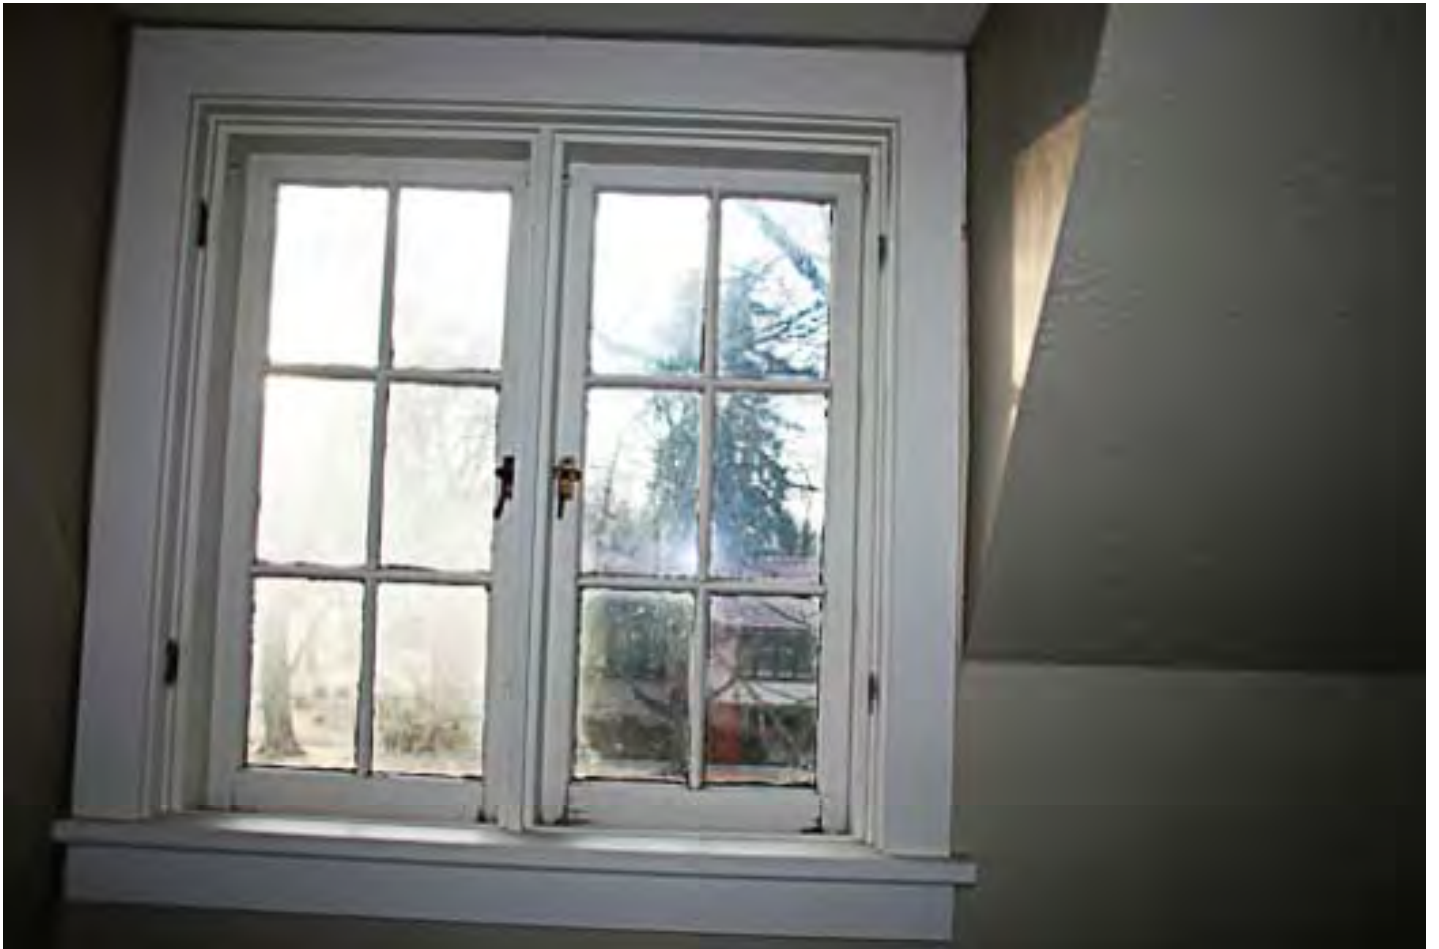
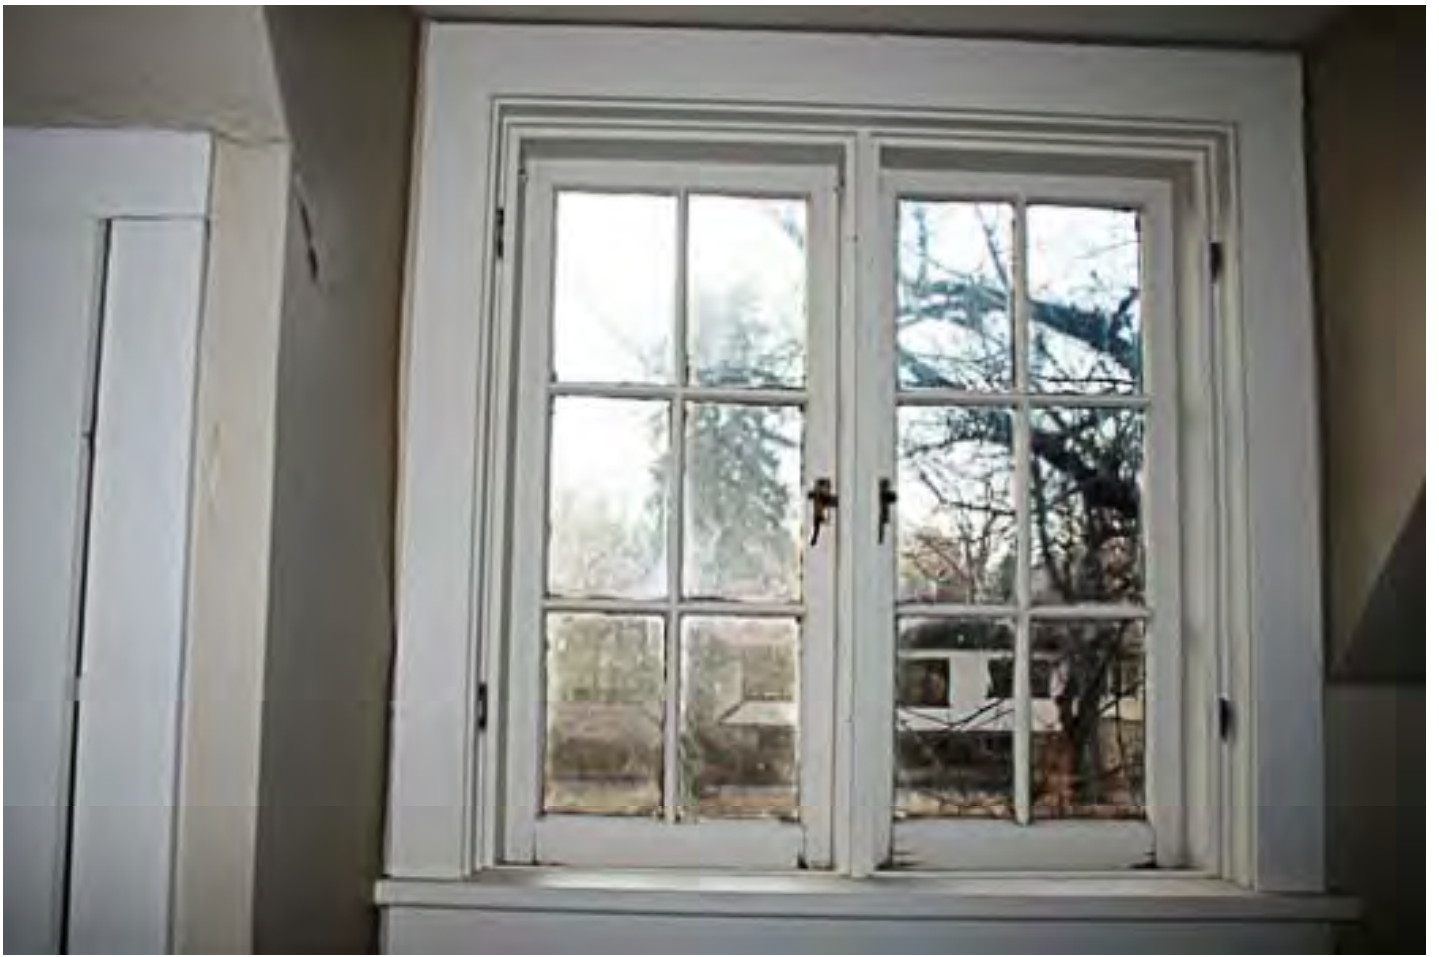
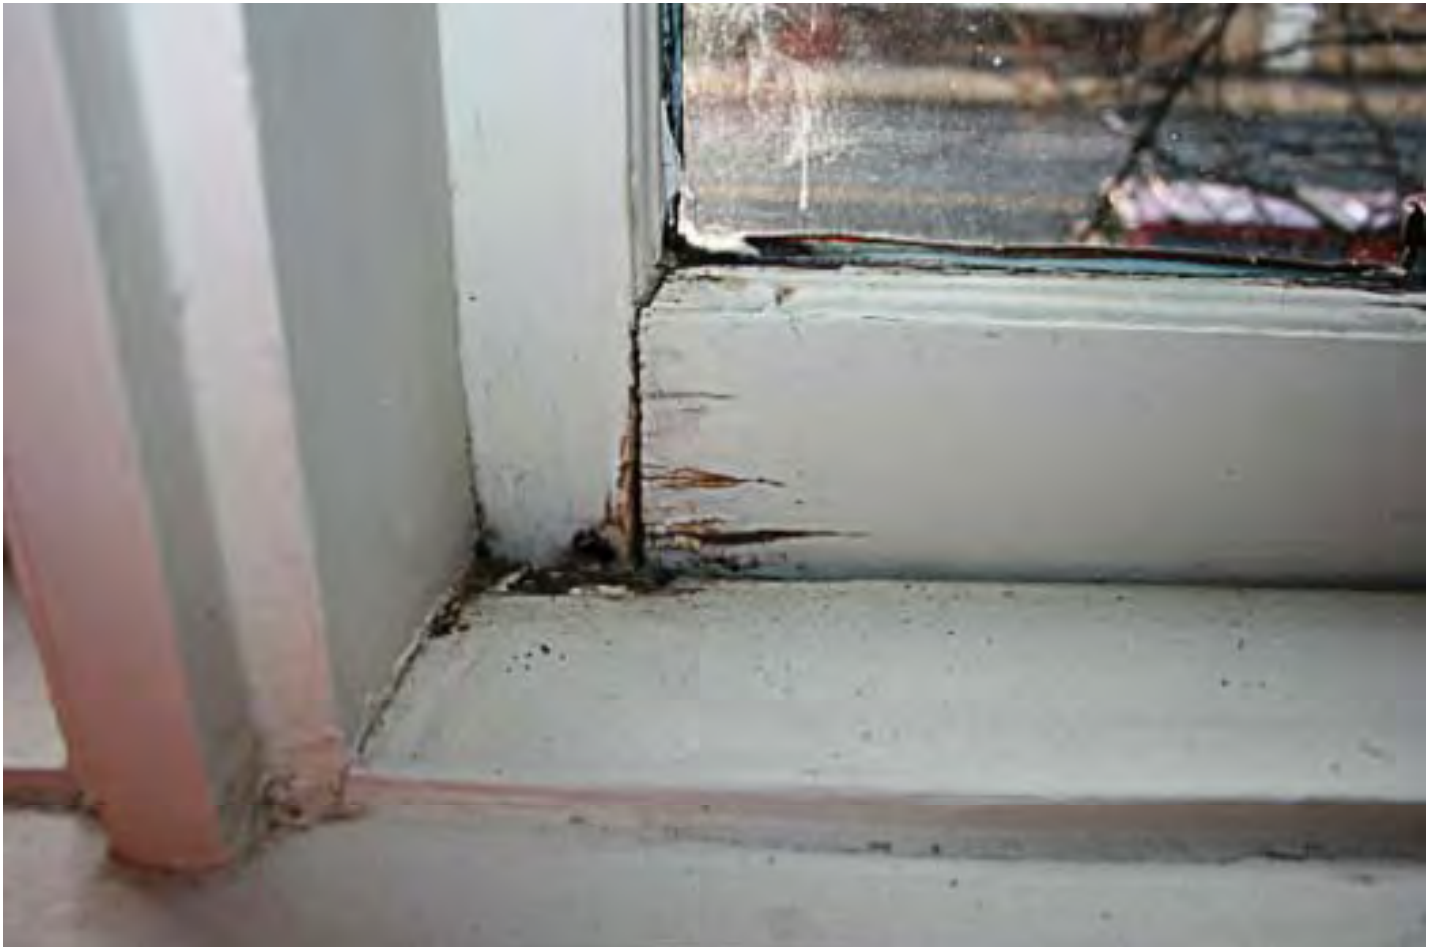
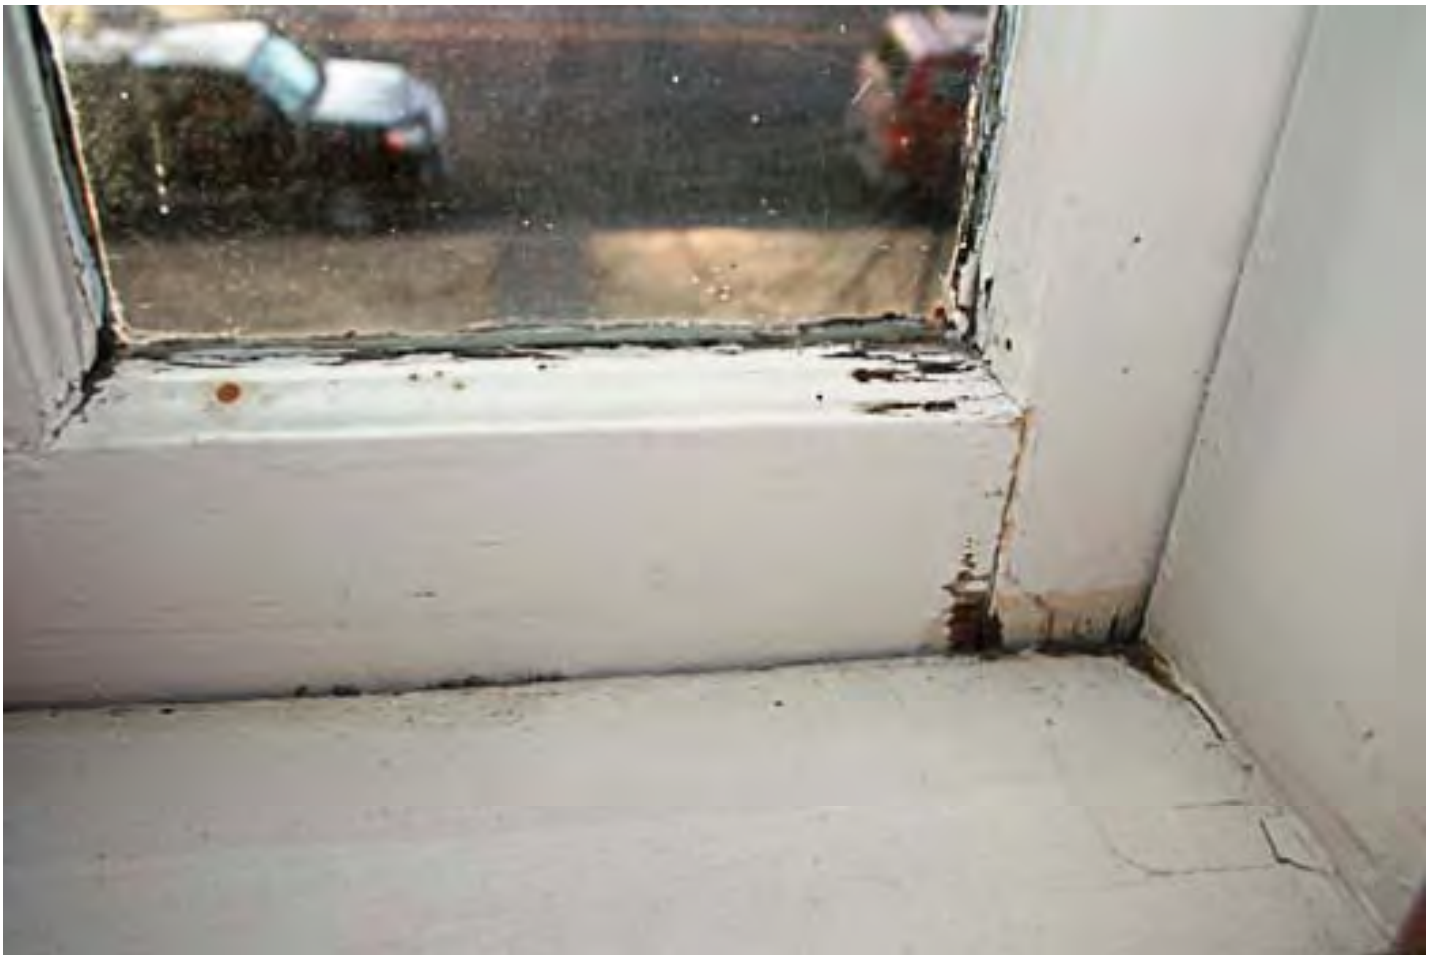
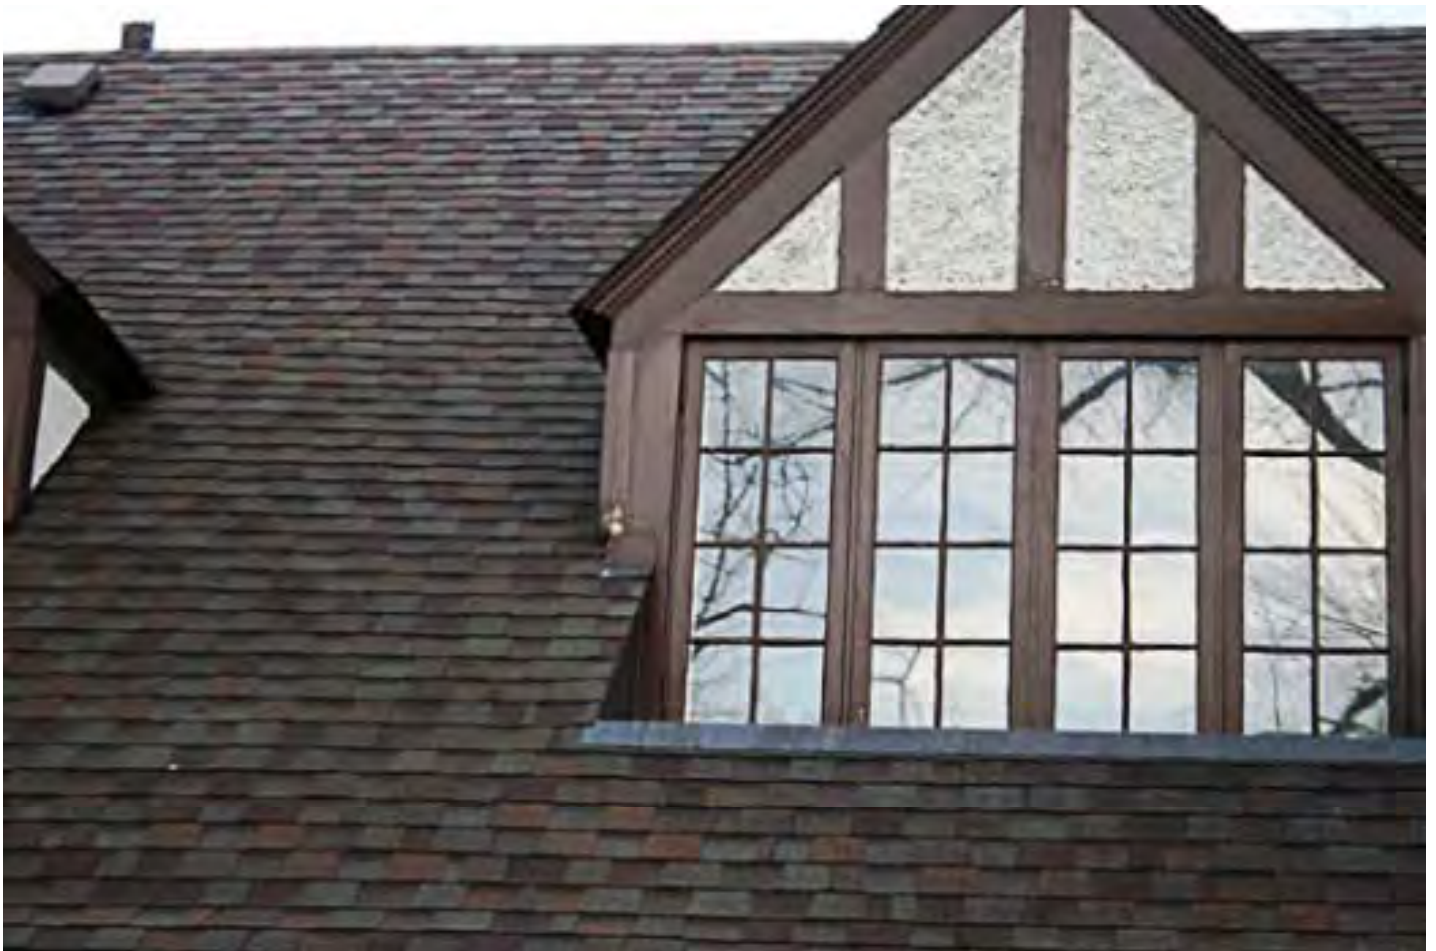
Windows 2-1, 2-2, and 2-7 through 2-14 should also be restored and the weatherstripping updated. While there is deterioration here, it is not sufficient to warrant wholesale replacement.
