**CERTIFICATE OF APPROPRIATENESS  
AND  
LANDMARK REHABILITATION LOAN AWARD NOTICE  
ISSUED: March 12, 2021  
EXPIRATION: March 12, 2022**

# WINDOW EVALUATION

**122 JACKSON AVENUE**

EVALUATION DATE: FEBRUARY 26, 2019

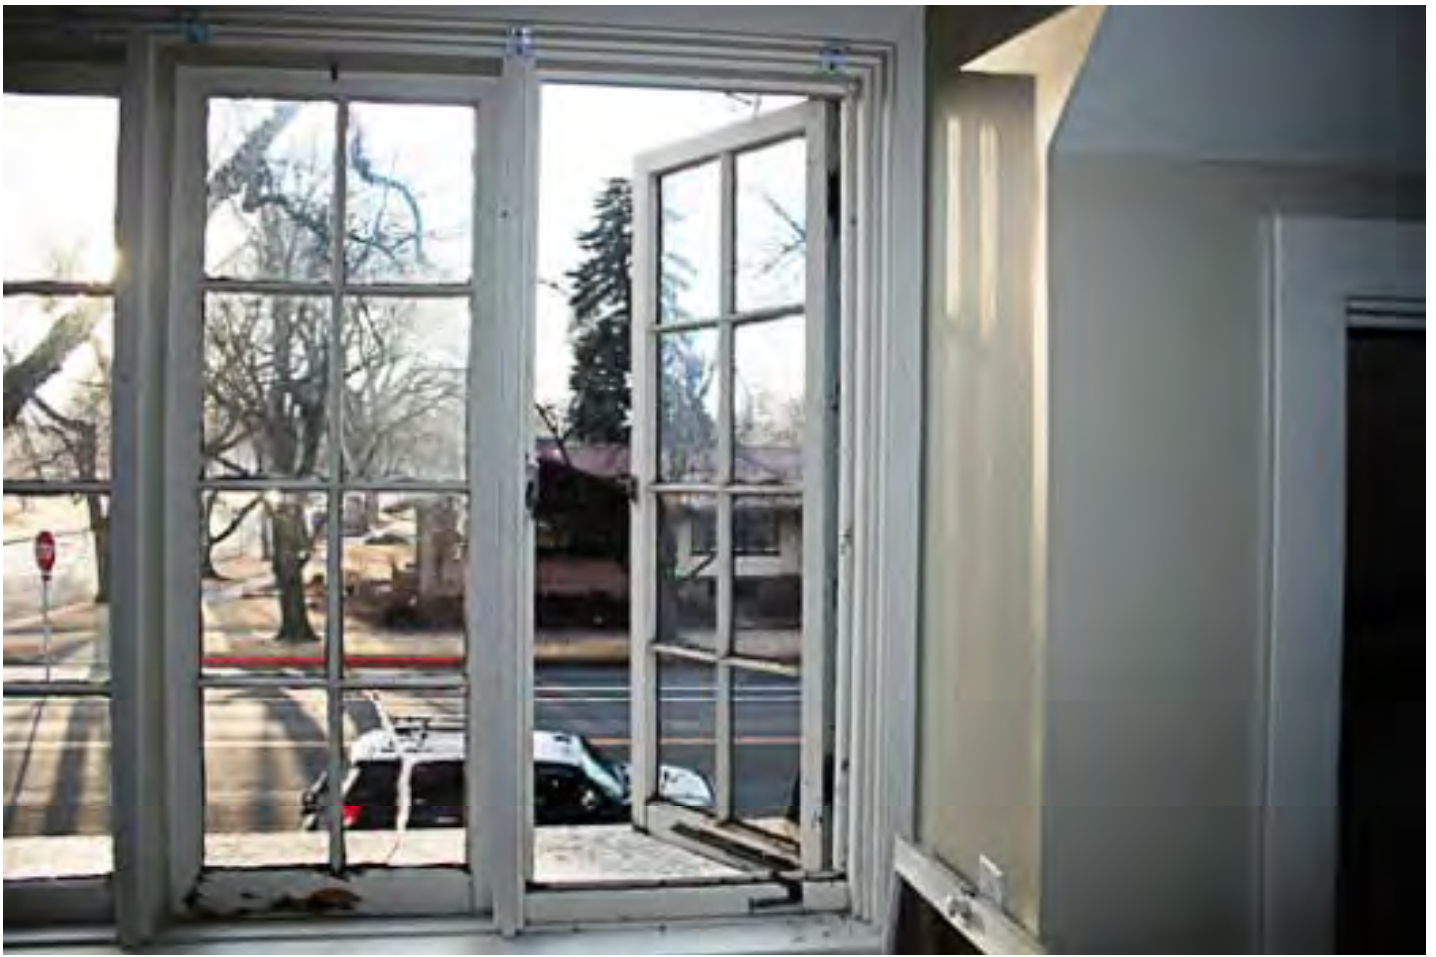
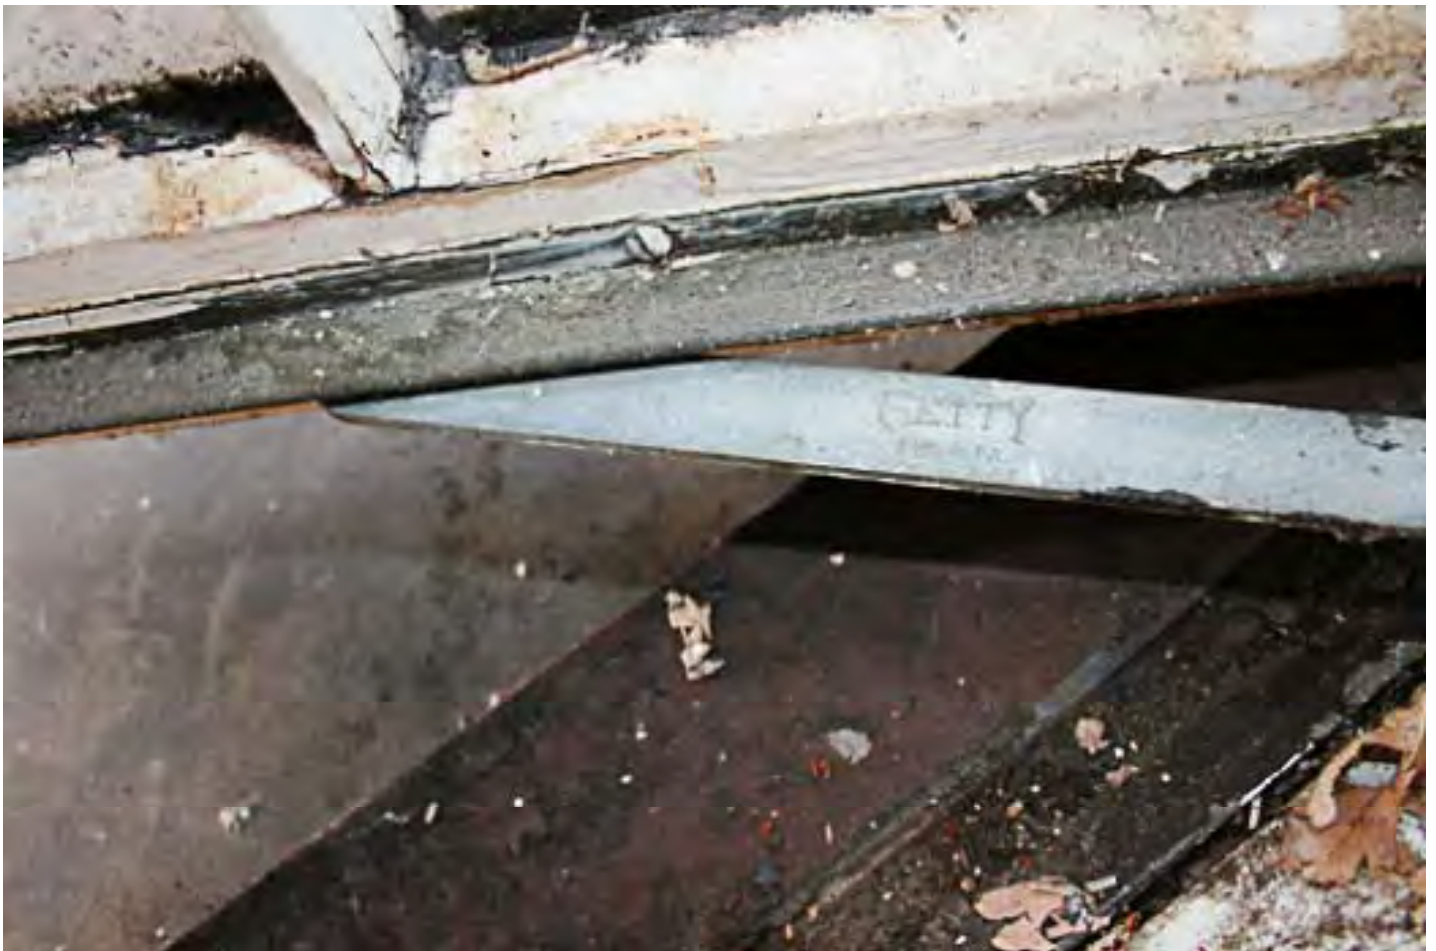
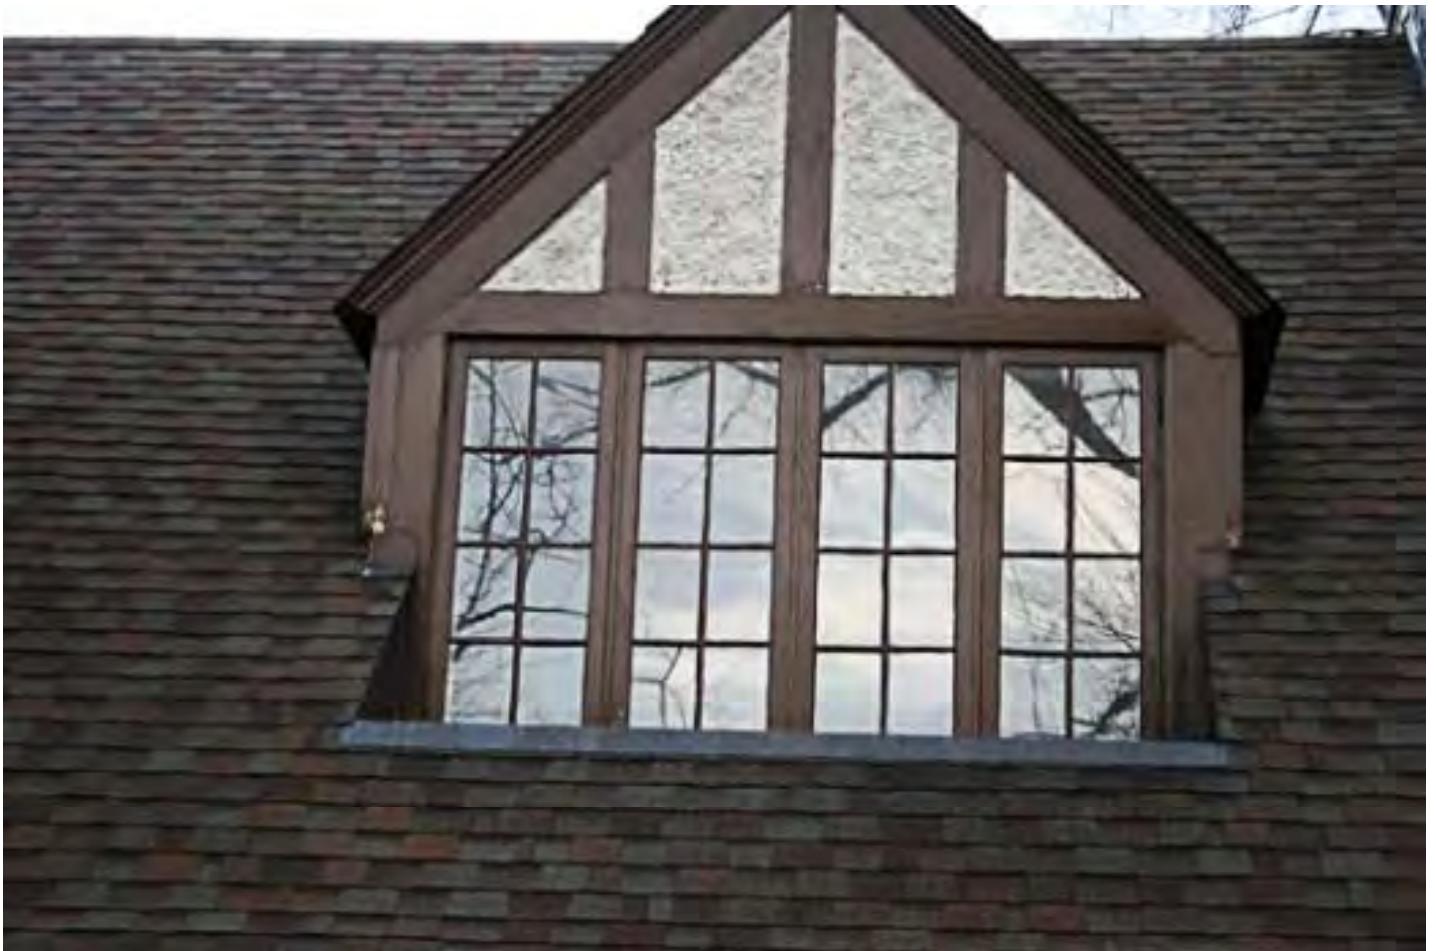
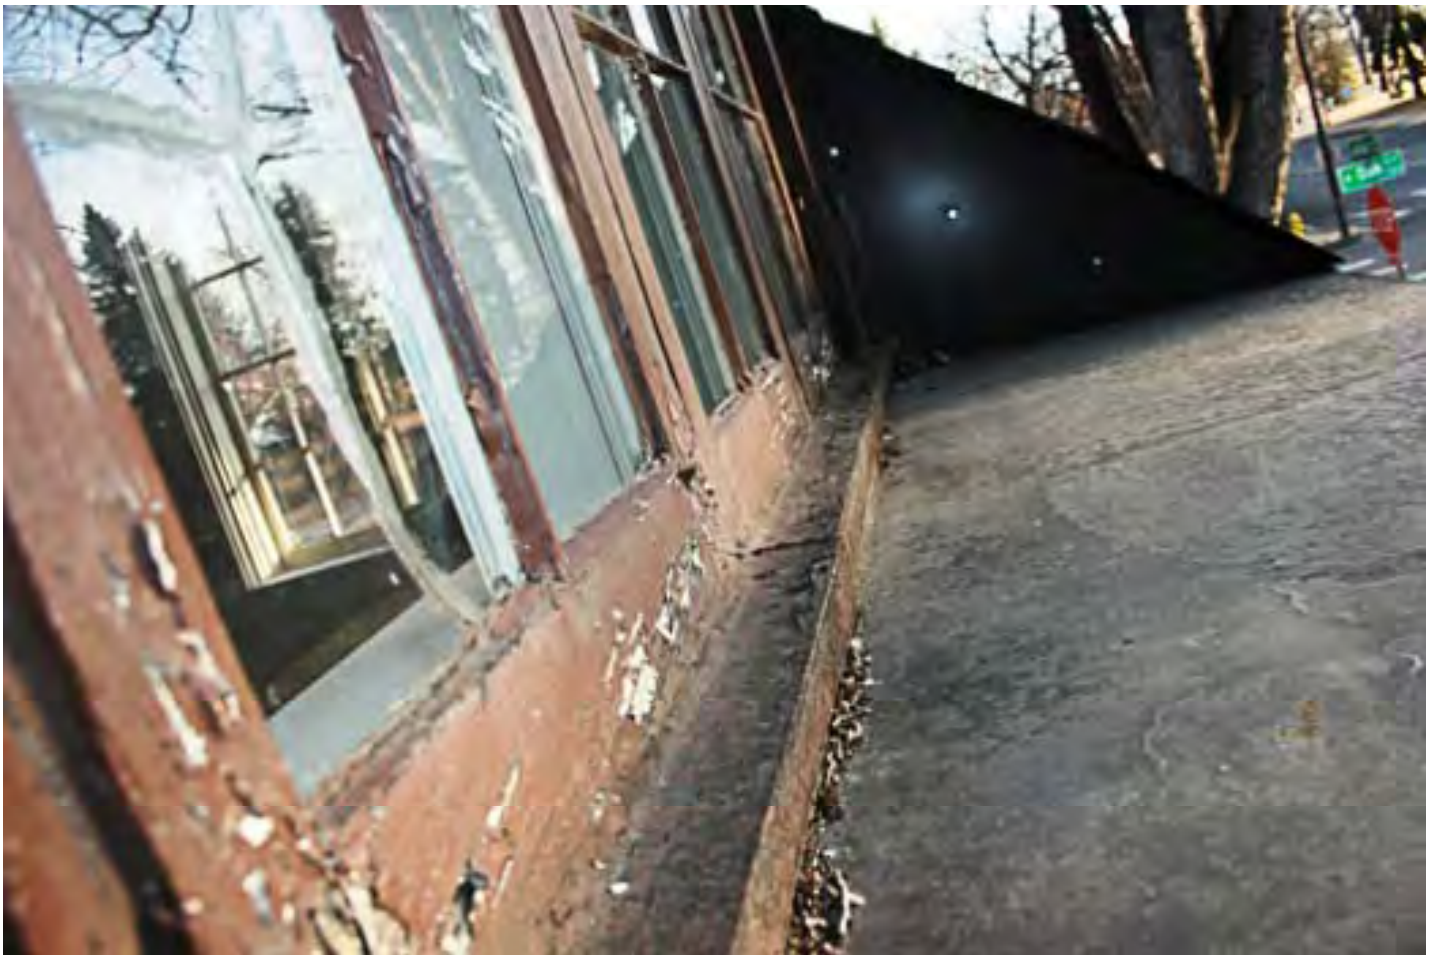
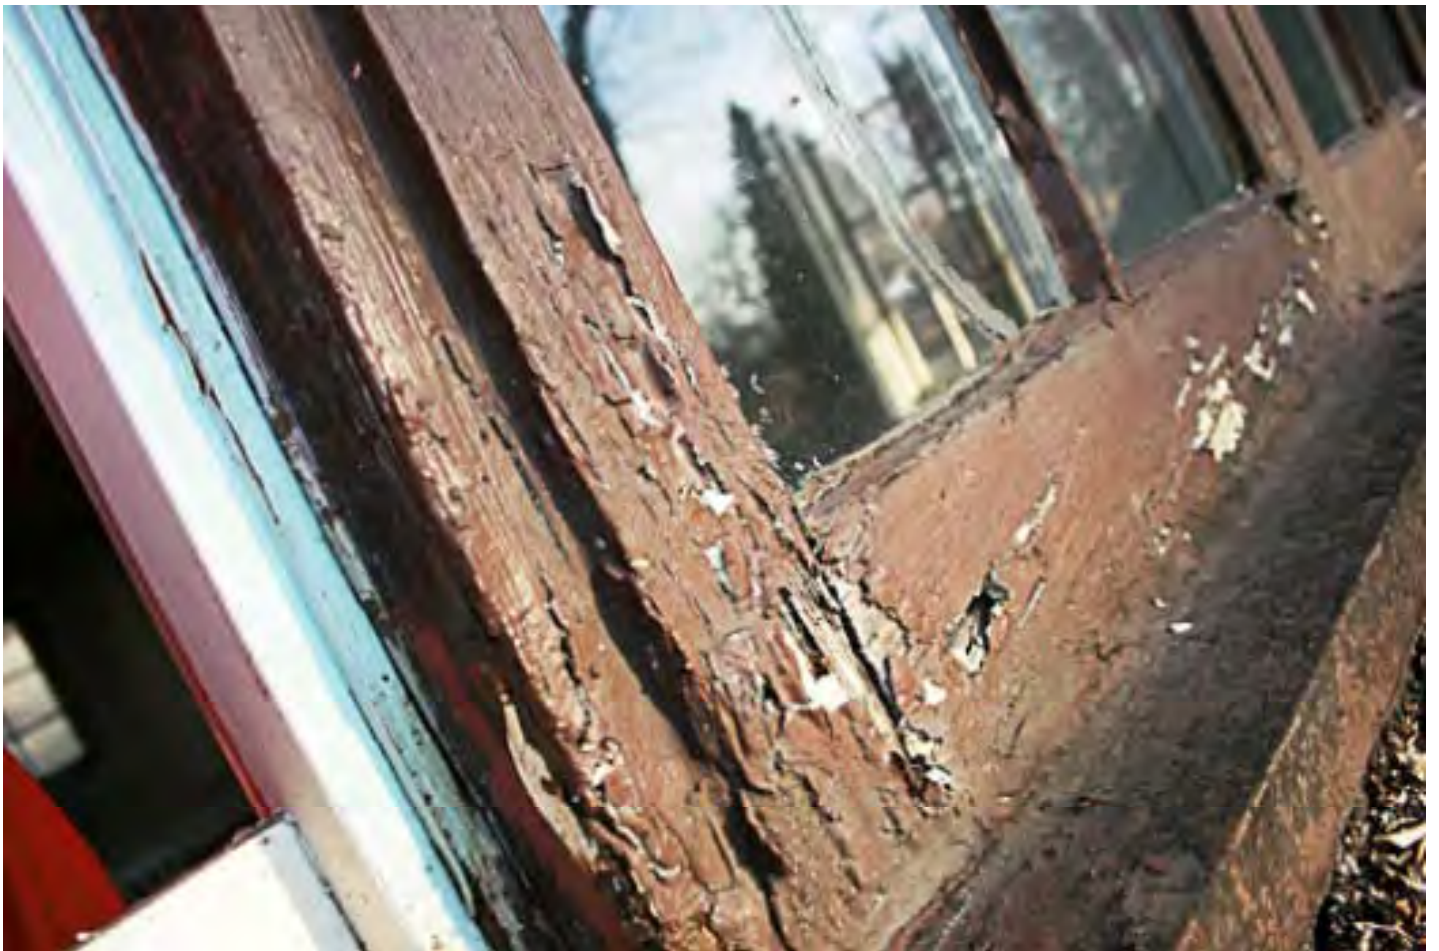
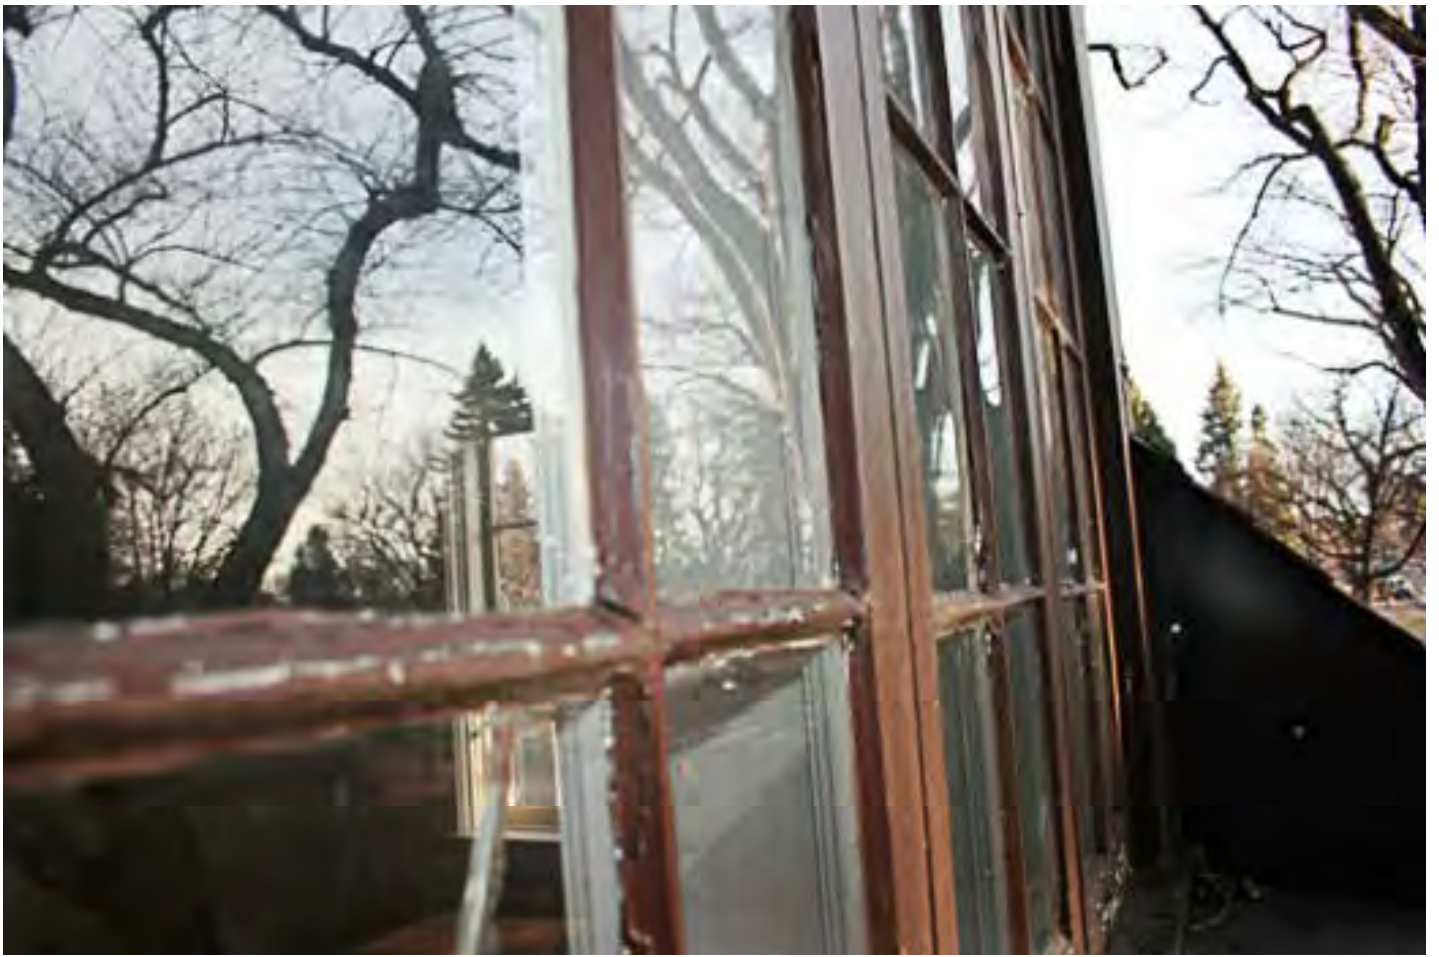
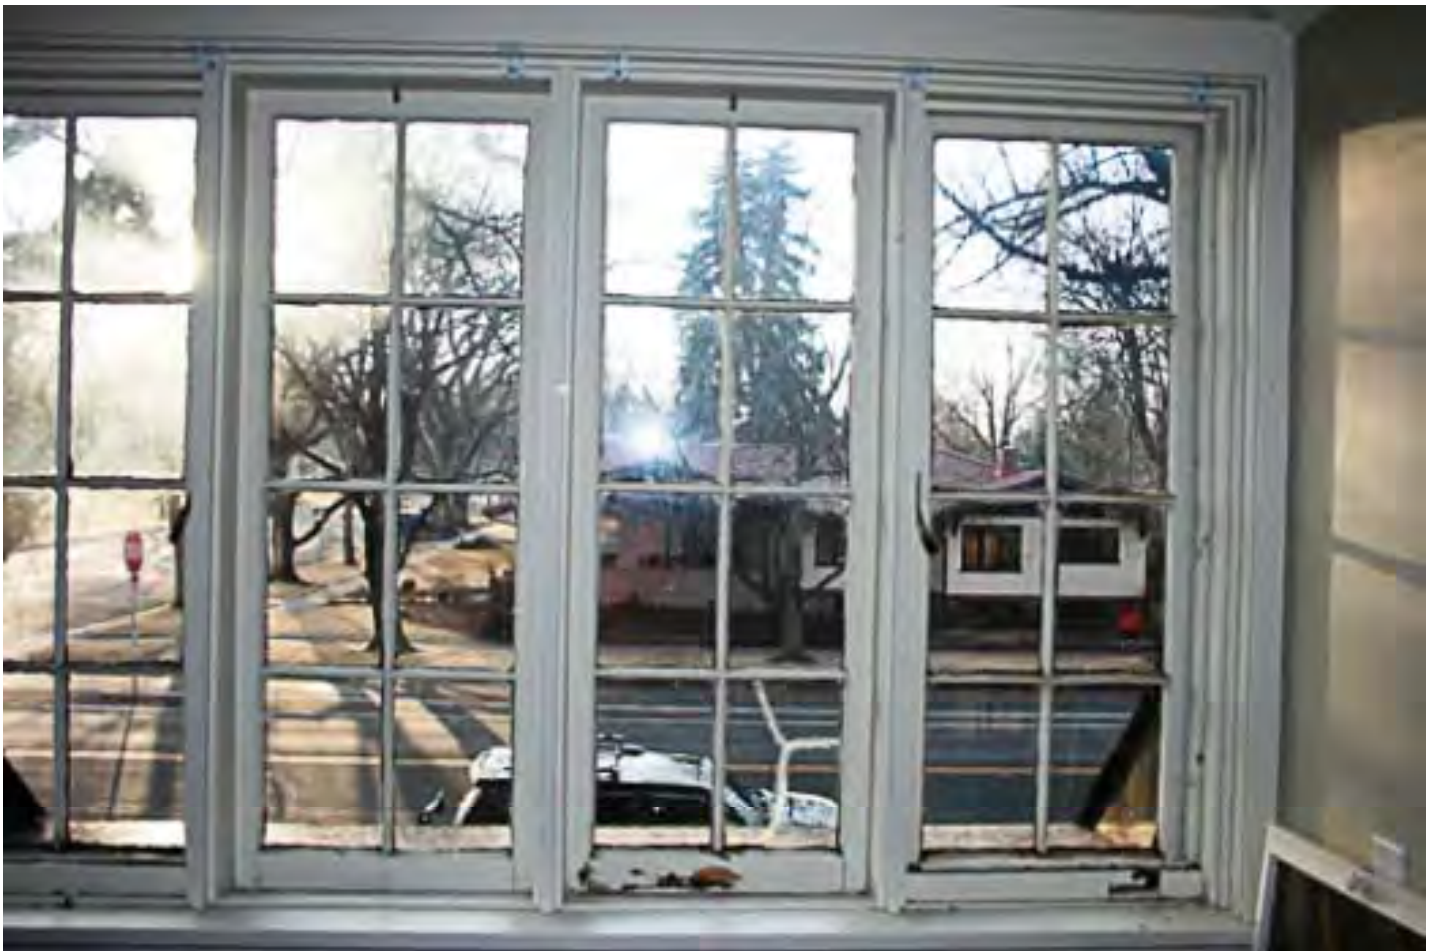
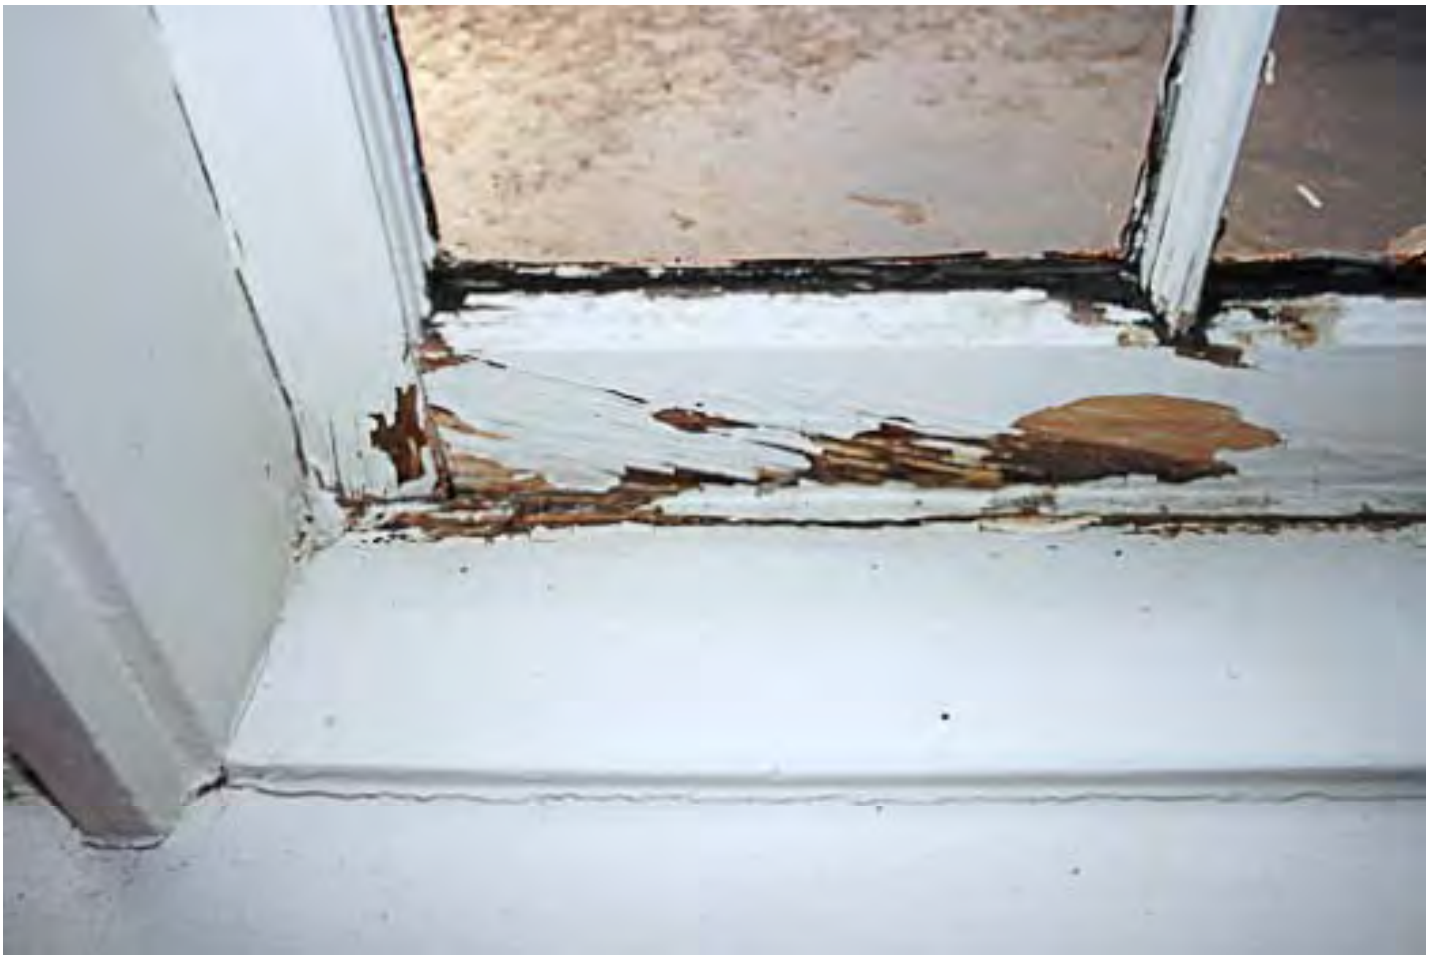
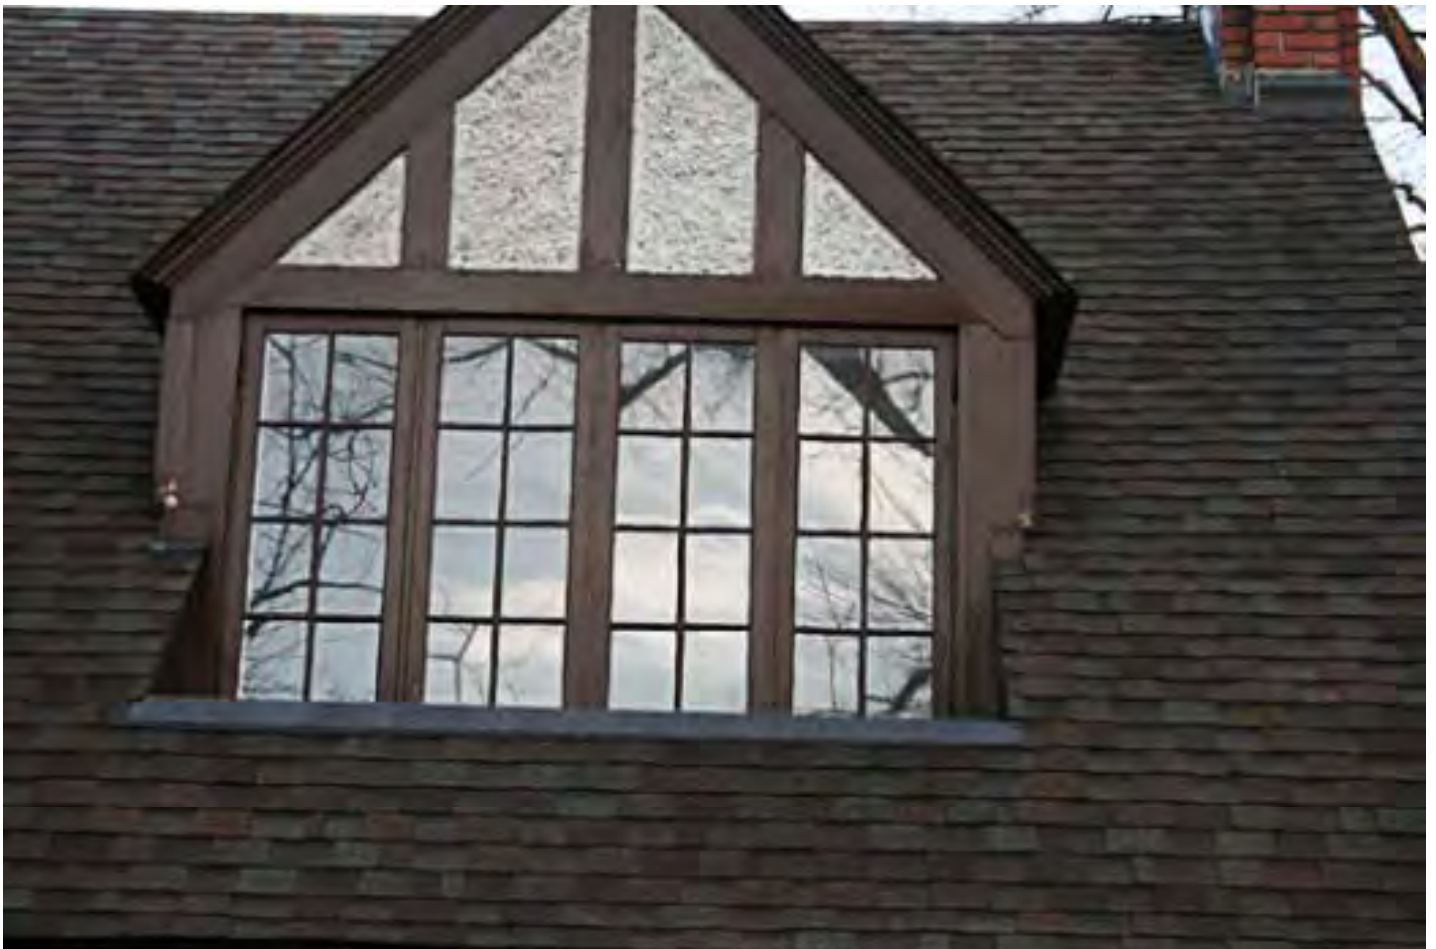
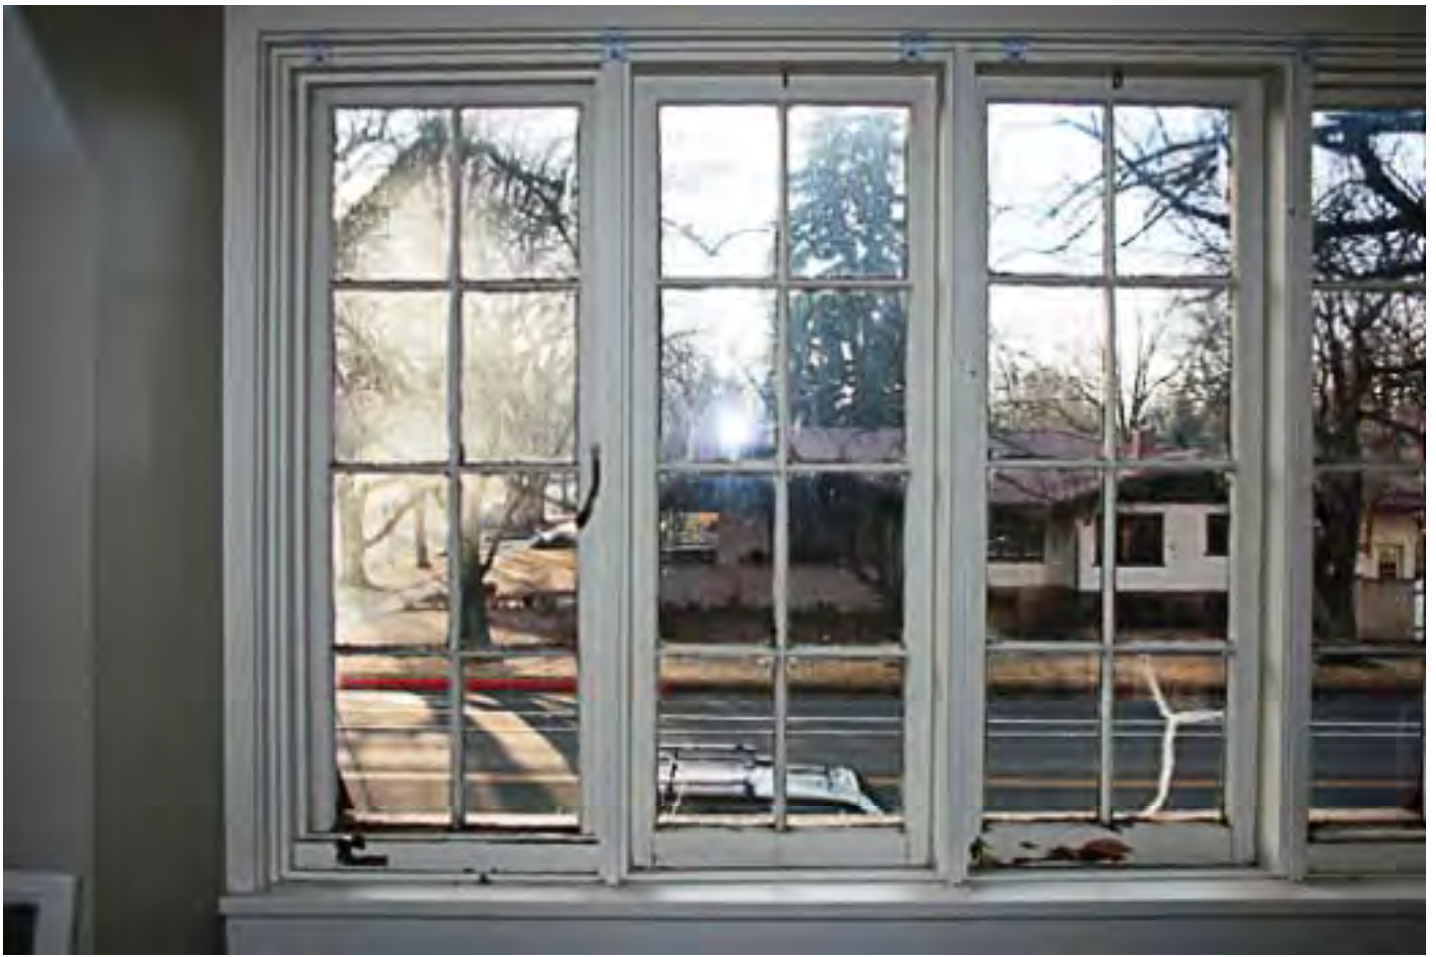
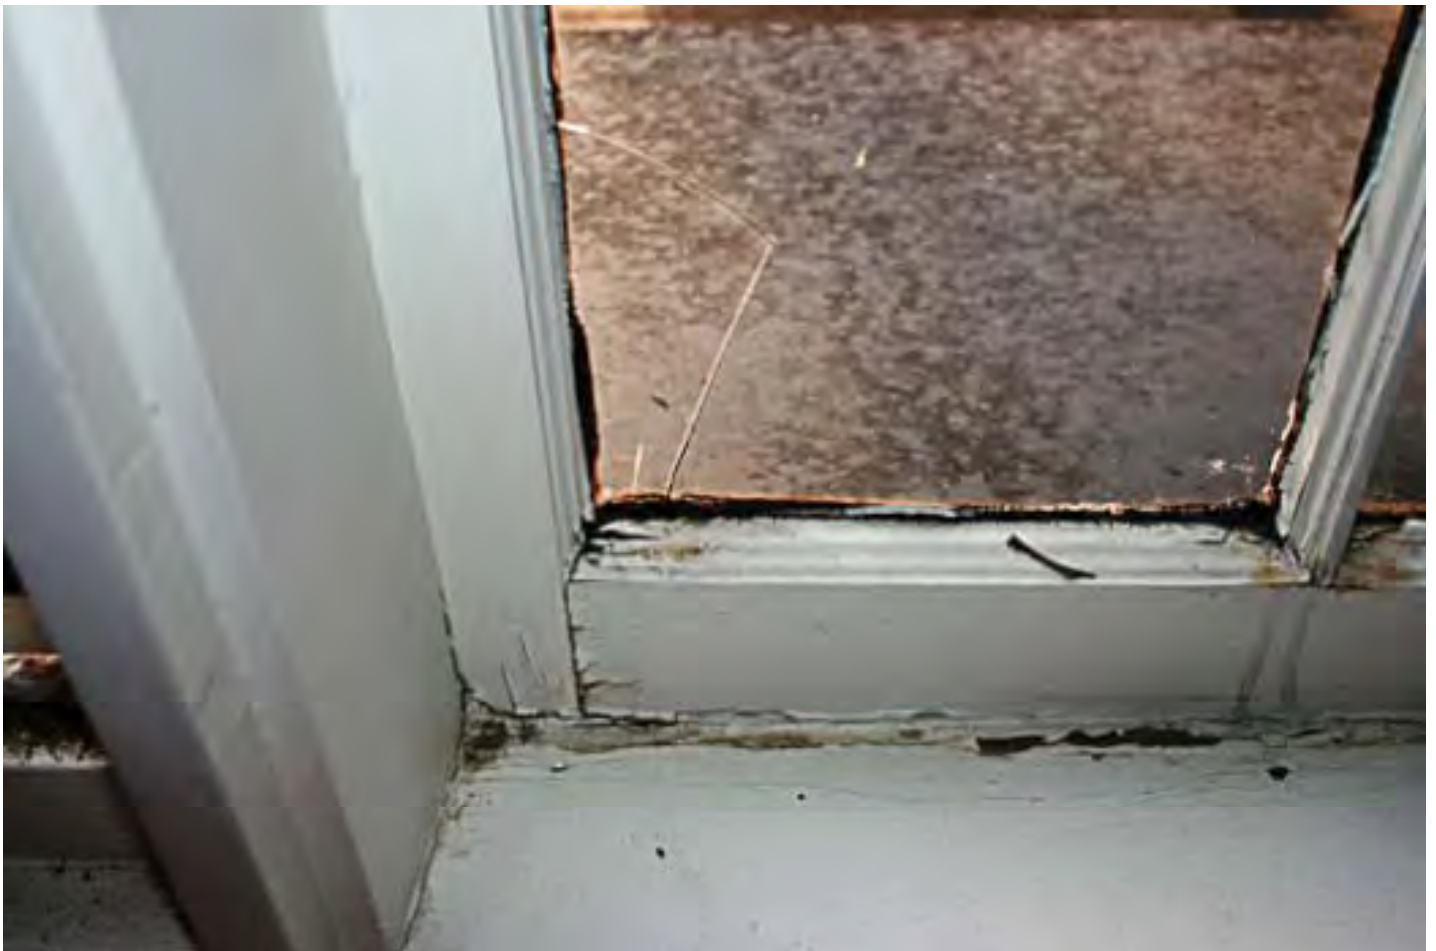
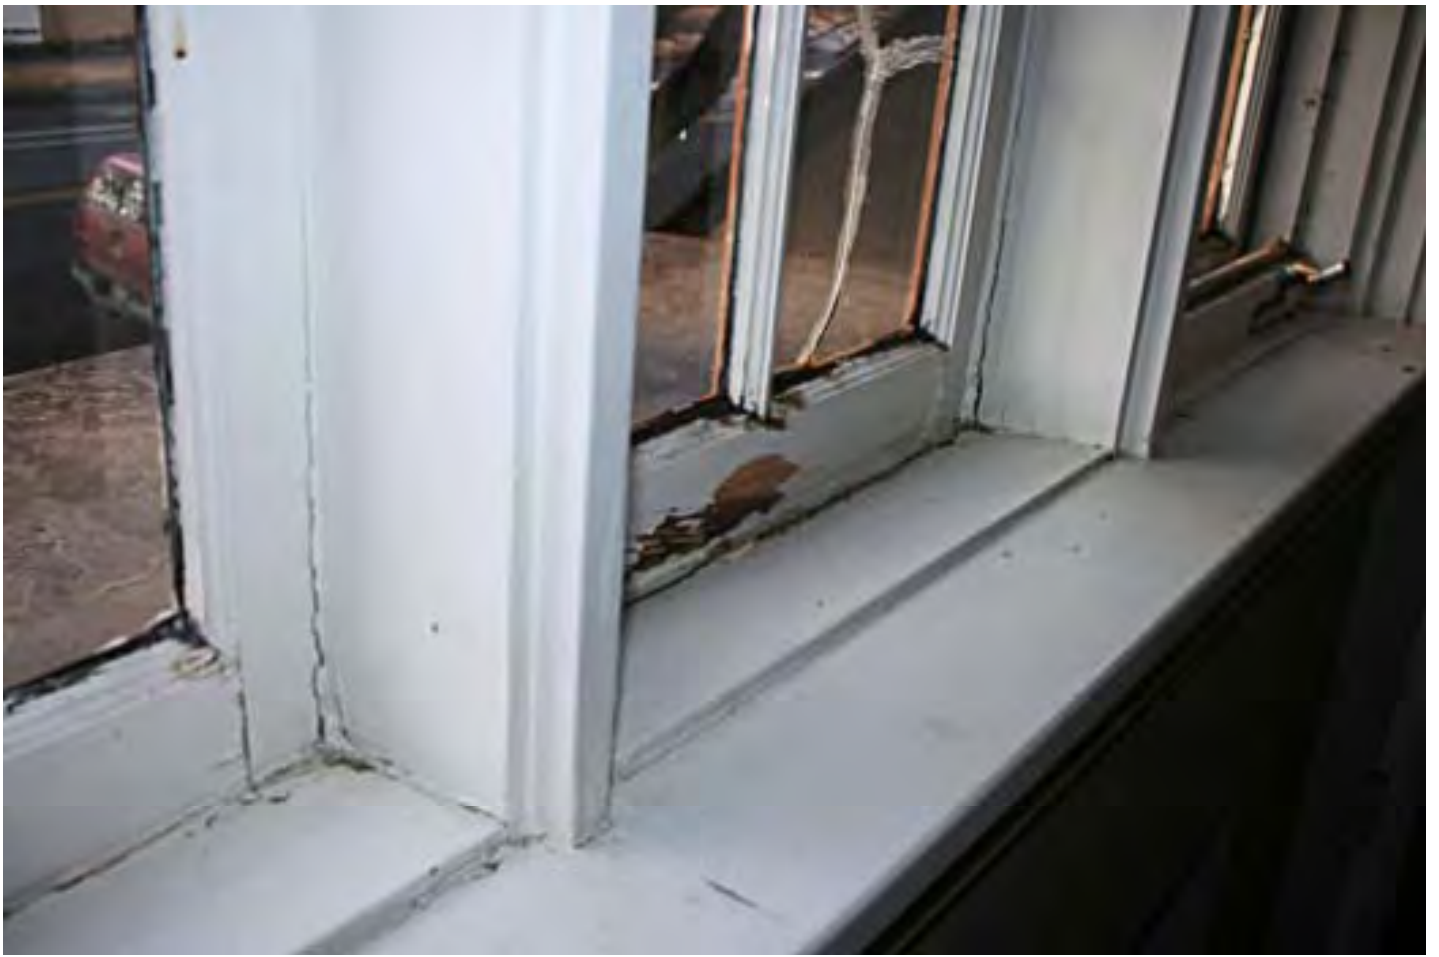
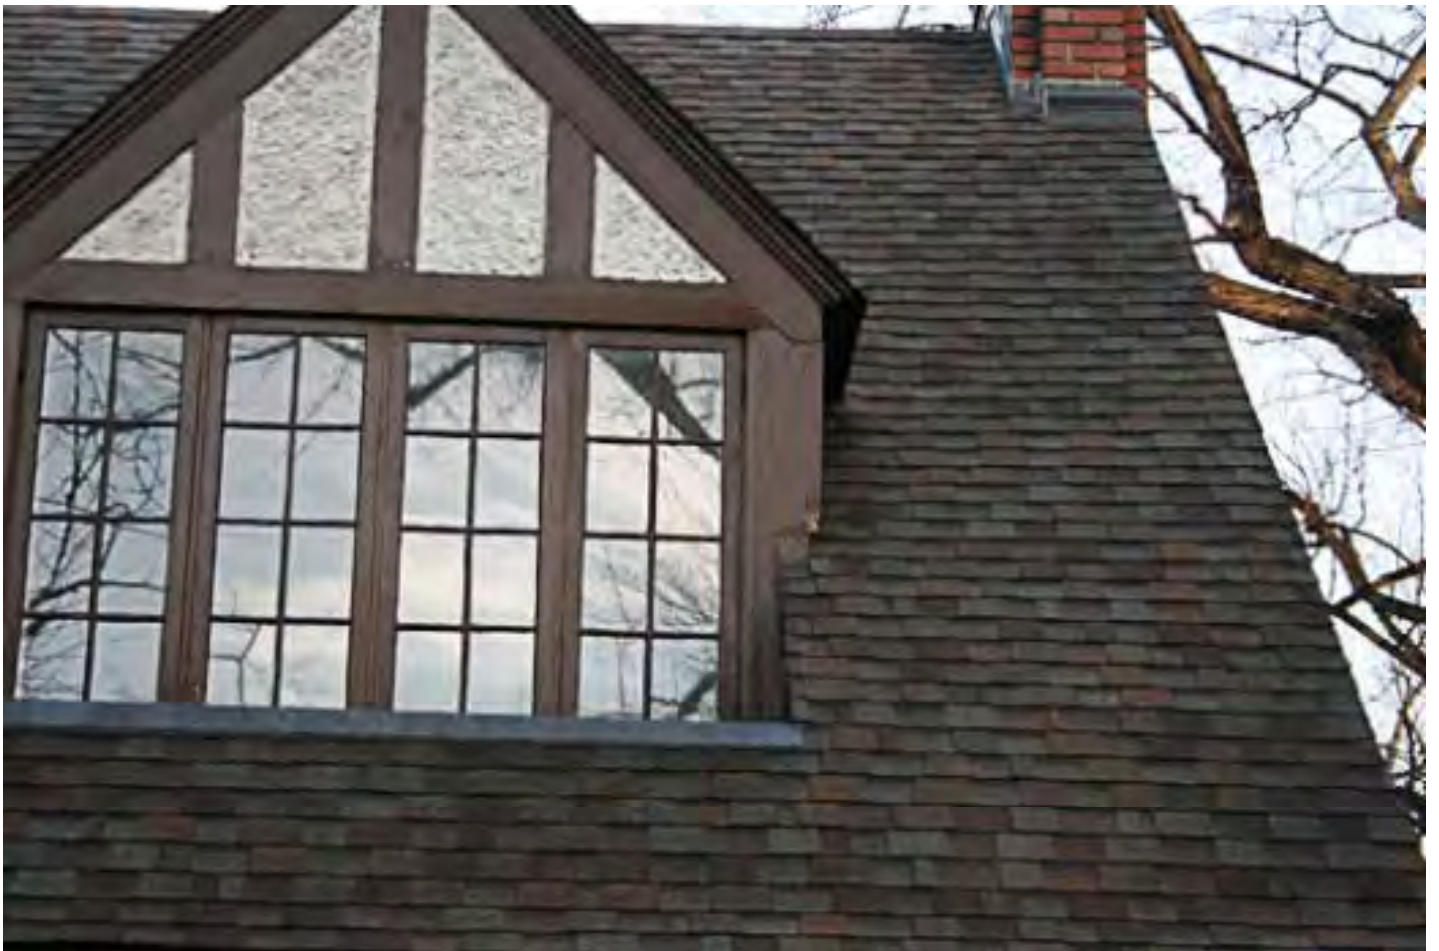
Windows 2-3 through 2-6 should be considered for replacement. If a replacement cannot be sourced that matches the original adequately then these windows should undergo a restoration to return functionality as best as possible. Guidance from the National Park Service regarding selecting appropriate replacement windows follows this section.
