**CERTIFICATE OF APPROPRIATENESS  
AND  
LANDMARK REHABILITATION LOAN AWARD NOTICE  
ISSUED: March 12, 2021  
EXPIRATION: March 12, 2022**

# WINDOW EVALUATION

**122 JACKSON AVENUE**

EVALUATION DATE: FEBRUARY 26, 2019

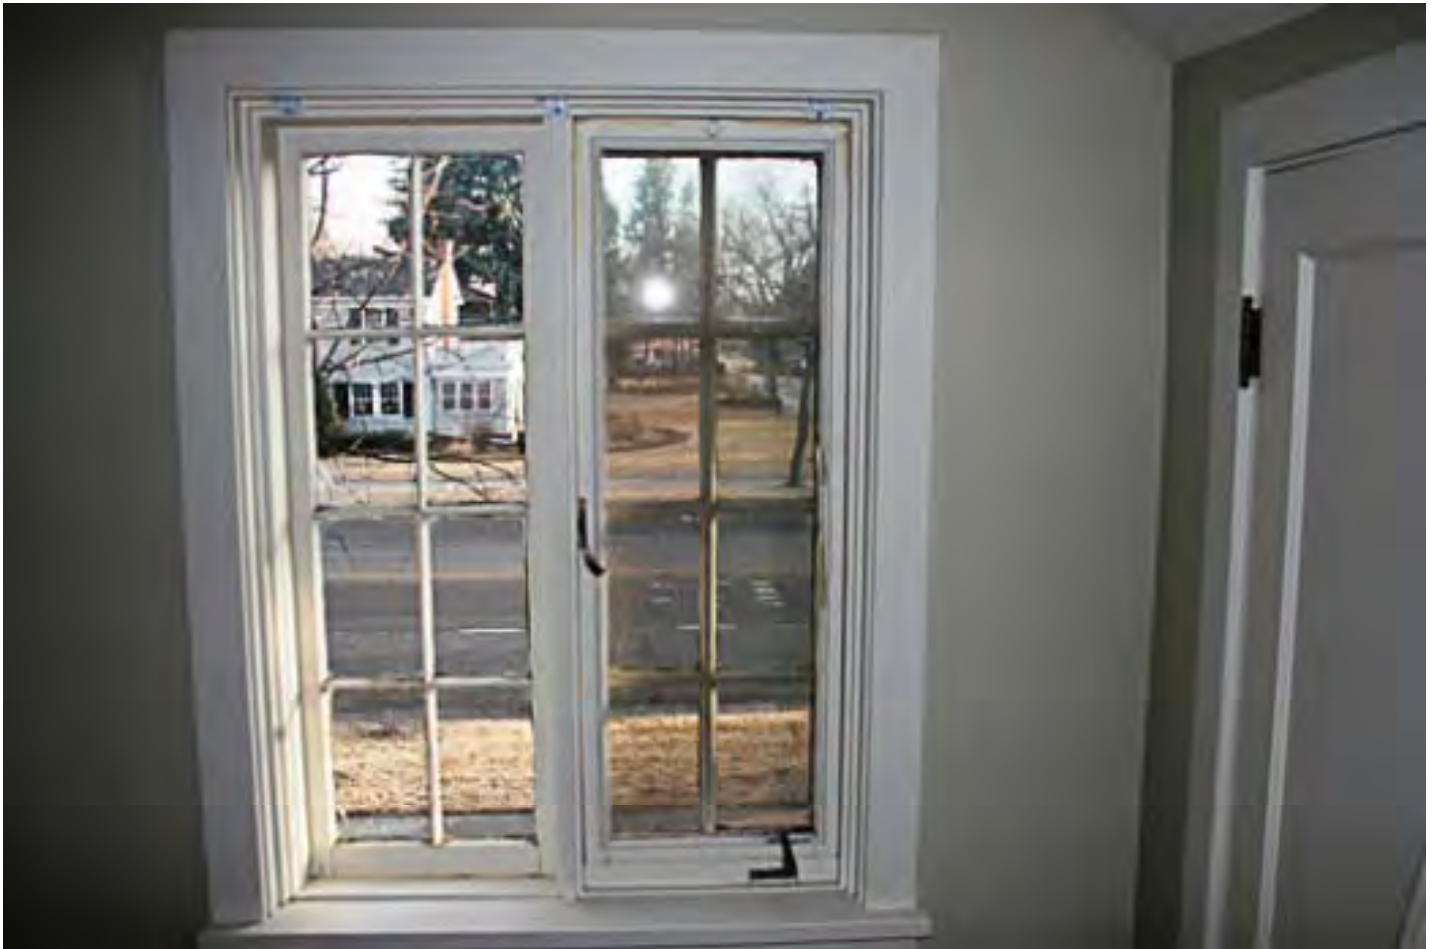
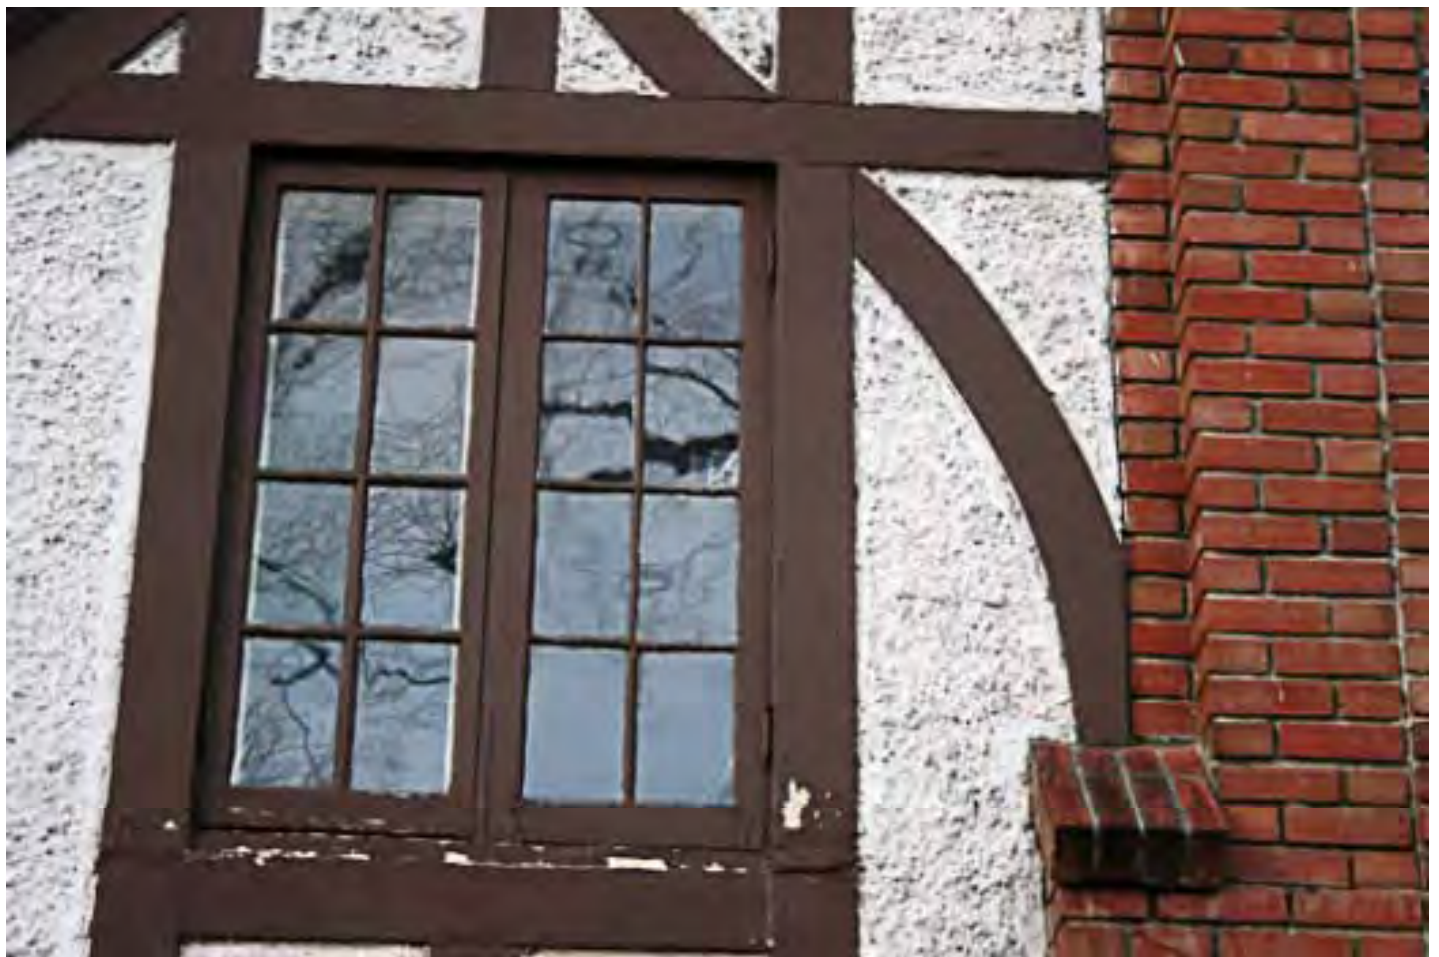
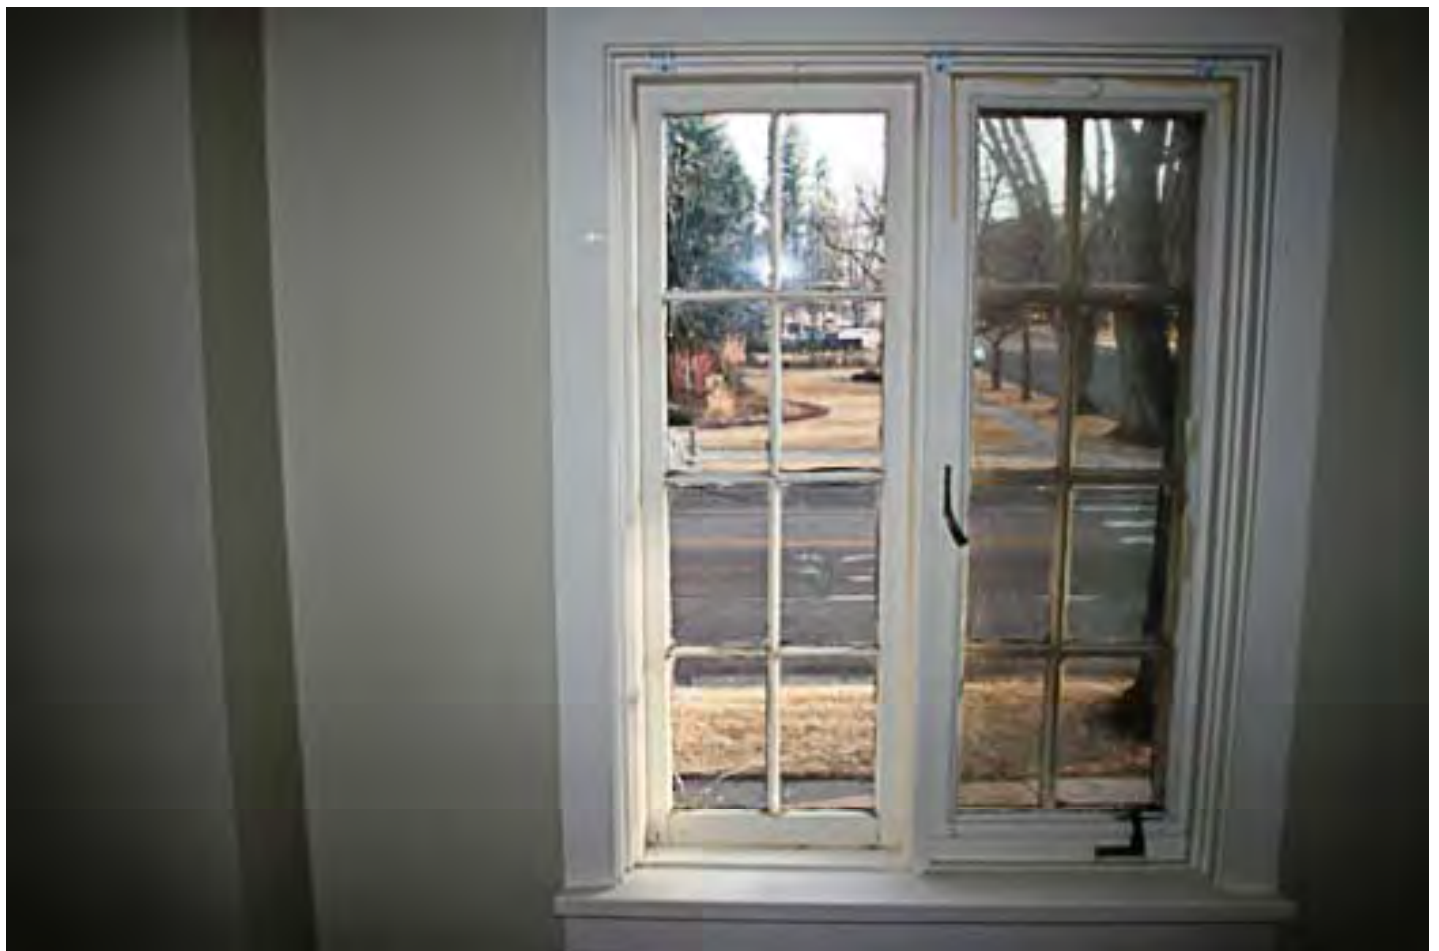
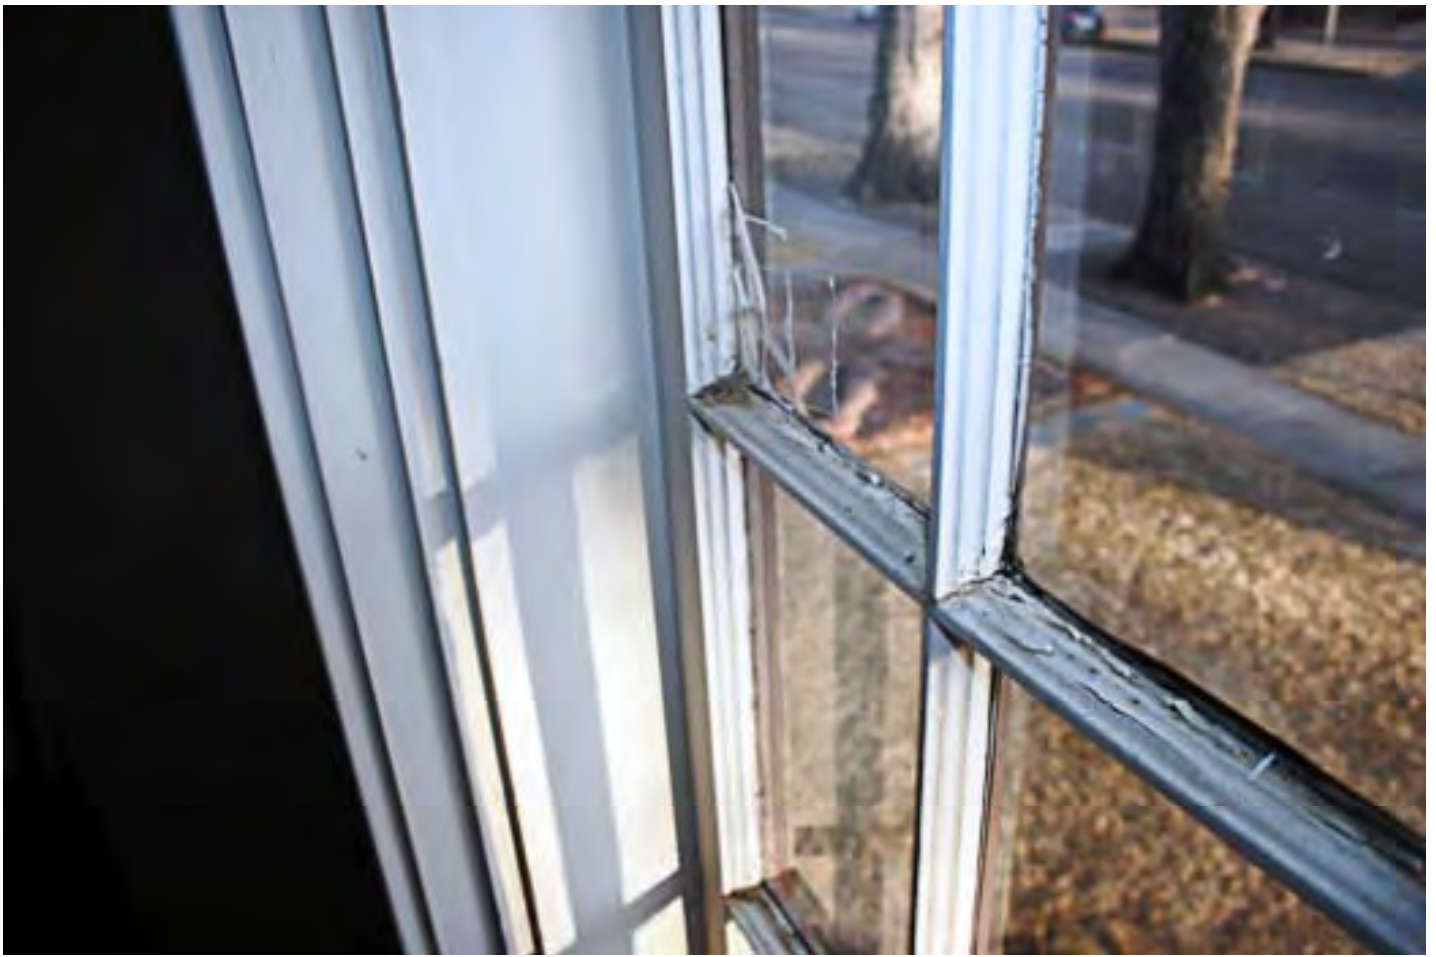
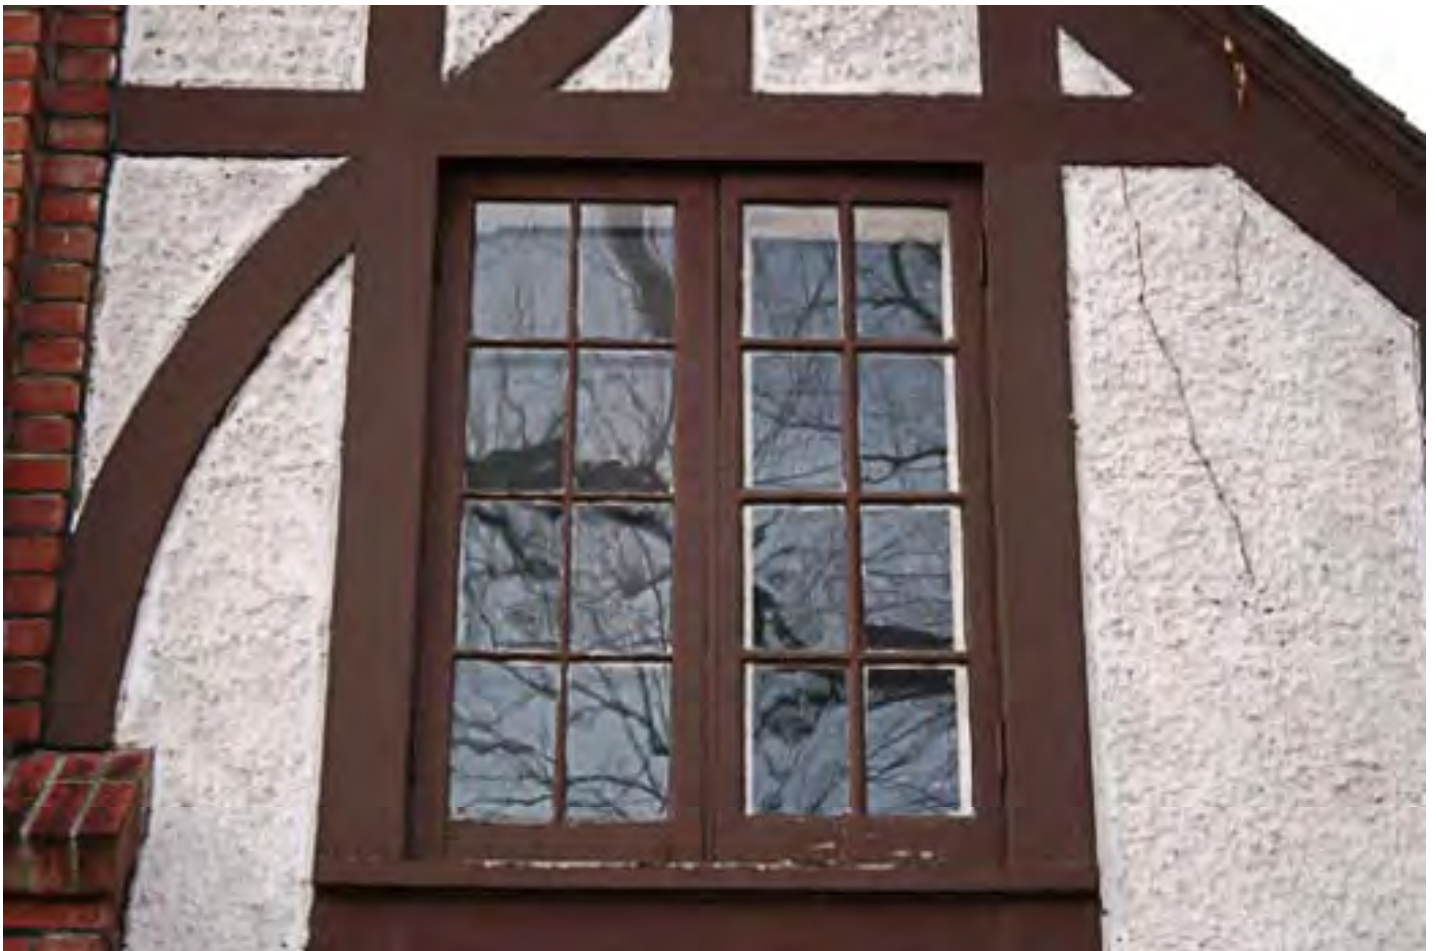
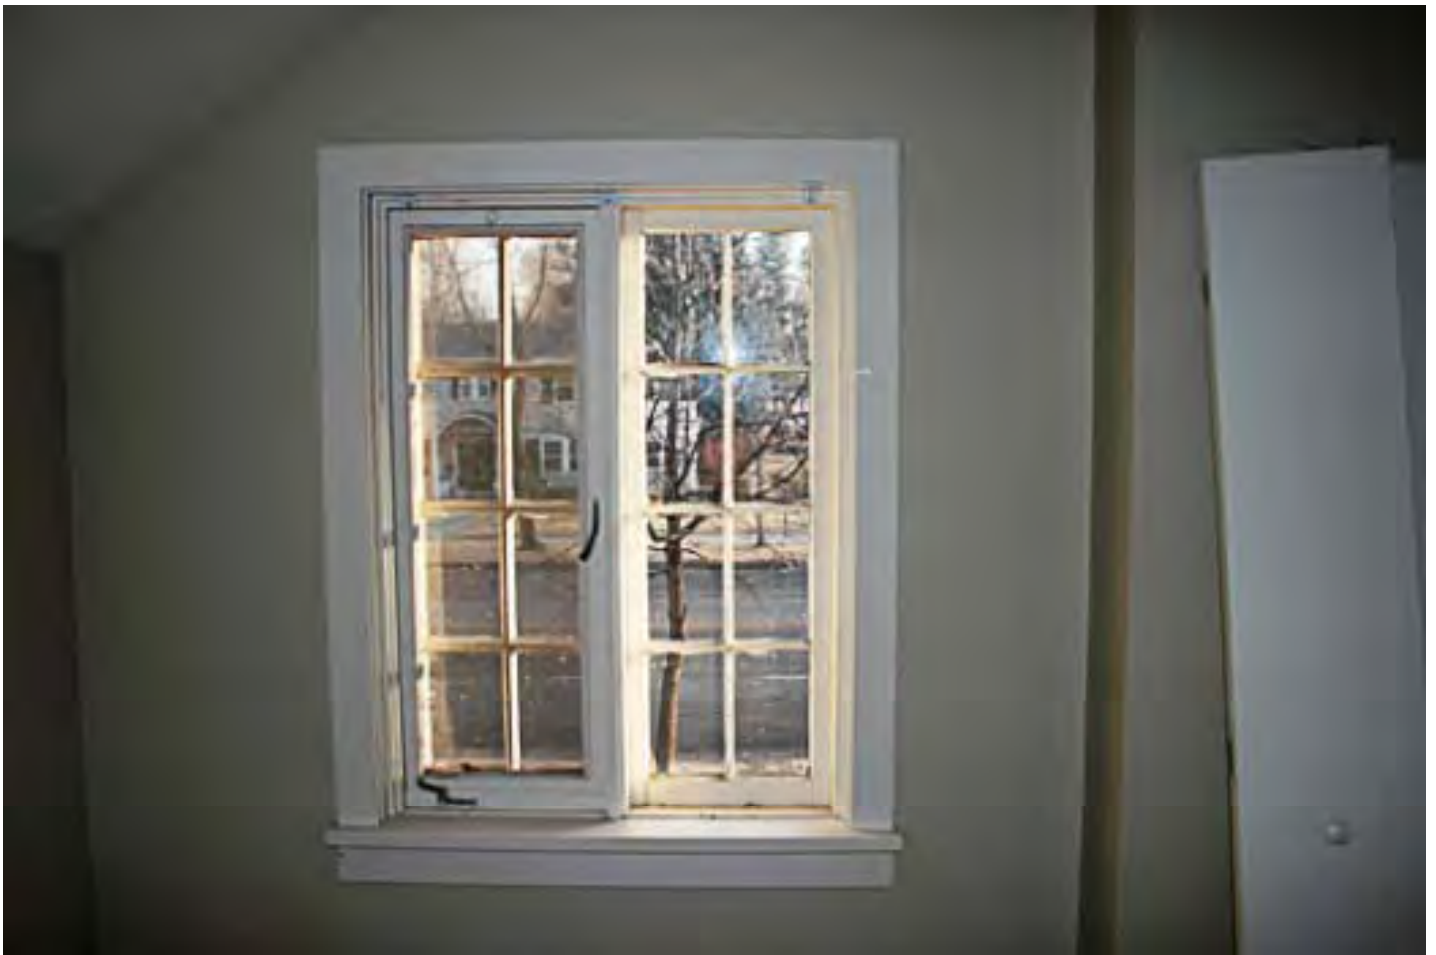
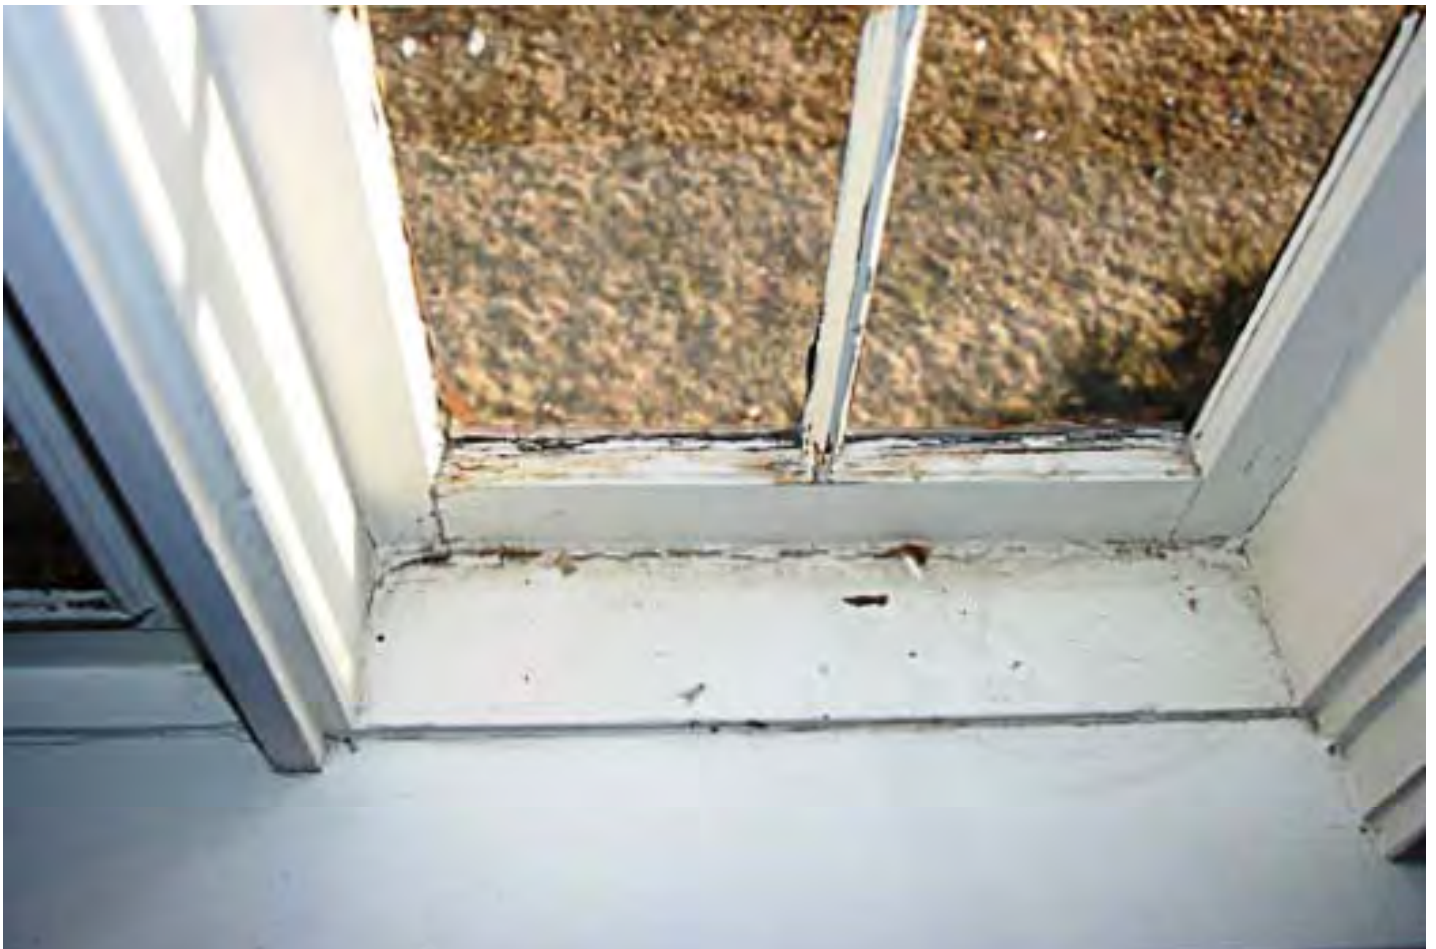
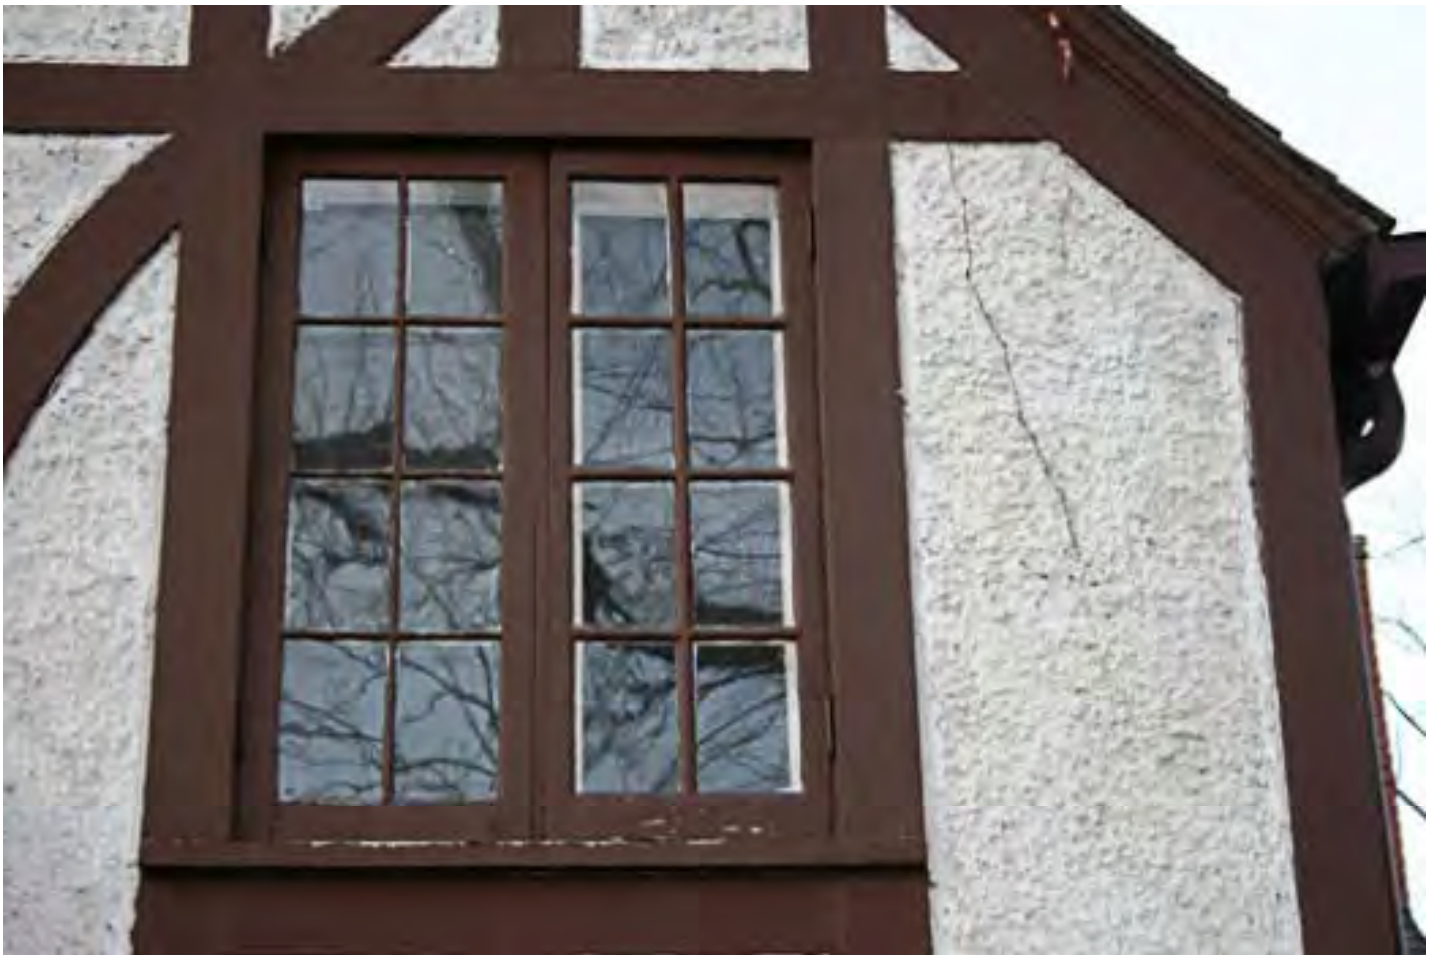
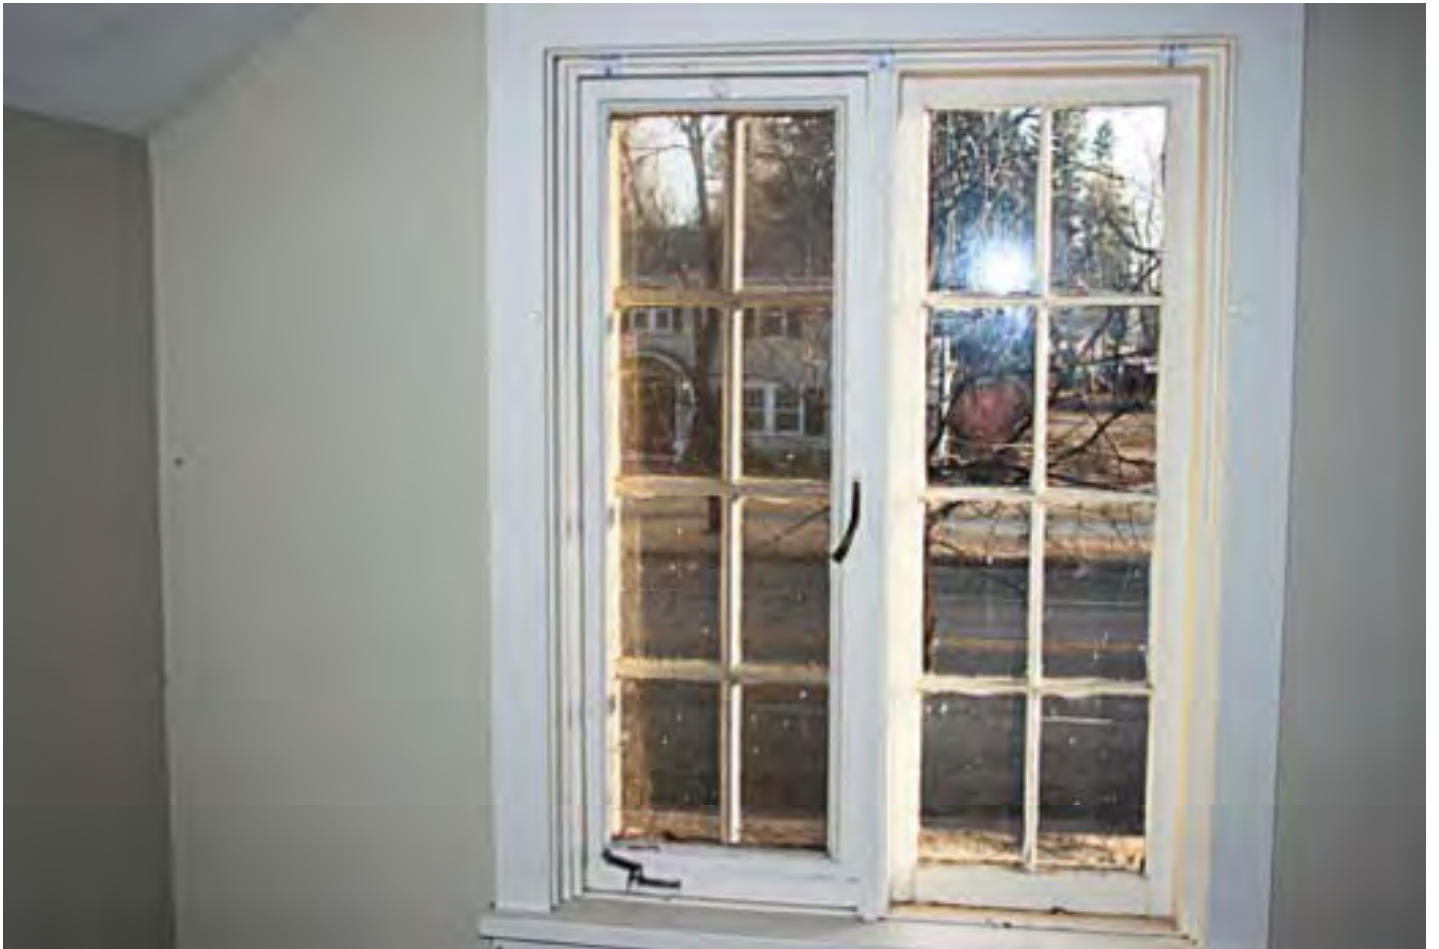
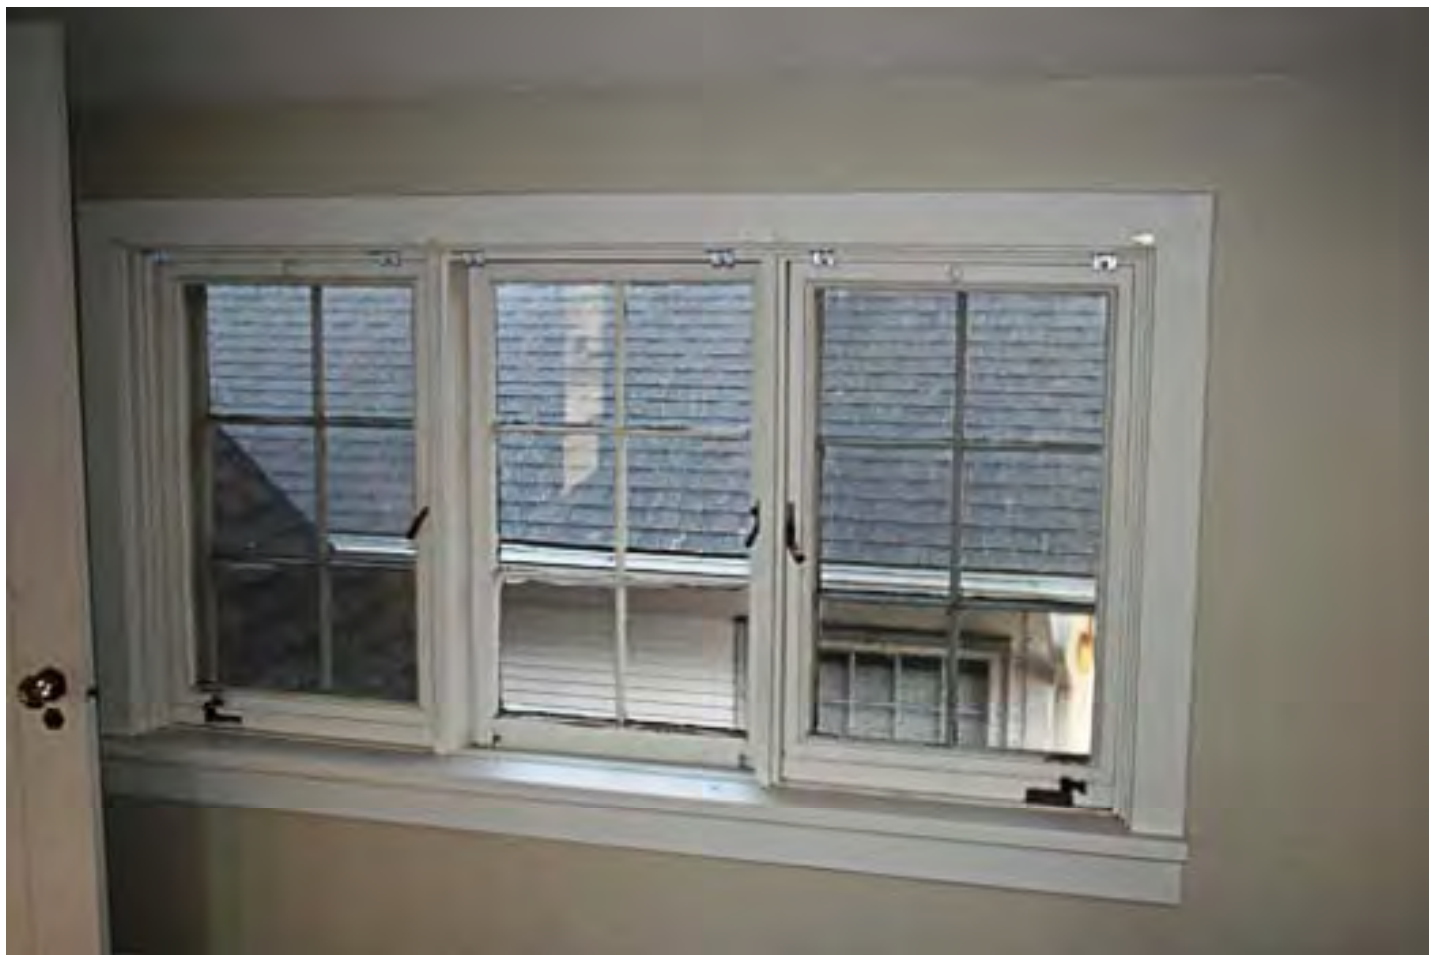
Windows 2-1, 2-2, and 2-7 through 2-14 should also be restored and the weatherstripping updated. While there is deterioration here, it is not sufficient to warrant wholesale replacement.

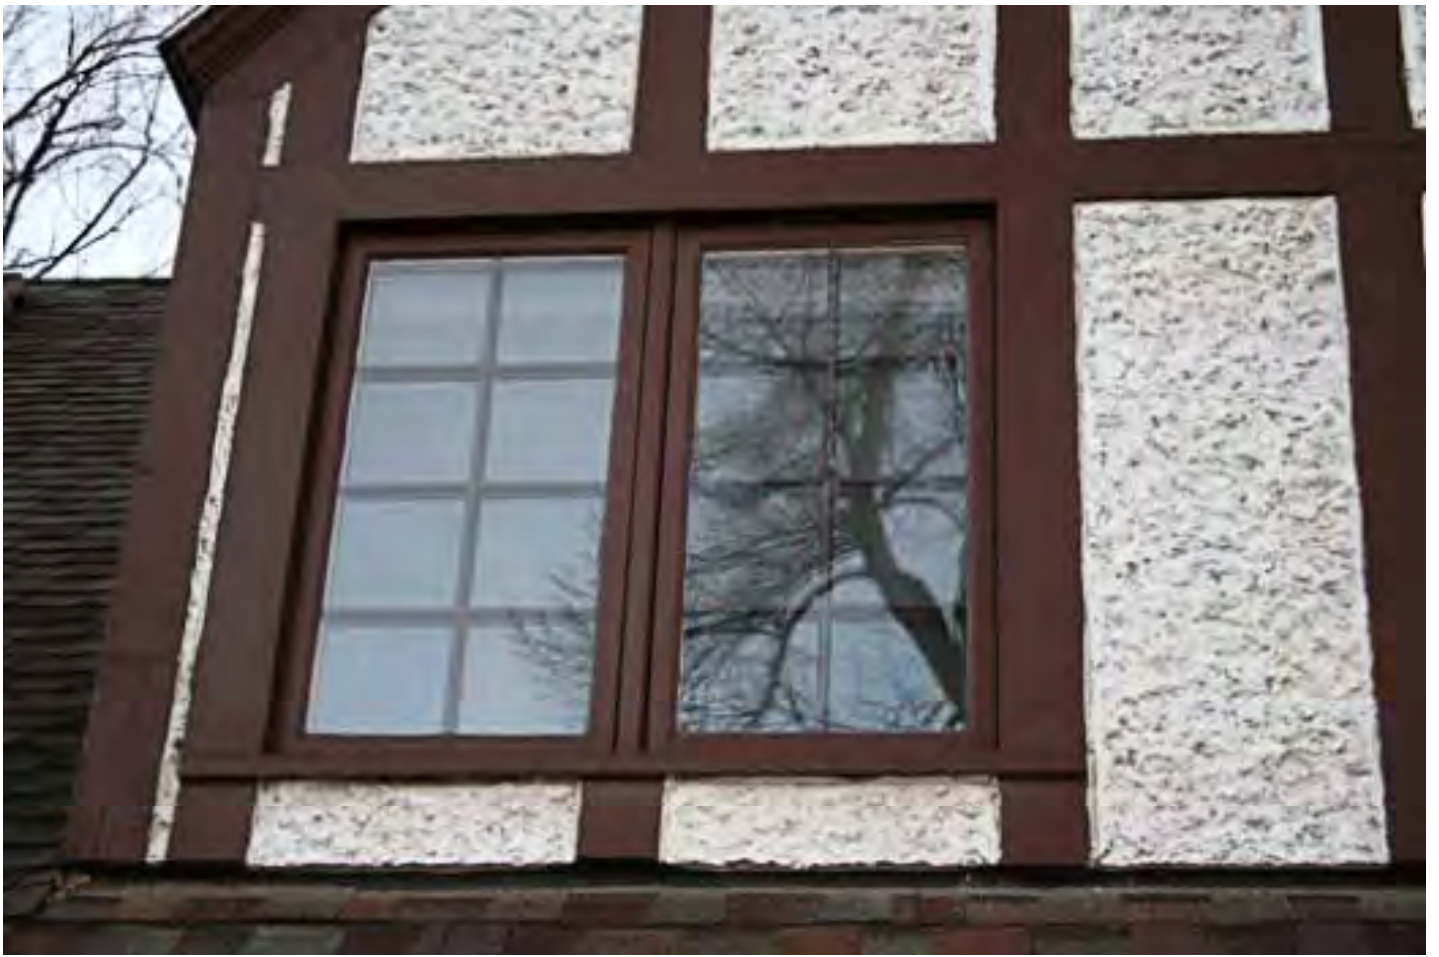
2-20\_2-21 Exterior

2	20	23" x 43" - Replacement																			
2	21	23" x 43" - Replacement																			
2	22	23" x 43" - Replacement																			
2	23	23" x 43" - Replacement																			
2	24	23" x 43" - Replacement																			
2	25	23" x 43" - Replacement
