CERTIFICATE OF APPROPRIATENESS ISSUED: February 19, 2025 EXPIRATION: February 19, 2026

As you are aware, the Historic Preservation Commission gave Final Design Review approval for the work you are proposing for the Willard and Gladys Eddy House and Shared Barn at 509 Remington St. at the HPC meeting held Feb. 19, 2025.

STRUCTURAL OBSERVATION – EXISTING BARN

509 Remington Street, Fort Collins

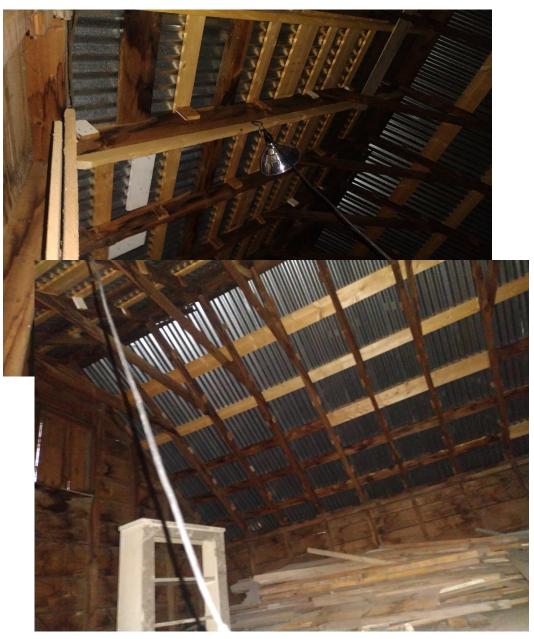
Figure 1: Existing Roof Framing

The roof is framed with uniformly spaced batten boards (purlins) bearing on 2x wood rafters. A corrugated metal roof is attached to the batten boards. Collar ties and the ceiling provide lateral restraint for the rafters. Refer to Figure 1.

As can be seen in Figure 1, the roof has been reinforced and possibly re-constructed since original construction. Although there is water staining on some of the structural members, no significant deterioration was observed.

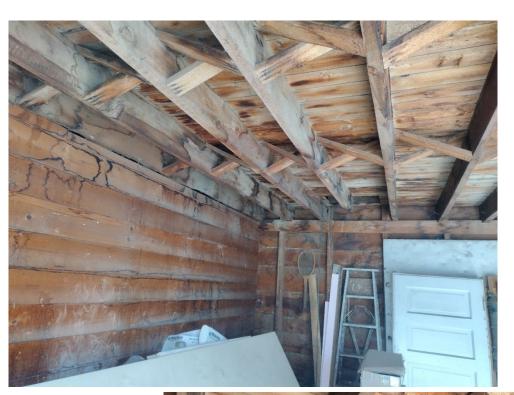
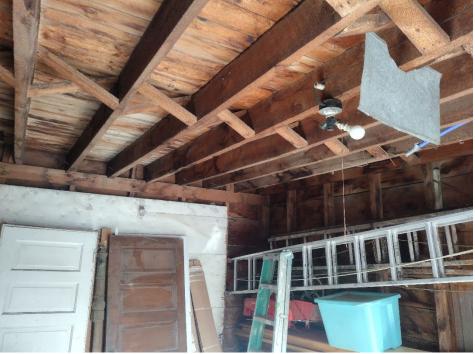
Figure 2: Existing Second Floor Structure

The ceiling / second floor of the barn is constructed with wood boards bearing on $2^{"} \times 7 \frac{3}{4}$ " (actual) joists spaced at 18" on center. Refer to Figure 2.

The second floor joists also exhibit some water staining, but no apparent loss of integrity. However, some joists have been cut or notched over the years and no longer have their original capacity. Joists that are cut and no longer have their original geometry (e.g. notched, discontinued) should be reinforced before lifting the structure.

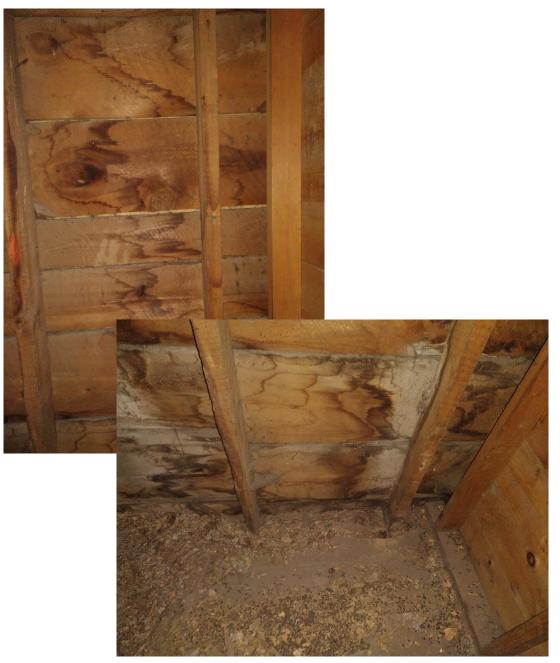
Figure 3: Wall Framing

The walls are framed with 2x4 (actual) studs spaced at 24" o.c. Nominal 1" horizontal boards are attached to the exterior face of these studs. In most locations, the bottom of these studs extend below finished grade. Refer to Figure 3.

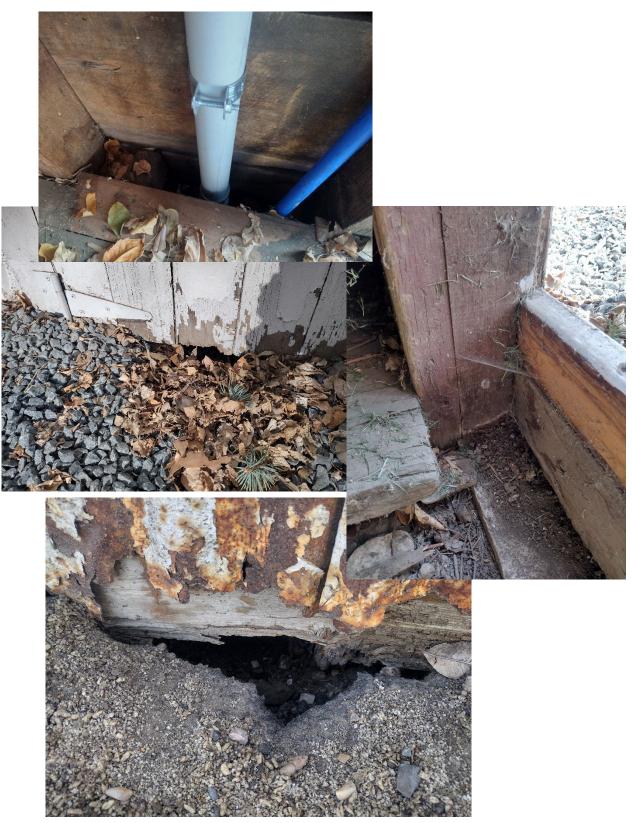
Figure 4: Base of Framing

Along all sides of the barn, it appears that the finished grade has been raised since original construction. It is most apparent along the west side where the alley grade is pushed up against the siding and studs. Deterioration of the bottom of the studs can be observed in multiple locations. Figure 4 shows some areas of deterioration and the built-up grade.

One important note from the structural report is the observed deterioration of the bottom of the wood studs in multiple locations. To prevent further deterioration, the bottom 12 inches of the wood studs will be cut and attached to a new treated sill plate bearing on a new foundation wall. This intent is depicted in the building sections on Sheet A1 of the included drawings for proposed barn renovation.

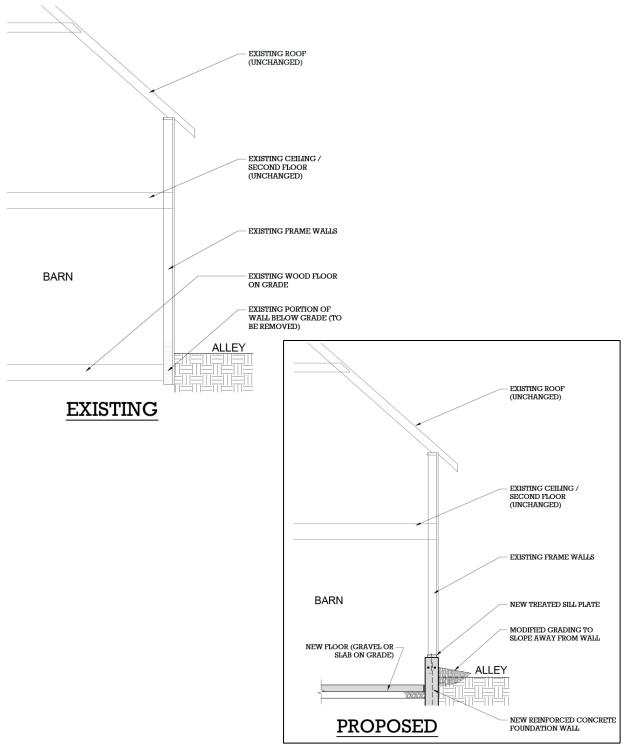
Figure 5: Schematic Sections

Once moved, the structure will be supported on a new concrete foundation. That foundation will need to extend a minimum of 6 inches above final grade to allow for improved grading and good drainage, and prevent future deterioration of the wall framing. This can be achieved by cutting the deteriorated portions of the existing walls (estimated as the bottom 8-12 inches), then attaching the studs to a new treated sill plate bearing on a new foundation wall. If a higher ceiling is desired in the final configuration, the foundation walls could be raised to accommodate. Similarly, the alley-side foundation walls can be raised higher than the others to protect the structure from snow build-up and possible minor snowplow impacts. There is no limit on the height that the structure can be raised, so long as the new foundation supporting it is designed accordingly.

Refer to Figure 5 for a schematic of the existing and proposed conditions.

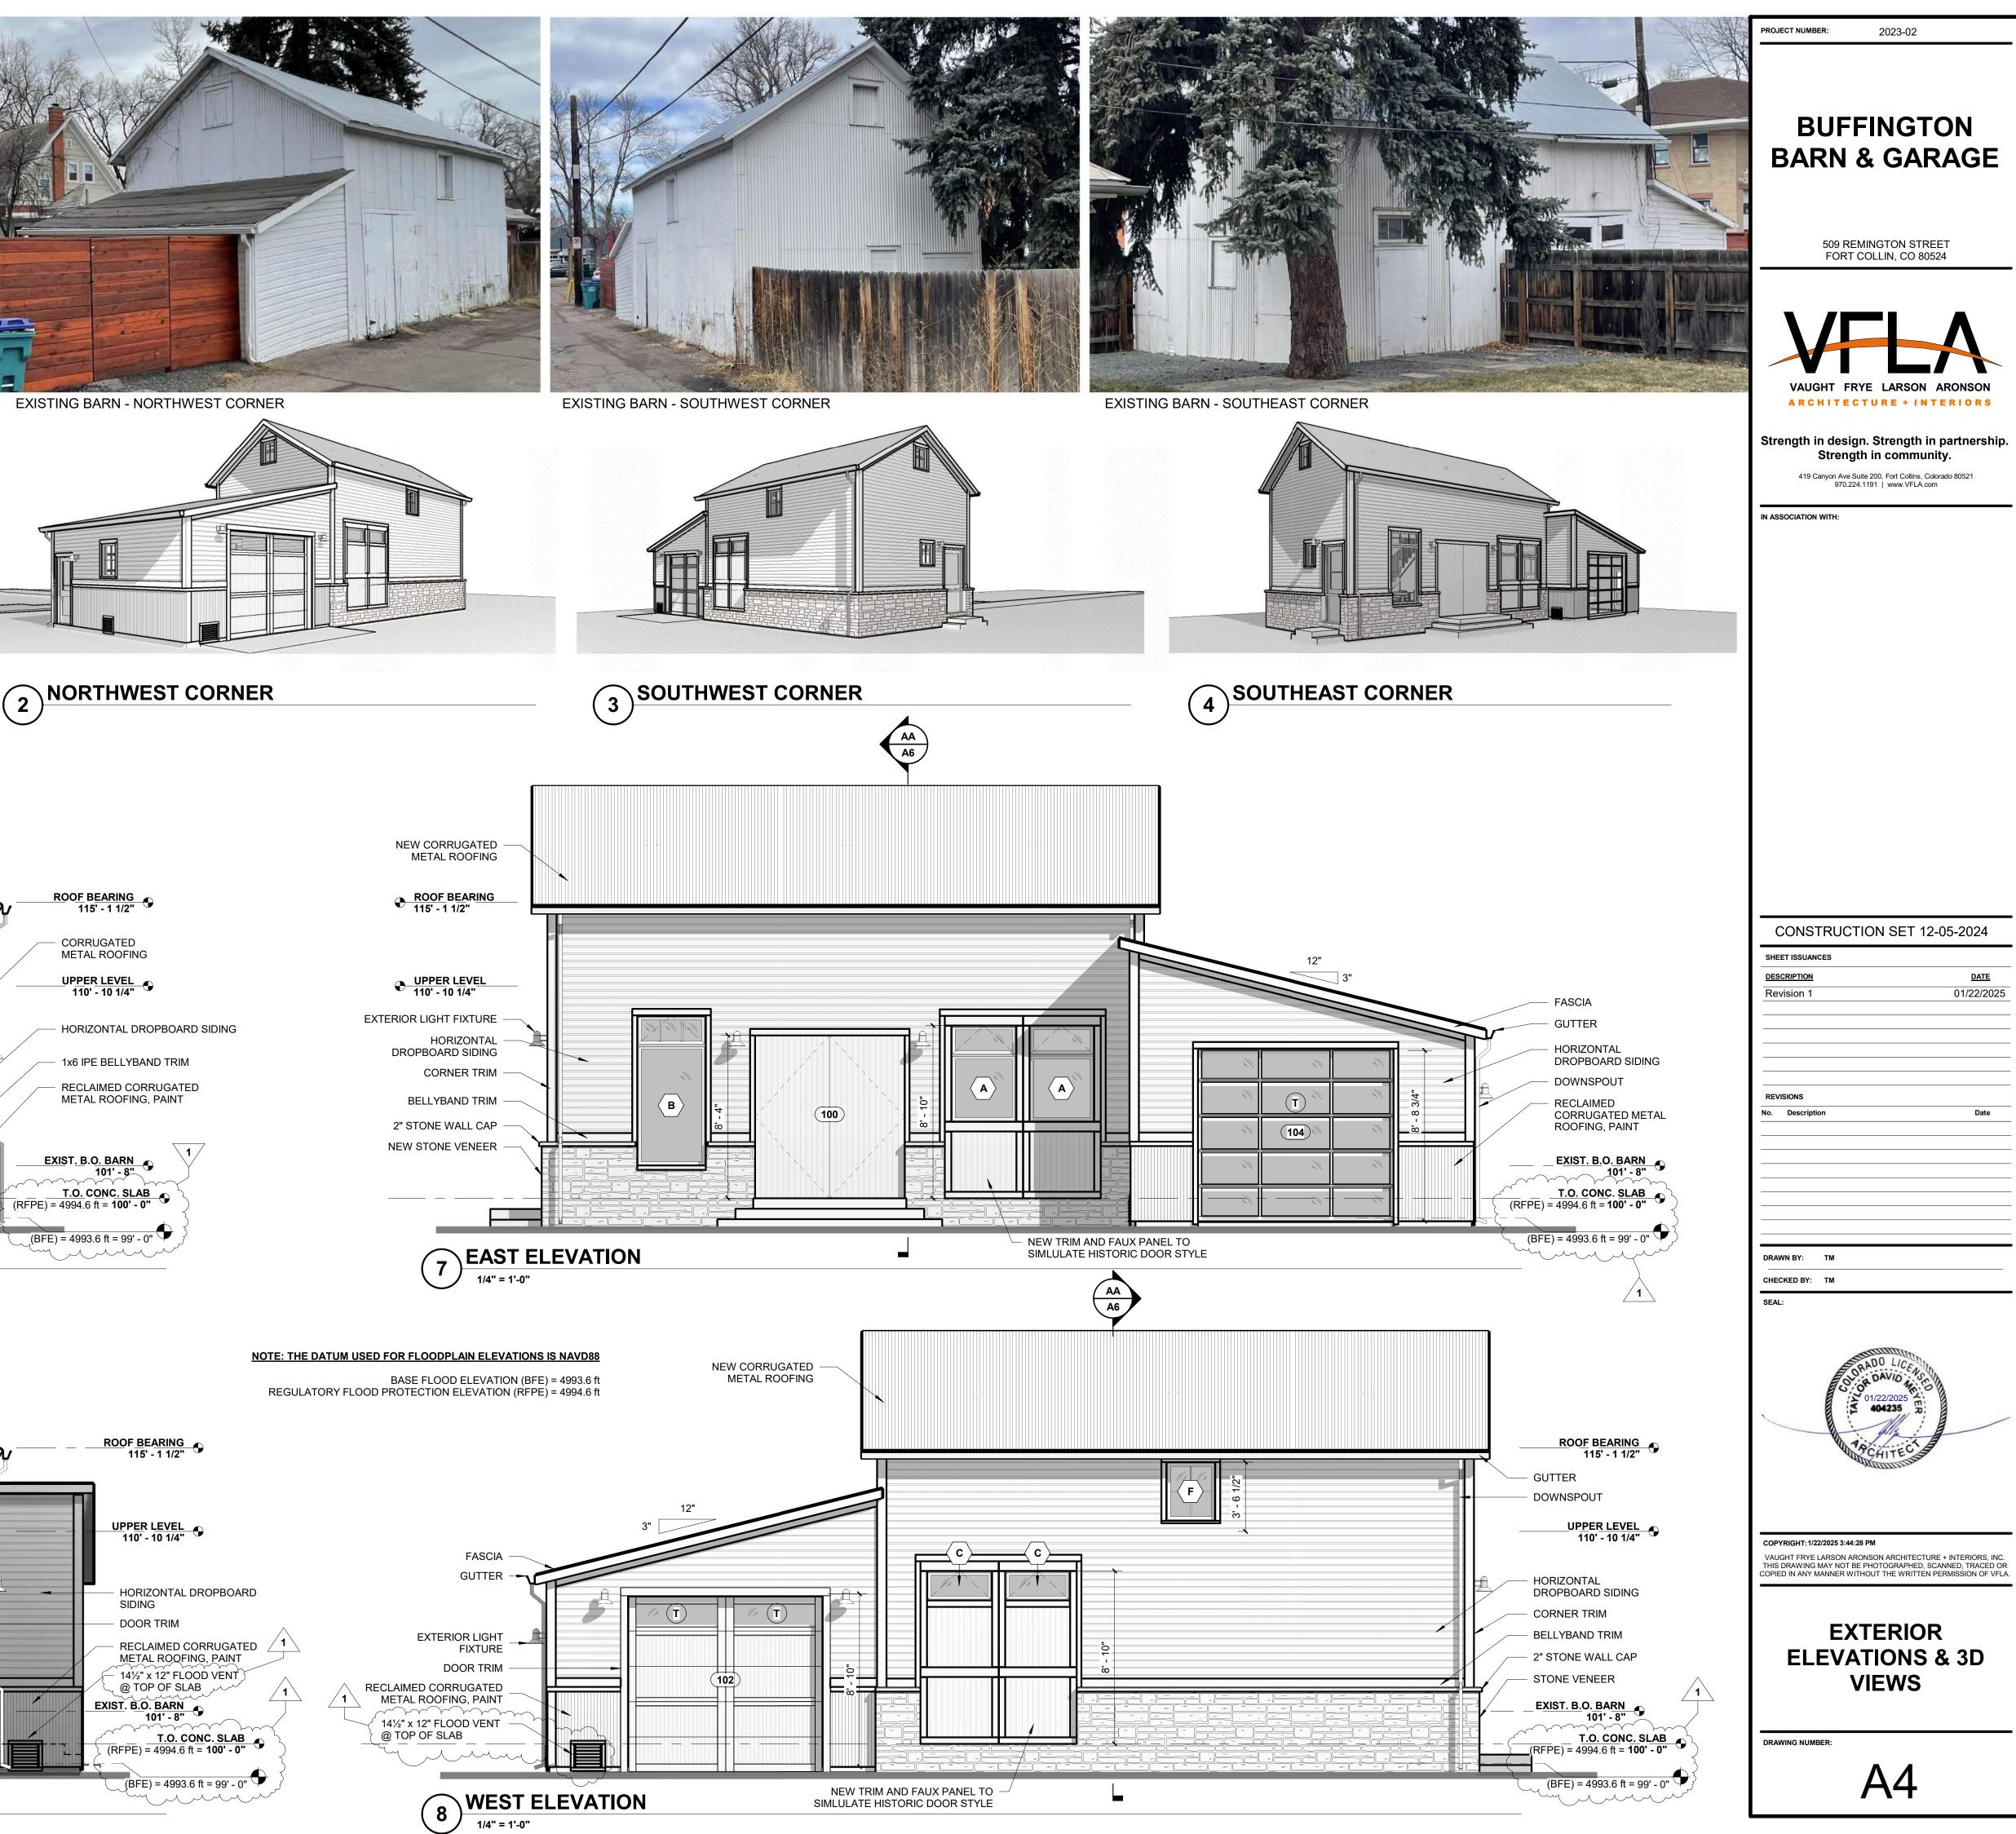
1 NORTHEAST CORNER

EXISTING BARN - NORTHEAST CORNER

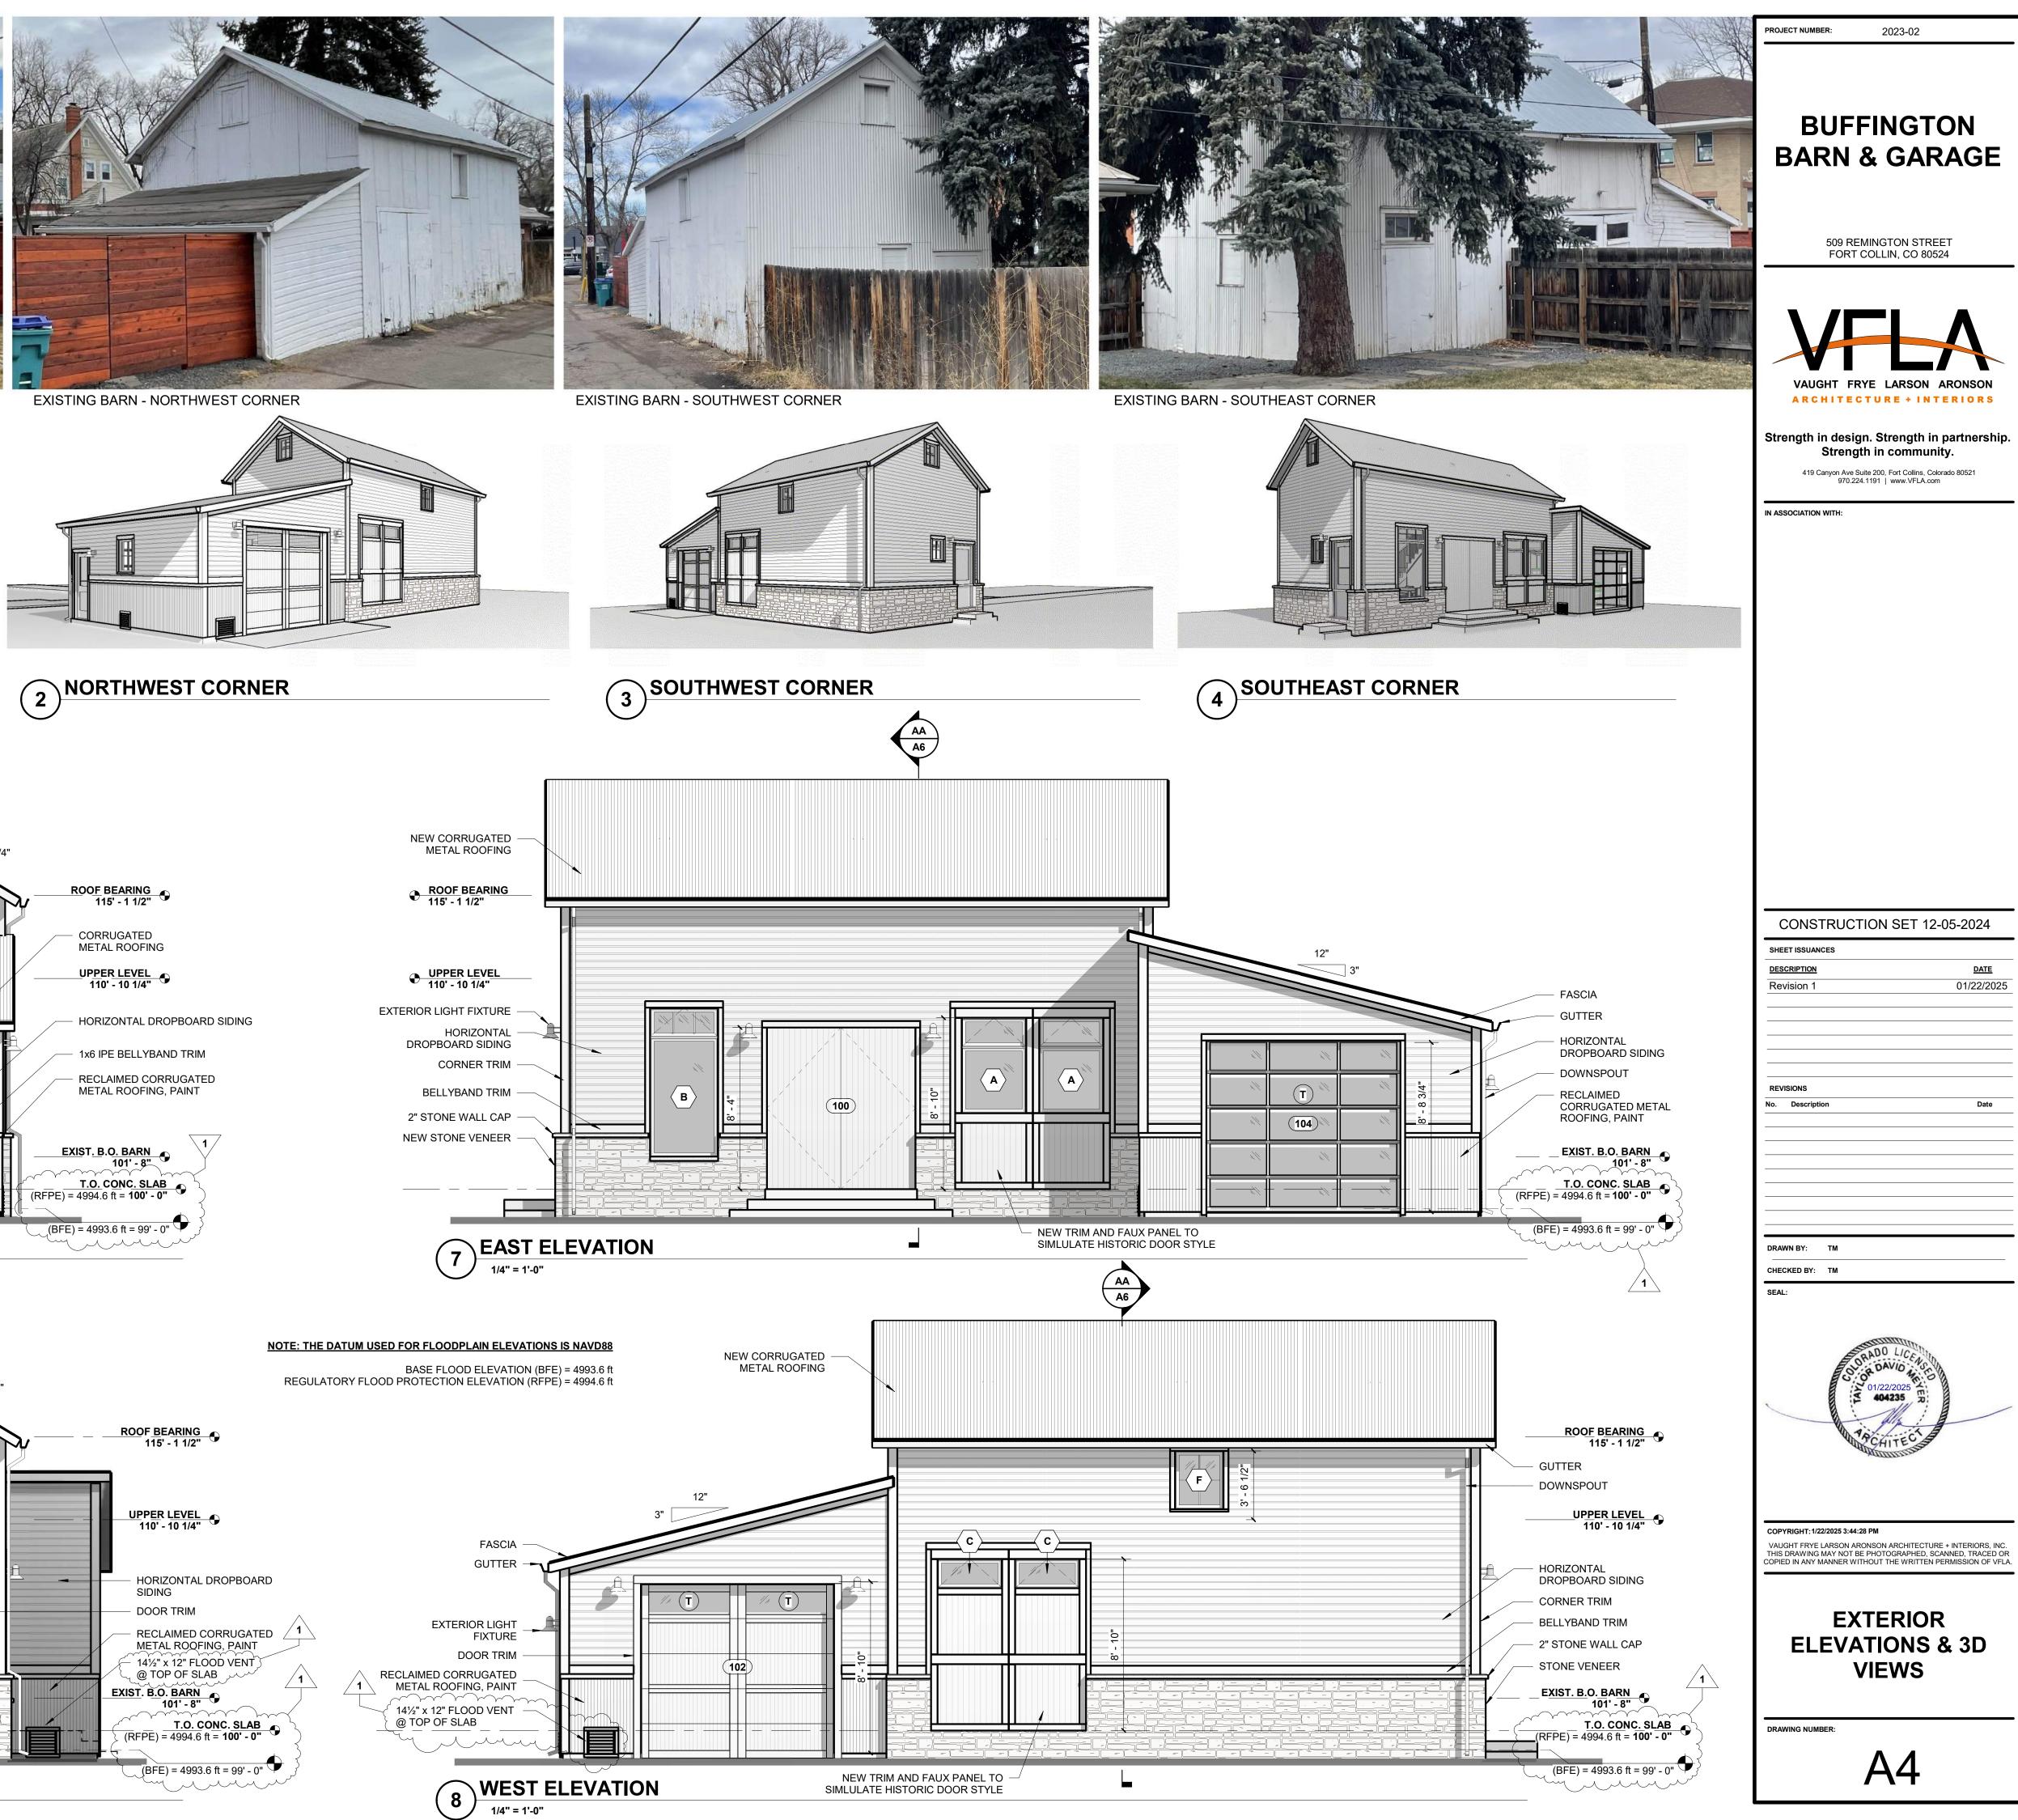
A6
 FASCIA 12" GUTTER DOWNSPOUT CORNER TRIM < Ο ` (103) 5 NORTH ELEVATION - 14½" x 12" FLOOD VENT @ TOP OF SLAB ------1/4" = 1'-0" BB A6 12" 7 1/4" FASCIA GUTTER HORIZONTAL DROPBOARD SIDING CORNER TRIM T BELLYBAND TRIM (101) 2" STONE WALL CAP NEW STONE VENEER DOWNSPOUT -P 6 SOUTH ELEVATION

- Move barn about 5' 6" east and 7' 6" north and raise about 39" onto new concrete foundation
- Stone veneer (Edward's Stone thin stone veneer in Driftwood color; approx. 2" thickness; locally sourced stone) added to lower portion of building, demonstrating raised level and including lower wood wall area removed due to rot
