### CERTIFICATE OF APPROPRIATENESS - DENIAL

This letter provides you with confirmation that the proposed changes to your designated Fort Collins Landmark property, the C.M. Smith House at 622 Remington Street have been denied by the City's Historic Preservation Division because the proposed work does not meet the criteria and standards in Chapter 14, [Article IV](#) of the Fort Collins Municipal Code.

- 1) Demolition of two brick chimneys at the center and on rear elevation of the building to be replaced with metal chimneys/vents.

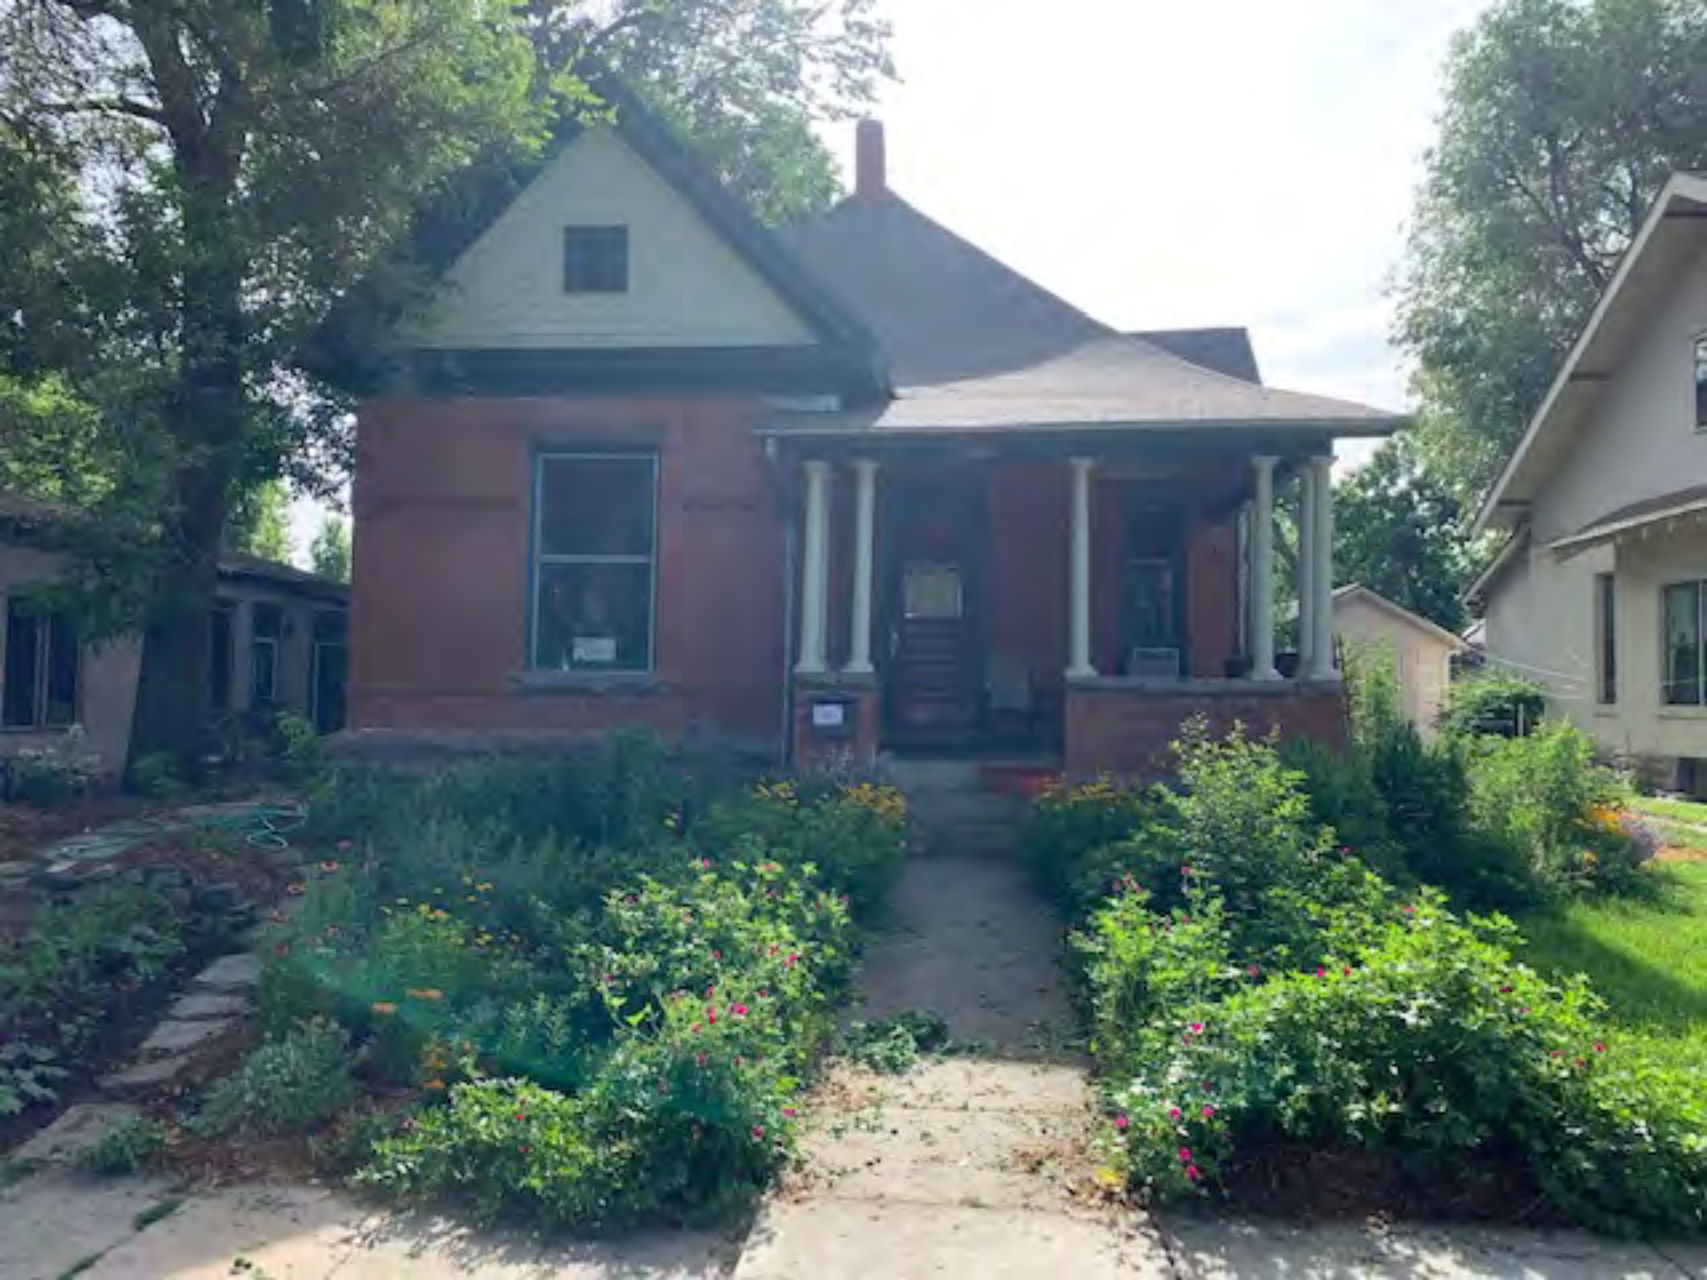
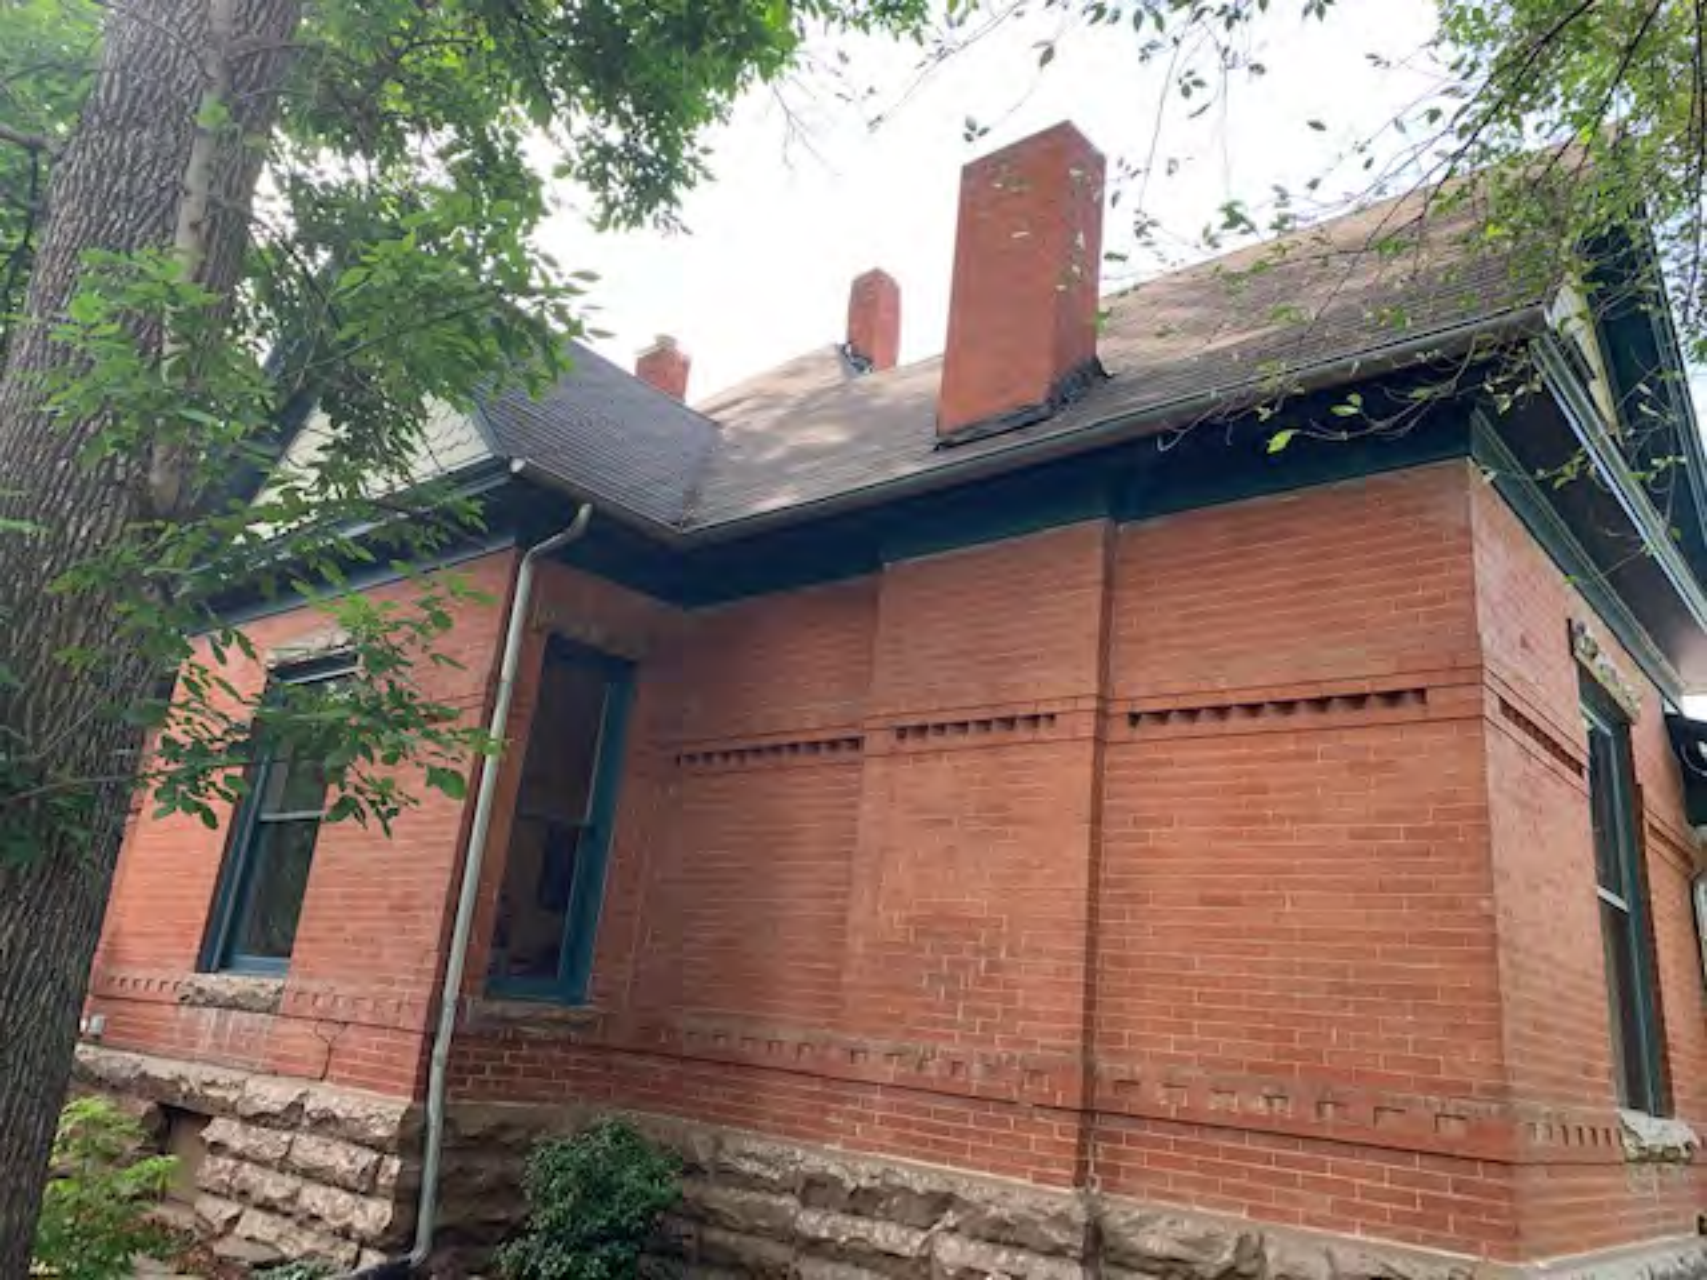
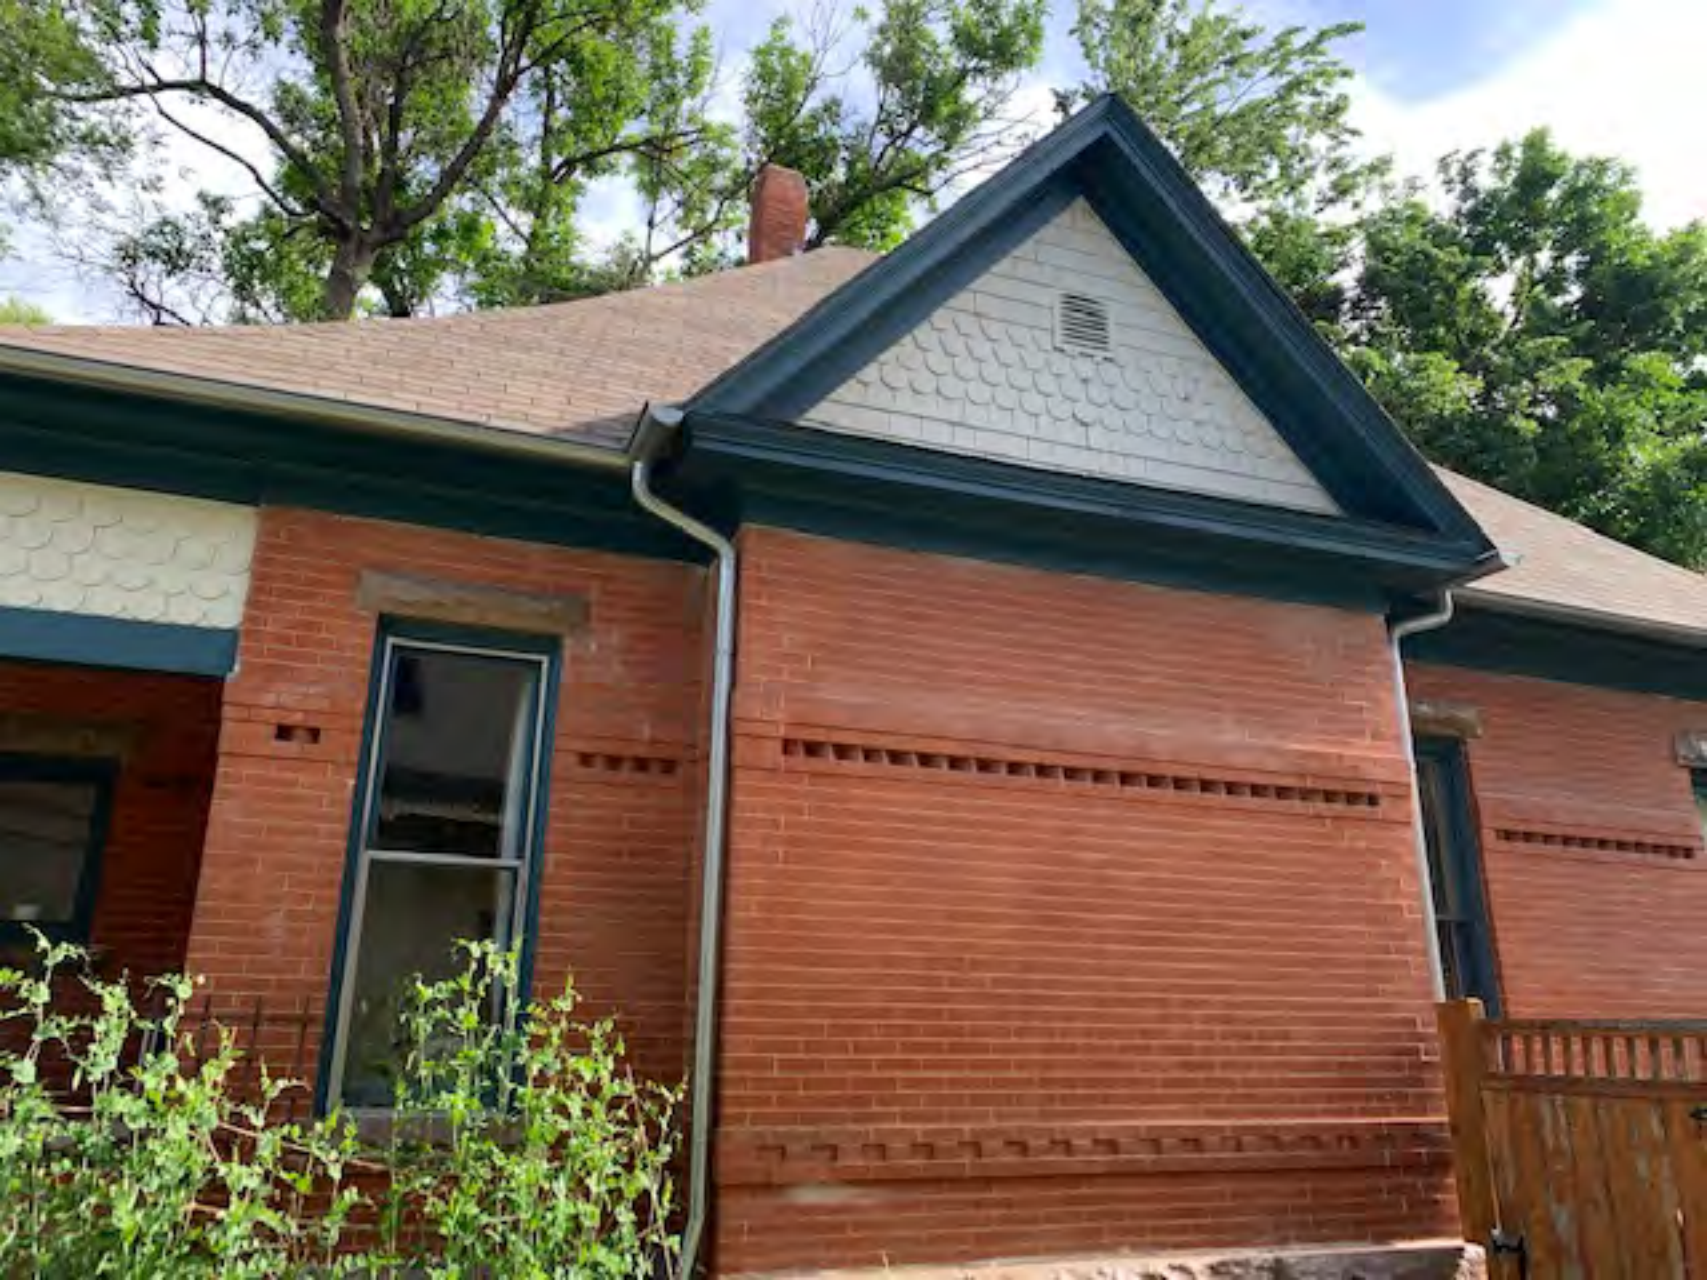
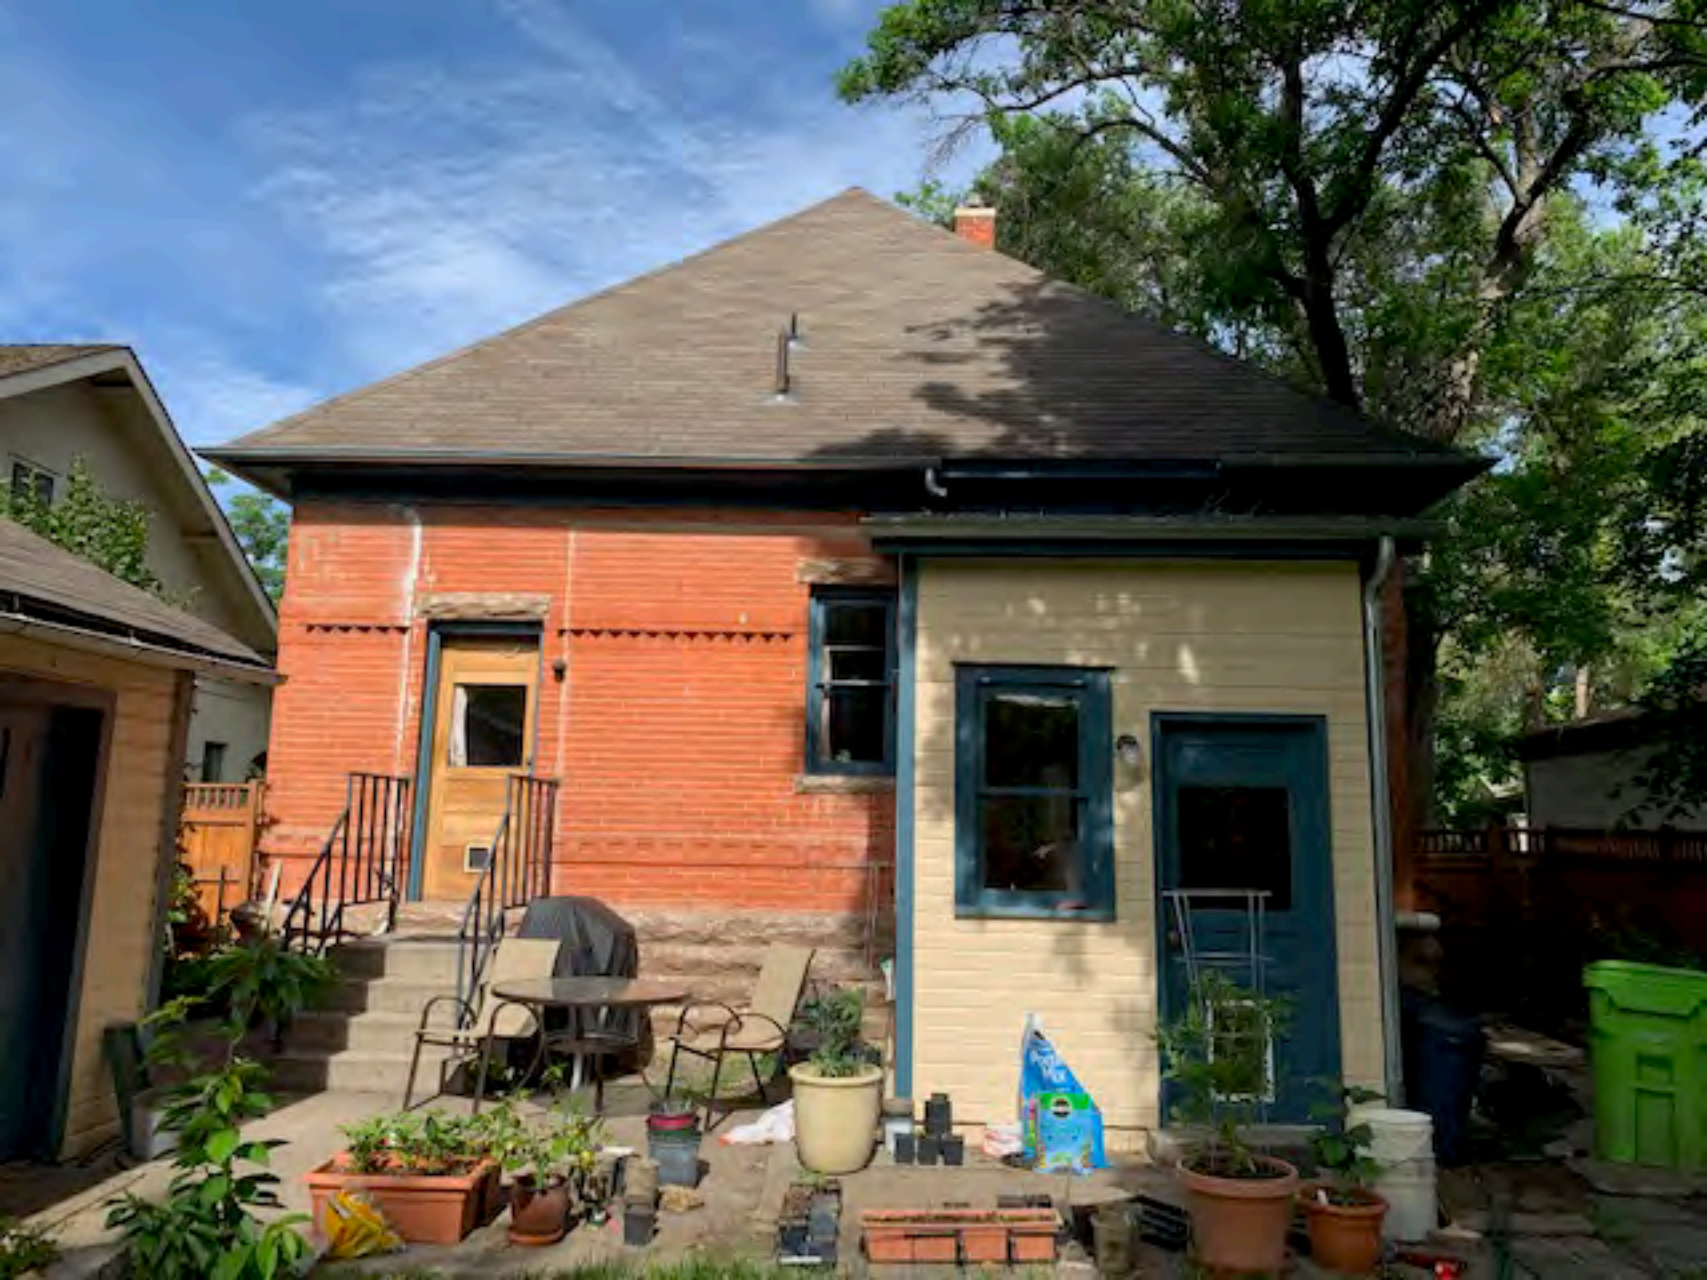
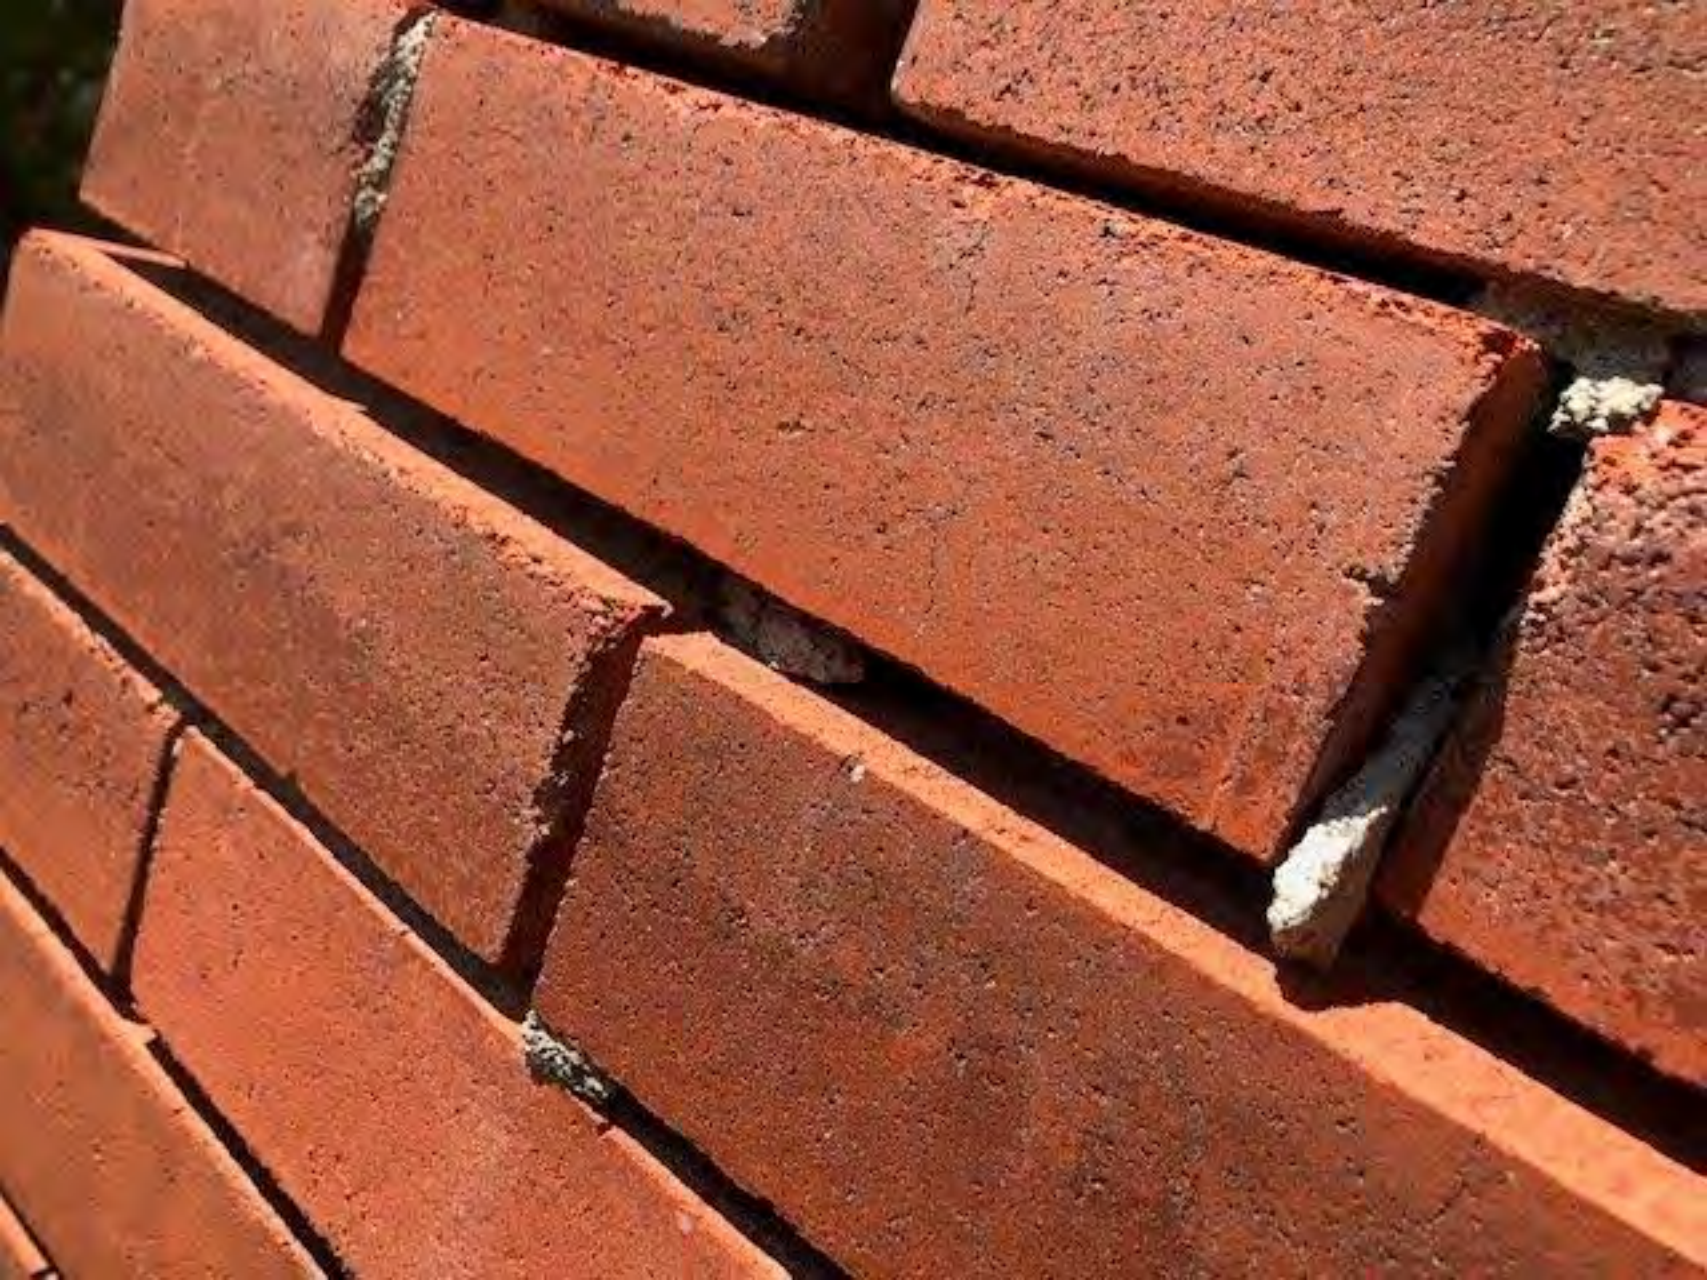
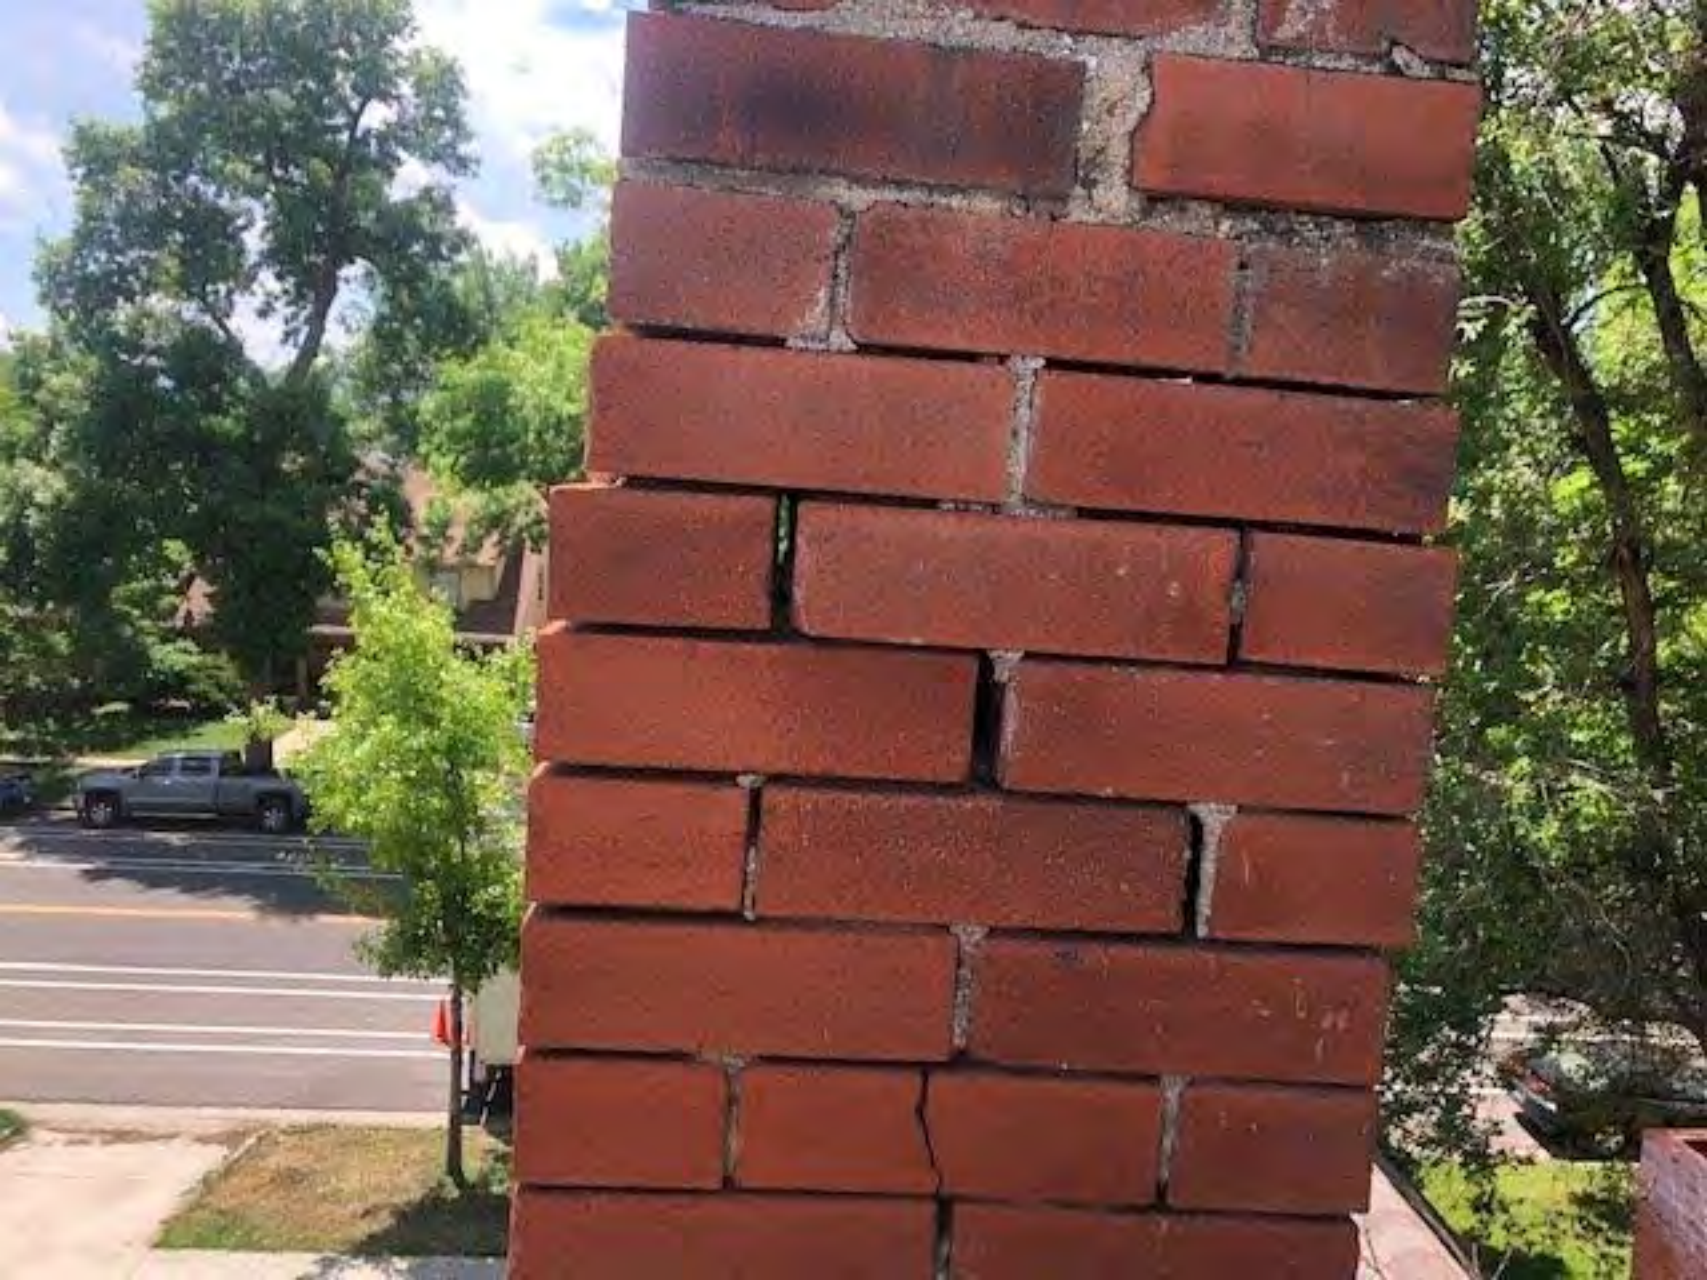
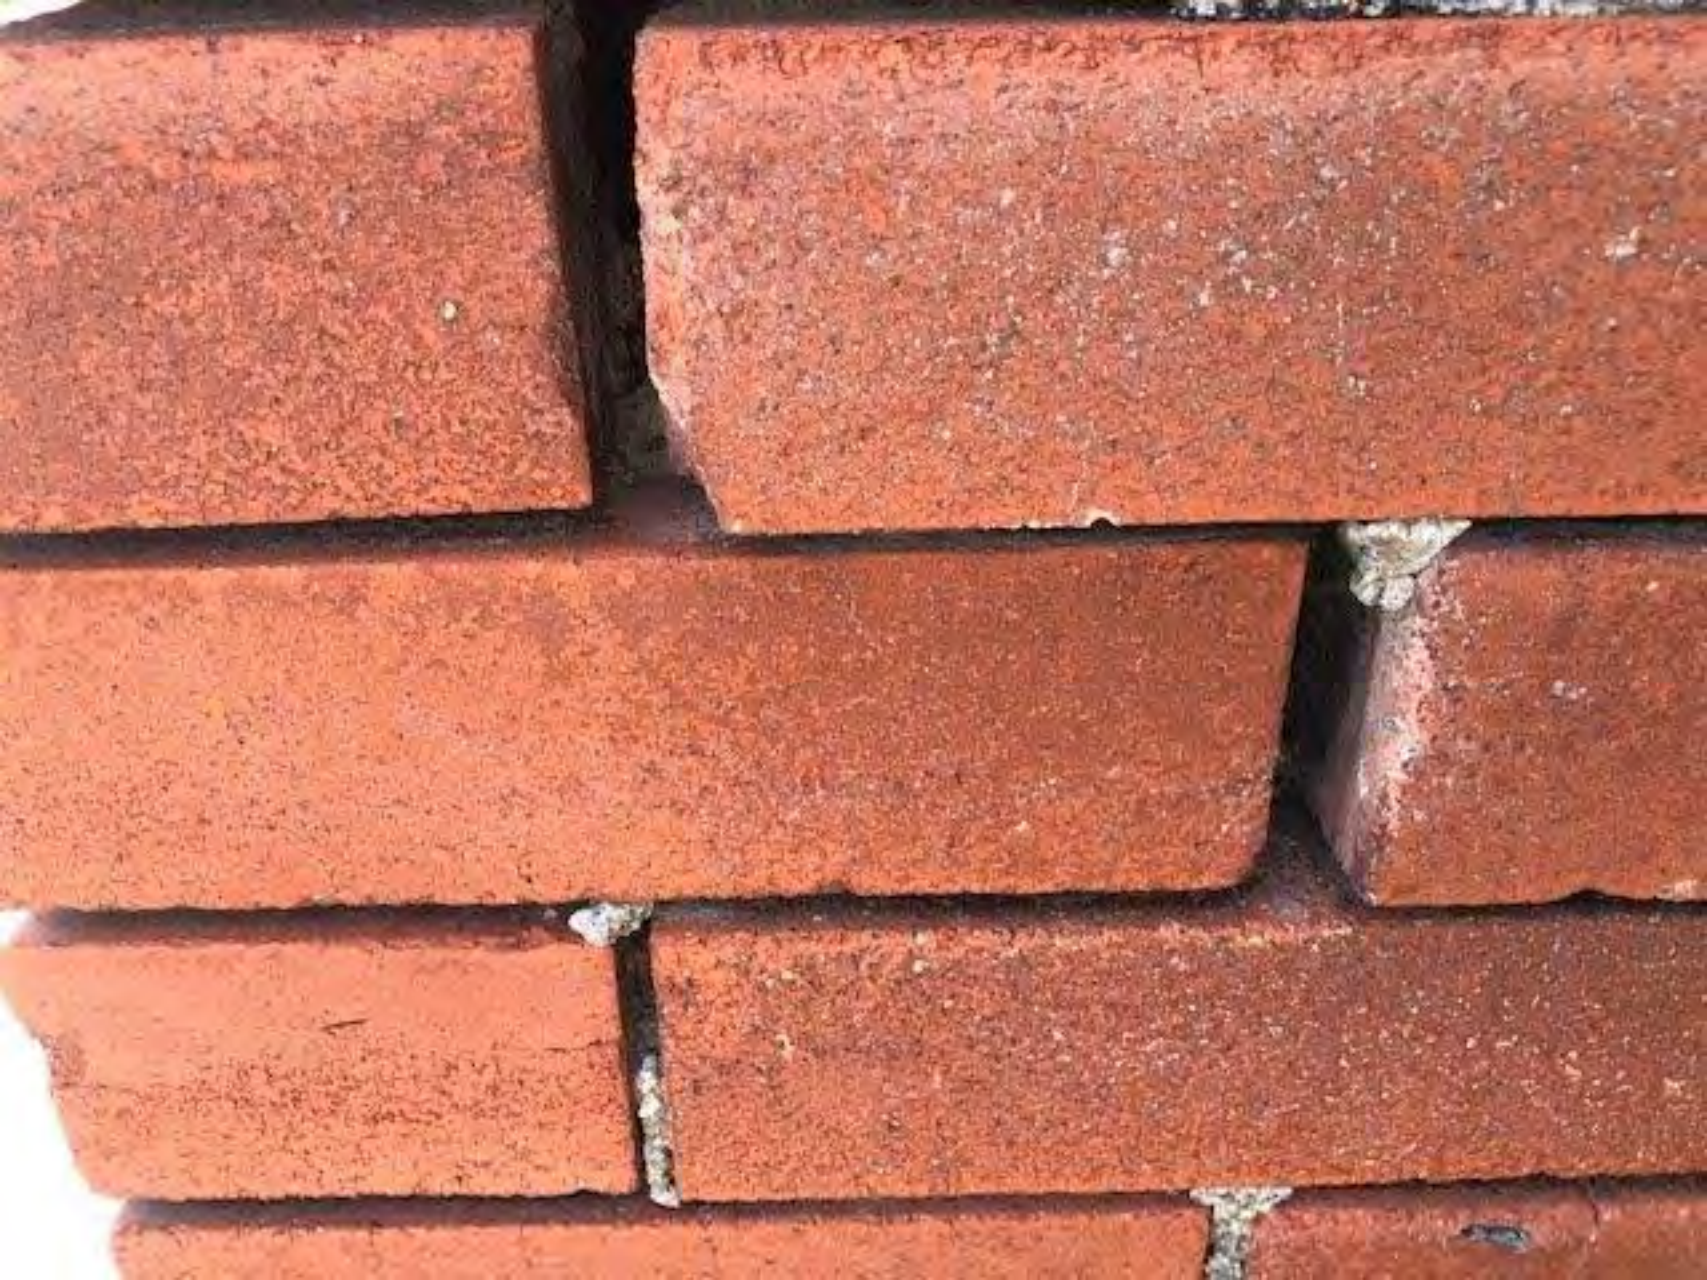
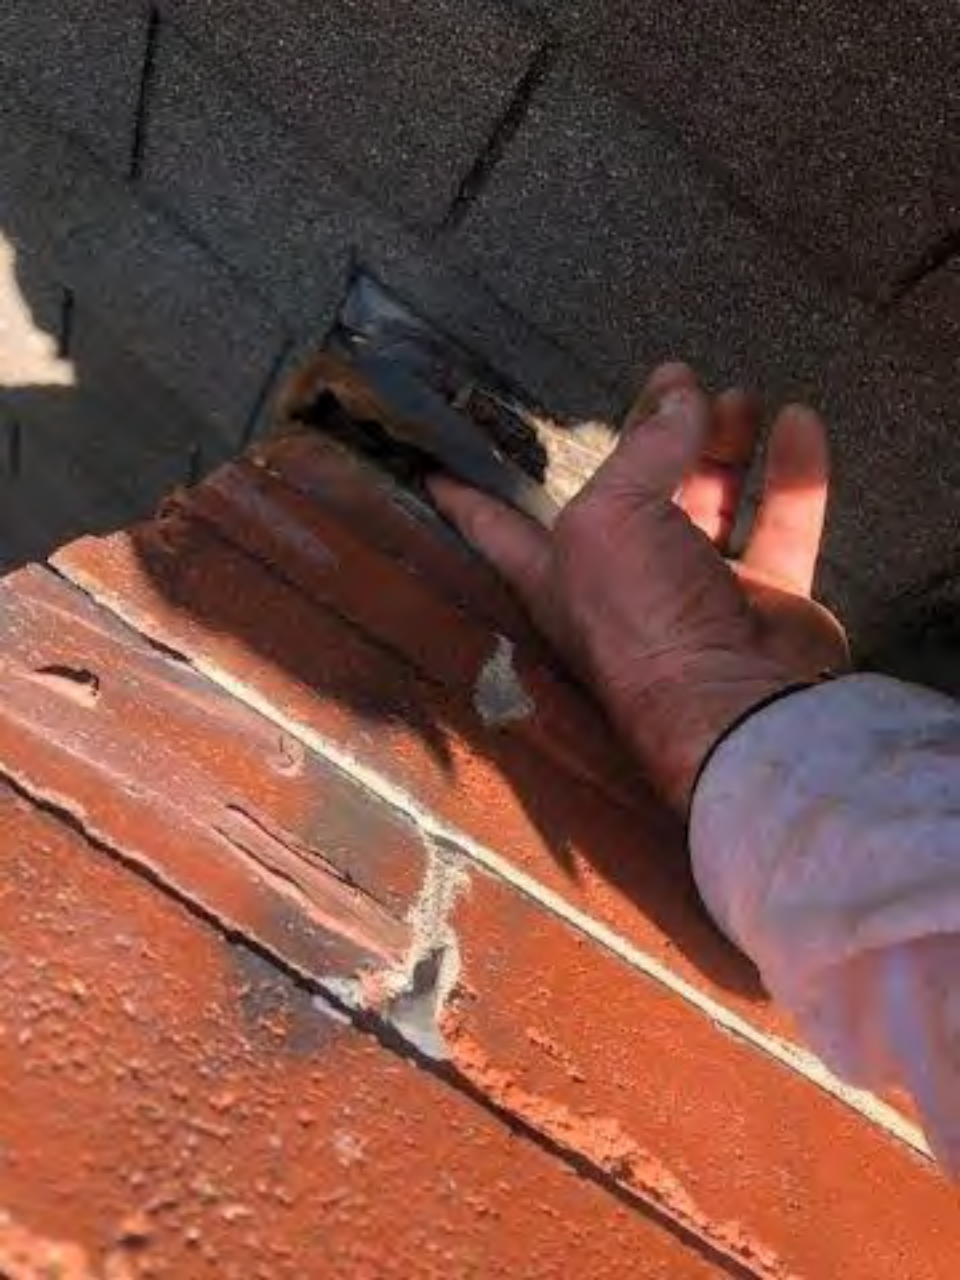
<b>Feature A Name:</b>	
<p>Describe property feature and its condition:</p> <p><b>Chimney A (center of roof):</b></p> <p>Both the mortar and the brick have seriously deteriorated. The chimney has become unstable and started to lean and is now on the verge of collapse.</p> <p>There are serious safety concerns with the chimney in its current state.</p> <p>The flashing has also become detached, and there are modest signs of water damage in the attic.</p>	<p>Describe proposed work on feature:</p> <p>Artisan Roof Repairs has recommended removing the chimney above the roof line. We believe that this would not only ensure the long-term health of the property, but also emphasize the quirky and unusual shape of our Queen Anne Revival style roof, which has a steep pitch and possesses a variety of interesting angles and features.</p> <p>The chimney currently contains the vent for our basement furnace, so we would need to replace it with a metal chimney pipe or flue.</p> <p>We wish to make as minimal an intervention to the exterior of the home as possible.</p> <p>The remaining area would be resingled. Roofing materials would be consistent with the existing roofing.</p>

<b>Feature B Name:</b>	
<p>Describe property feature and its condition:</p> <p><b>Chimney B (rear of roof):</b></p> <p>This chimney has also deteriorated significantly. There is a large gap between the roofing and the chimney. (See photos.) Water damage is likely, although it is not visible from our attic access point.</p> <p>Although the condition of this chimney is not as dire as Chimney A, it has suffered considerable mortar loss and will likely need to be rebuilt at a future date, if it is not removed.</p>	<p>Describe proposed work on feature:</p> <p>Artisan Roof Repairs has recommended removing the chimney above the roof line. This chimney is not widely visible from the street and is also, due to tree cover, not noticeable from the rear of the property. We believe removing it would have little or no impact on the visual and aesthetic appeal of the property.</p> <p>The chimney currently serves as the exhaust for our stovetop vent, so it would need to be replaced by a modest metal chimney pipe or flue.</p> <p>We believe removing this chimney would ensure the long-term durability, safety, and condition of our home, while making only a minimal impact on the historic nature of the property.</p>
